# Stearns County Ditch 04 Repair Proposal

April 22, 2022

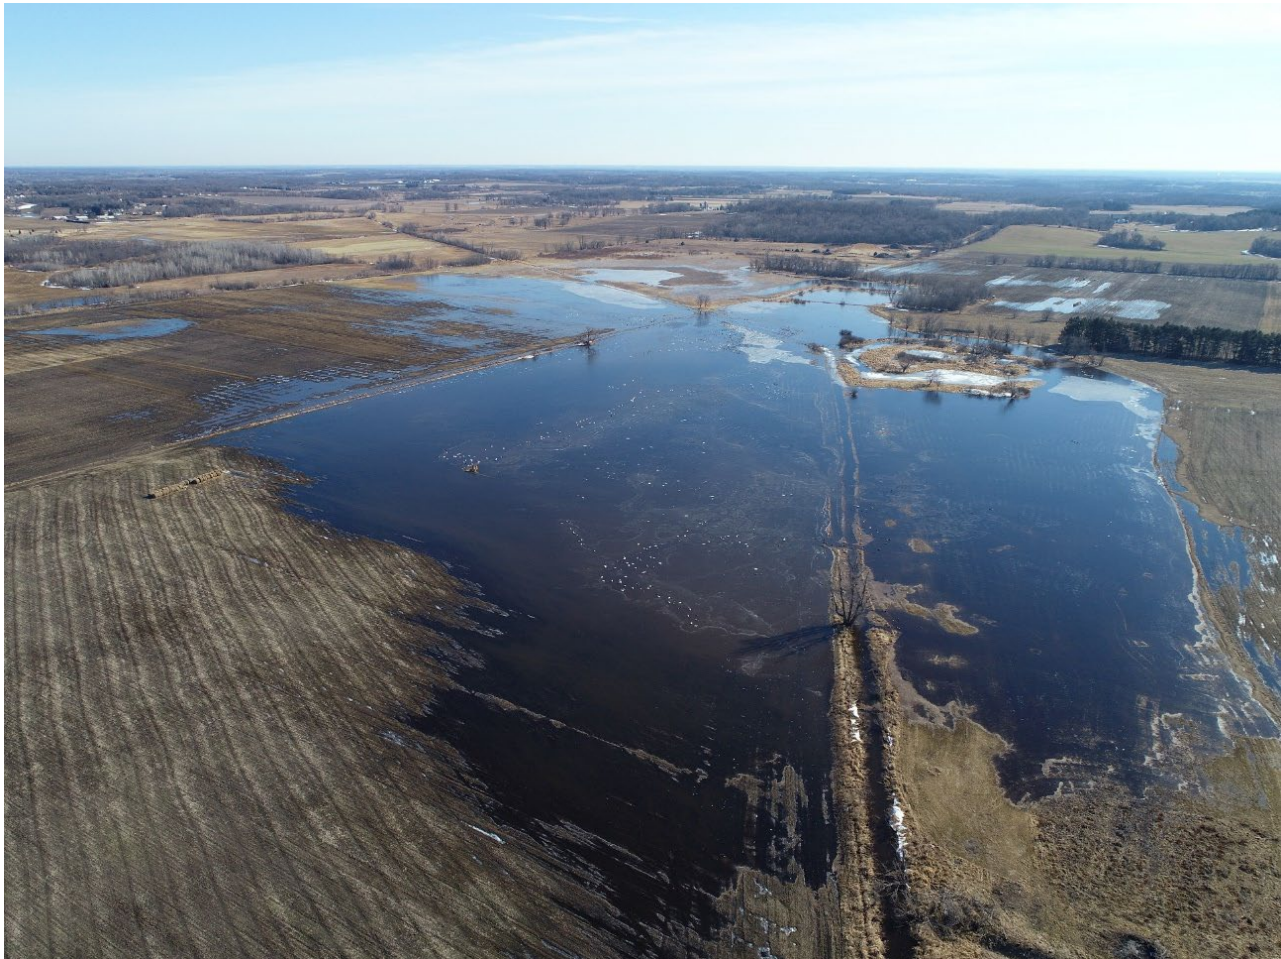
The area east of 130<sup>th</sup> Ave is known to hold water. The photo below is from April of 2022. While the water in the photo appears severe, frost was not out when this photo was taken which would contribute to excess pooling. This area is naturally low and the high ground to the north contributes water to the area. Two factors show opportunities for repair. The first being vegetation in the area on both sides of 130<sup>th</sup> Ave and the road culvert both visually holds water and plans developed during record reestablishment show the culvert to be high when compared to the legal ditch bottom elevation. Vegetation in the area has a limiting impact on the channels ability to move water. The purpose of the repair is to allow excess water to flow west as originally designed, which does not mean instances of flooding will not occur as shown in the photo below, but duration of flooding should be reduced.

*Area east of 130<sup>th</sup> Ave*

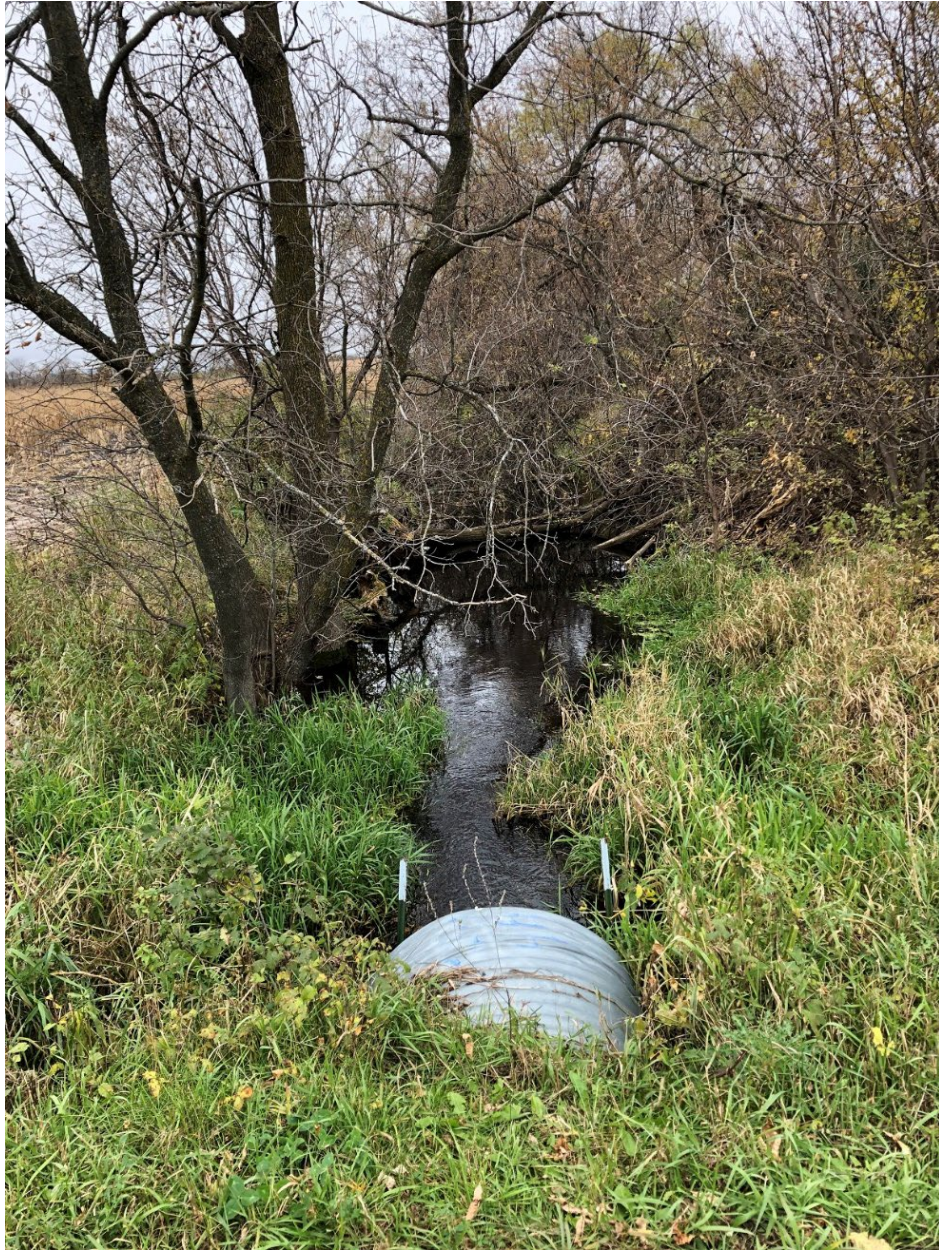
*From 130<sup>th</sup> Ave looking west at CD 04 Oct. 14, 2019*

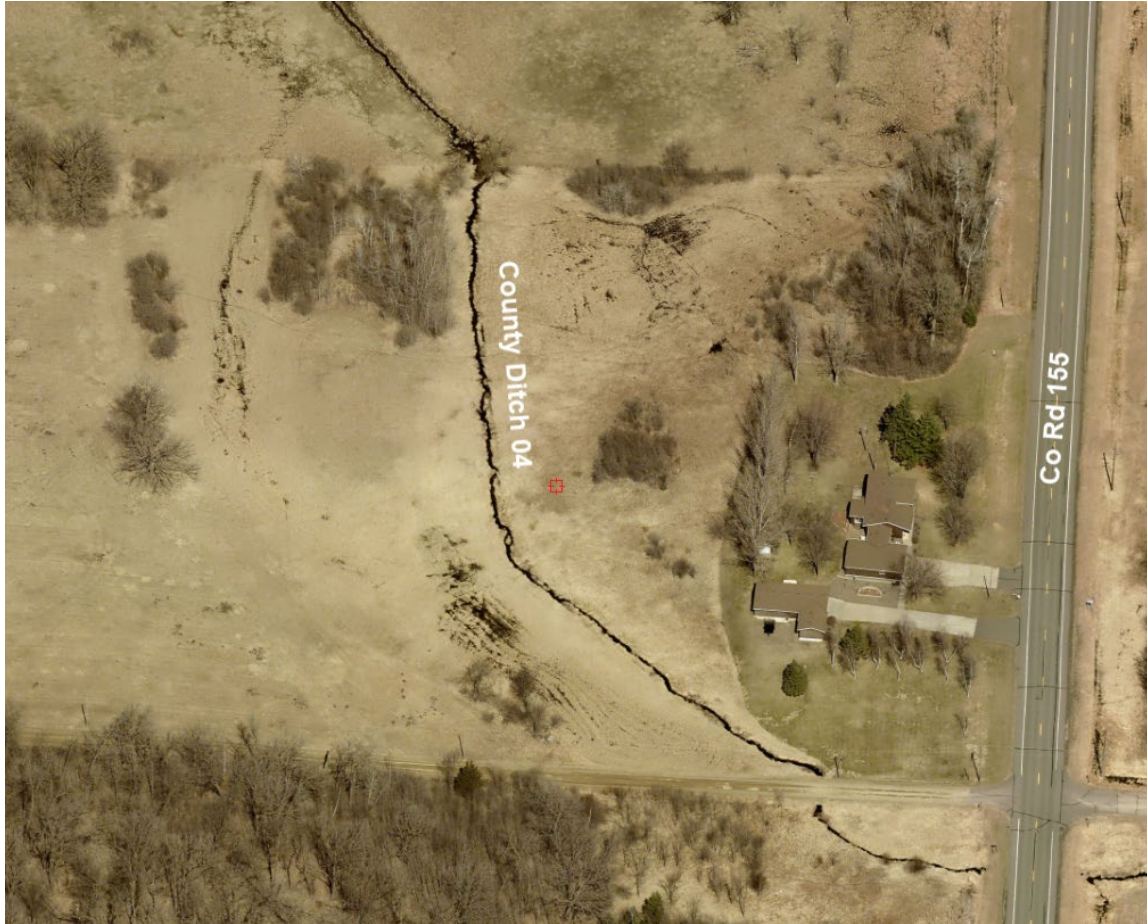
CR 155 Project Site

There have been concerns from property owners at the downstream end of the ditch regarding water being held in the area. The channel is overgrown, and the channel has both narrowed and filled with sediment since original ditch construction.

The goal for this section of County Ditch 04 would be to restore the channel to its as constructed and subsequently improved condition (ACSIC) to restore capacity and move water within the channel banks, which is expected to limit excess water from saturating the area.

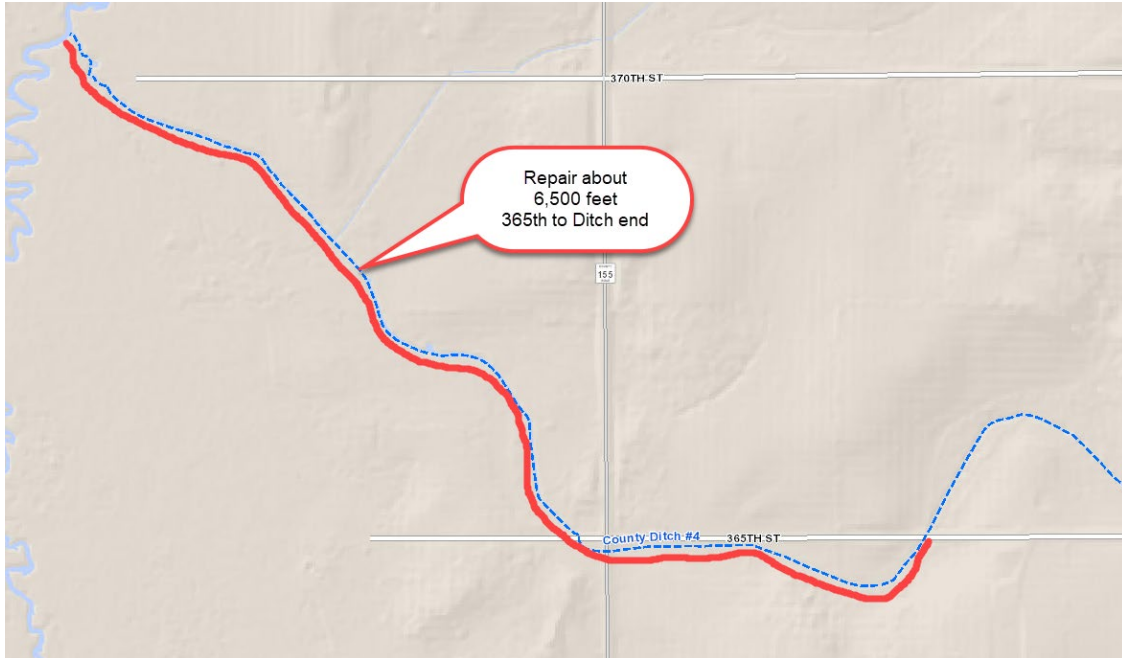
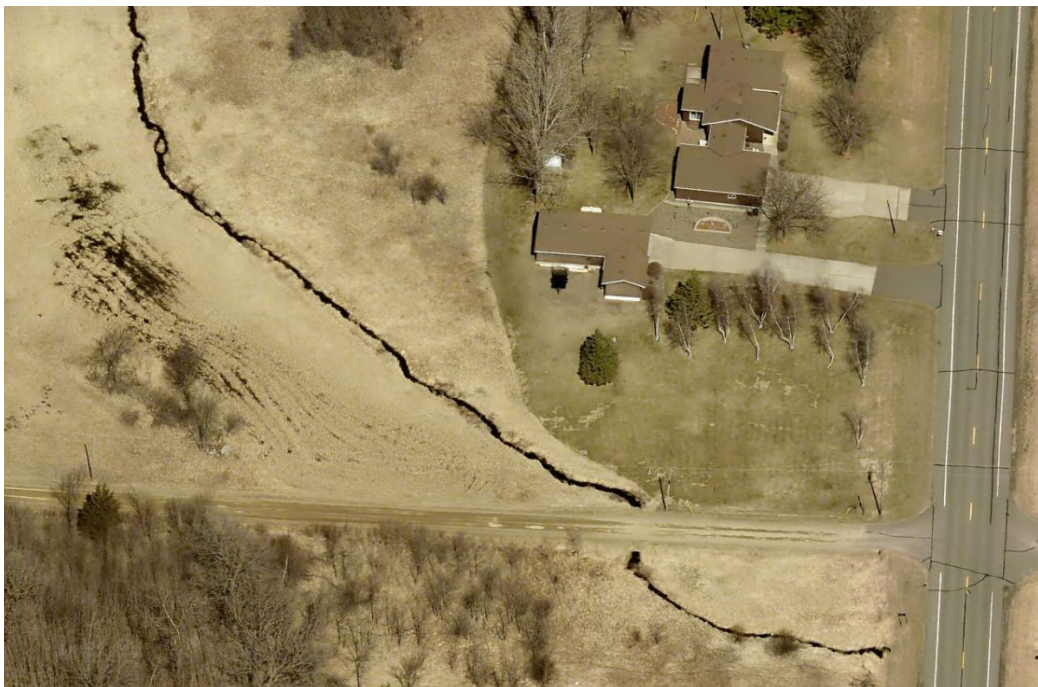
Ditch End to Co Rd 155 – approximately 6,500ft

The original construction files show a ditch top width range of 10.18 feet to 4.2 feet across in the area of the Co Rd 155 to ditch end. The original constructed ditch bottom was predominantly 4 feet. Issues in this area include steep side slopes and thick vegetation which is restricting flow.

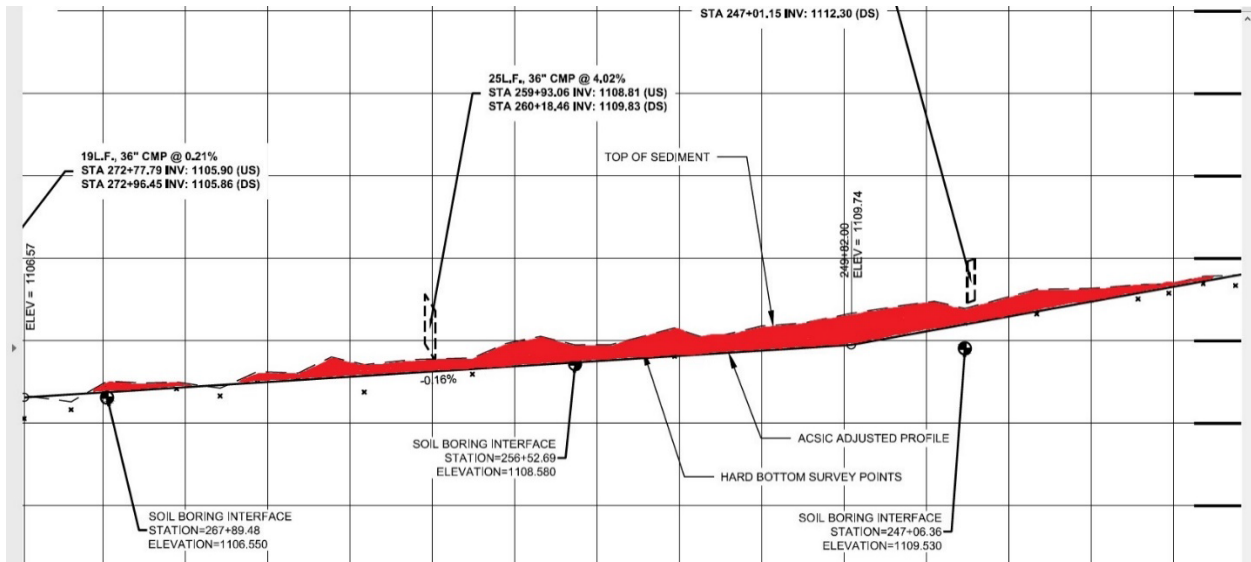
*Excerpt from Engineers Report on Reestablishment of Drainage Records*

While there is ample elevation fall in the ditch profile, the ACSIC profile showing the legal ditch bottom compared to the top of muck in the current ditch bottom, shows opportunities to address sediment in the channel. Excess sediment is shown in red shade below.

*Near ditch end and Co Rd 155*

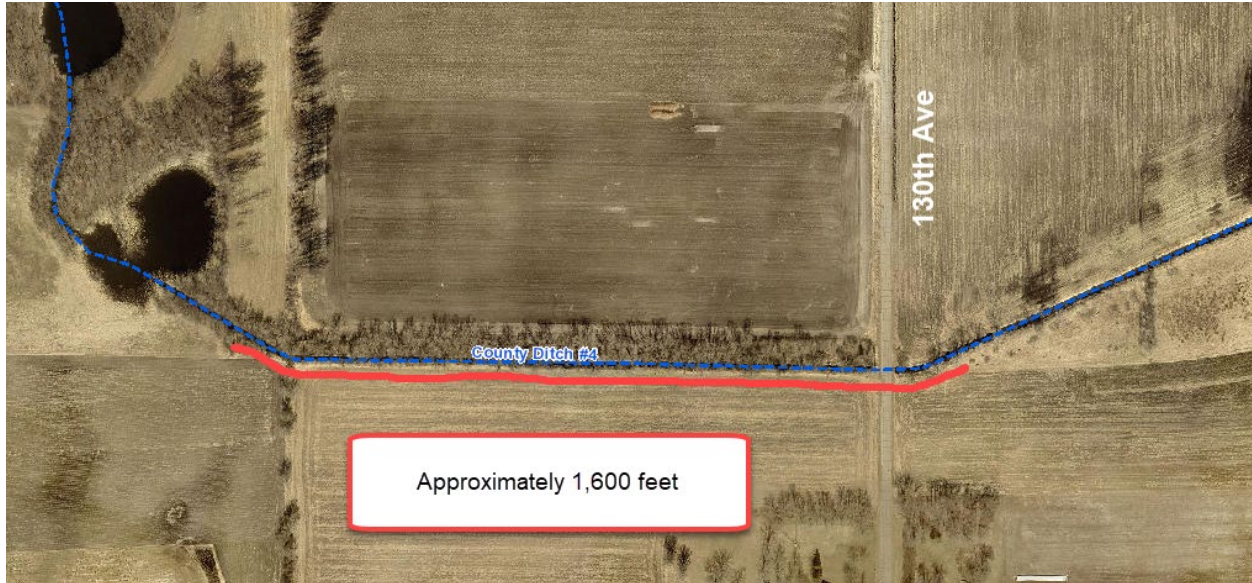
Area near 130<sup>th</sup> Ave – approximately 1,600 feet

Vegetation is the primary issue west of 130<sup>th</sup> Ave. Mature tree growth and dead fall accumulation in the channel are affecting the ability of water to flow. Stearns County staff performed a small clean up in the spring of 2021 and although the work was performed with only hand tools, the work completed had a visible positive effect. It should be expected that vegetation removal on a larger scale would not only restore drainage performance but enable access and result in fewer maintenance issues in the future.

As stated earlier, the goal of a repair in this area is not necessarily to repair to the legal ditch bottom elevation. To limit the scope and cost of any potential repair, in conjunction with vegetation removal, the repair would focus on shaping the channel and removing high spots of sediment accumulation to allow drainage in this flat area.
