DITCH INSPECTION REPORT

CD04

STEARNS COUNTY MINNESOTA

August 17, 2019

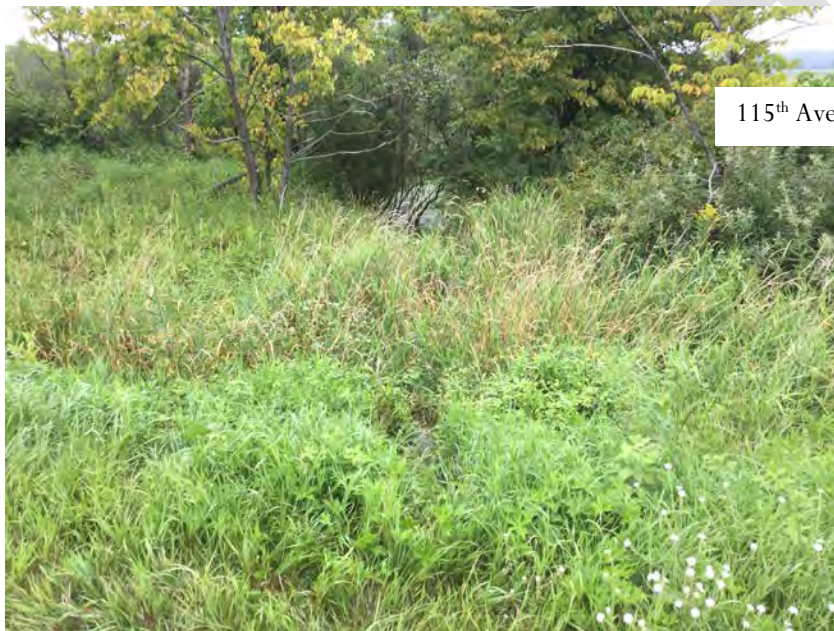
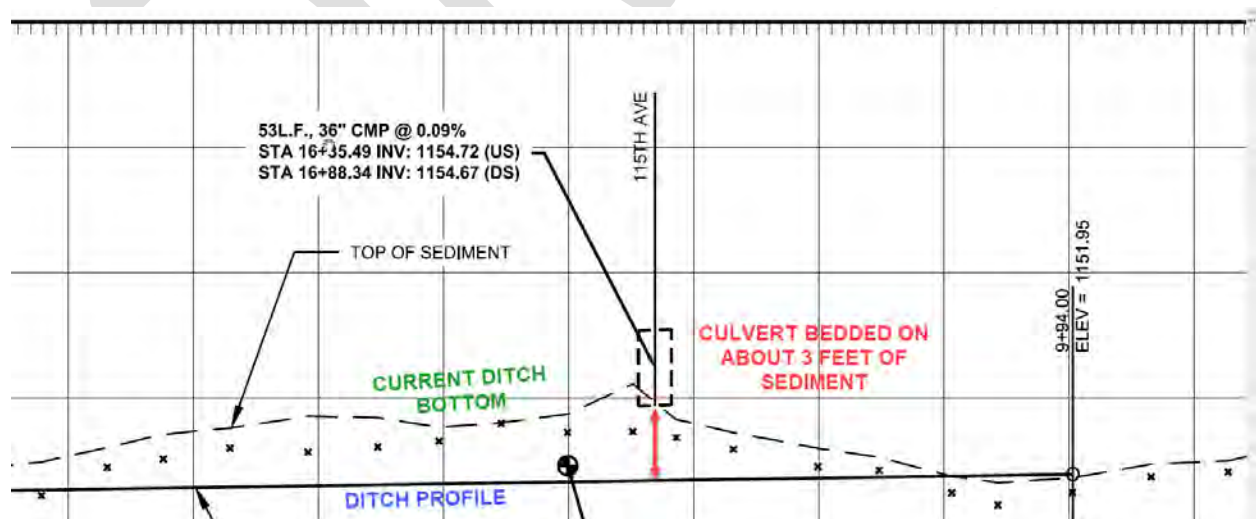
Inspection Section 1

This portion of the ditch inspection was completed on a crossing under 115th Avenue, which is a Township Road. The ditch was flowing, however, there is a large amount of vegetation and brush. The west side of the culvert contained a beaver grate in order to prevent the culvert from being plugged by beavers. The crossing information is as follows:

The ditch and crossing are in working condition however engineer profile shows the culvert to be about 3 feet higher than profile.

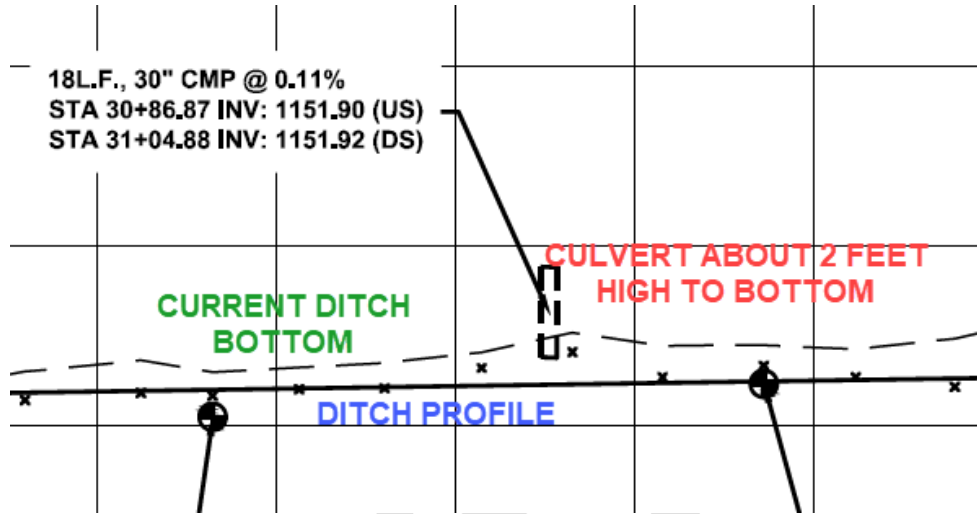
Inspection Section 1a

This ditch observation was completed on a private crossing located on PID 33.21845.0000. The crossing is higher than the ditch bottom and should be considered for lowering if work occurs upstream.

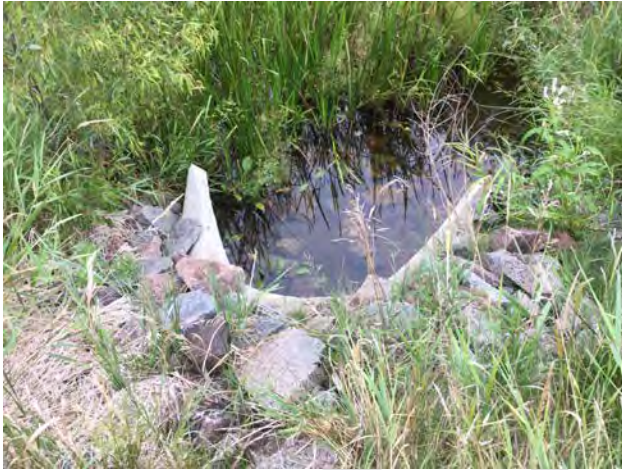
The ditch and crossing are in working condition.

Crossing under County State Aid Highway No. 4 looking northeast

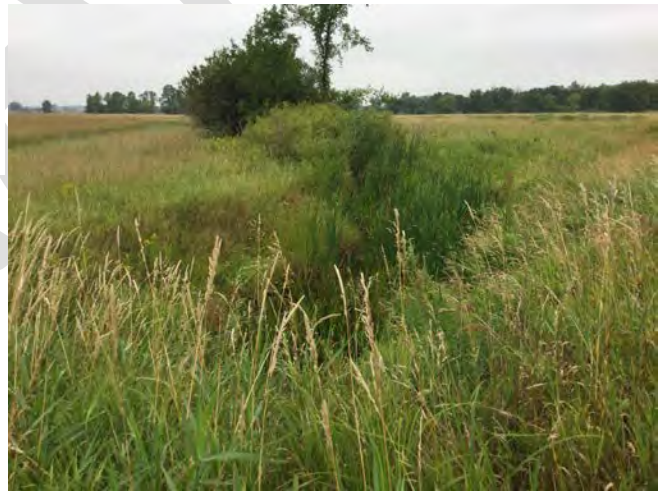
Crossing under County State Aid Highway No. 4 looking southwest

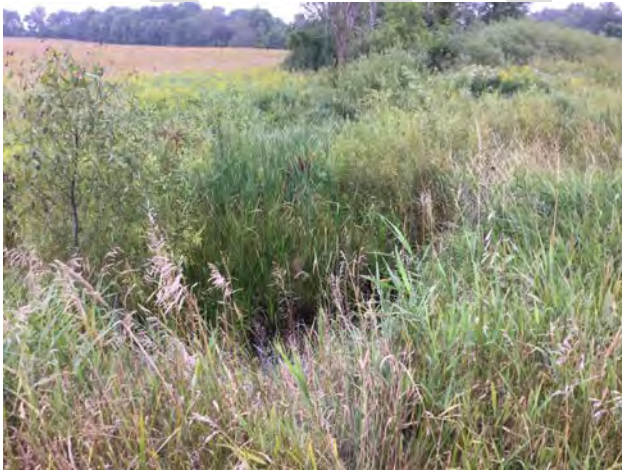
Crossing under County State Aid Highway No. 4 view of culvert.

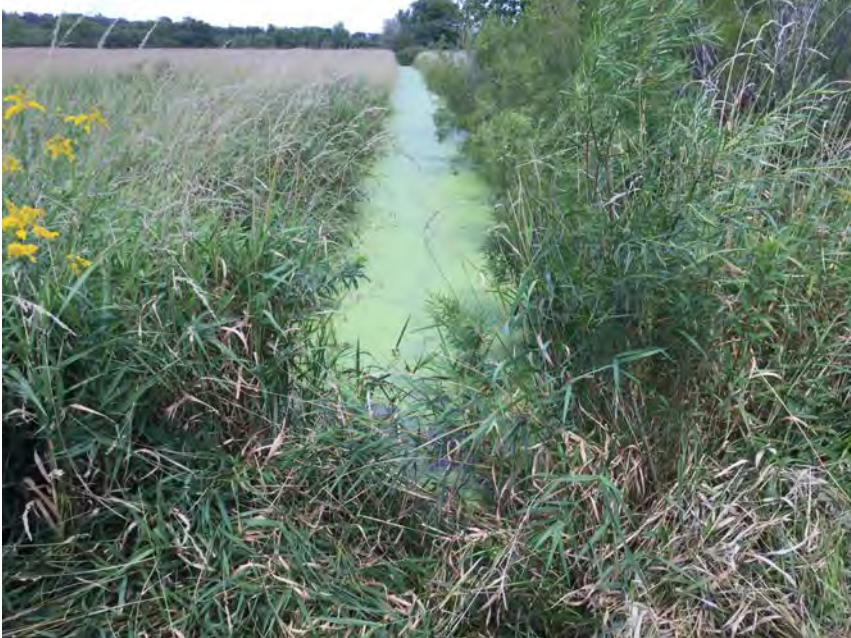
This ditch observation was completed on a private crossing located on PID 33.21851.0000. The field crossing contained approximately 50 inches of standing water, and the culvert was clean of sediment. Brush could be seen in the ditch looking up and down stream of the crossing. The crossing information is as follows:

Private Crossing looking northeast

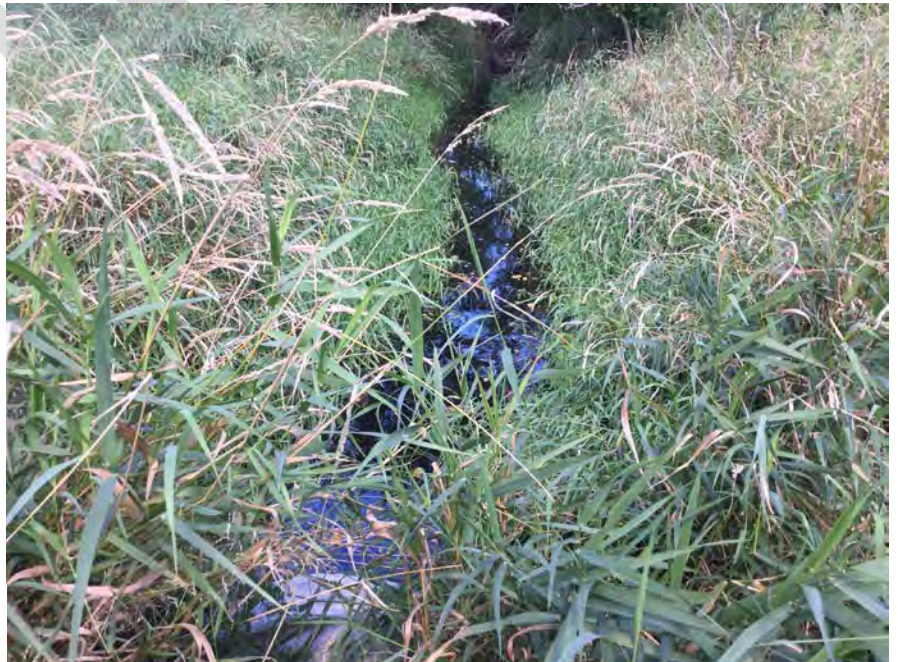
Private Crossing looking southwest

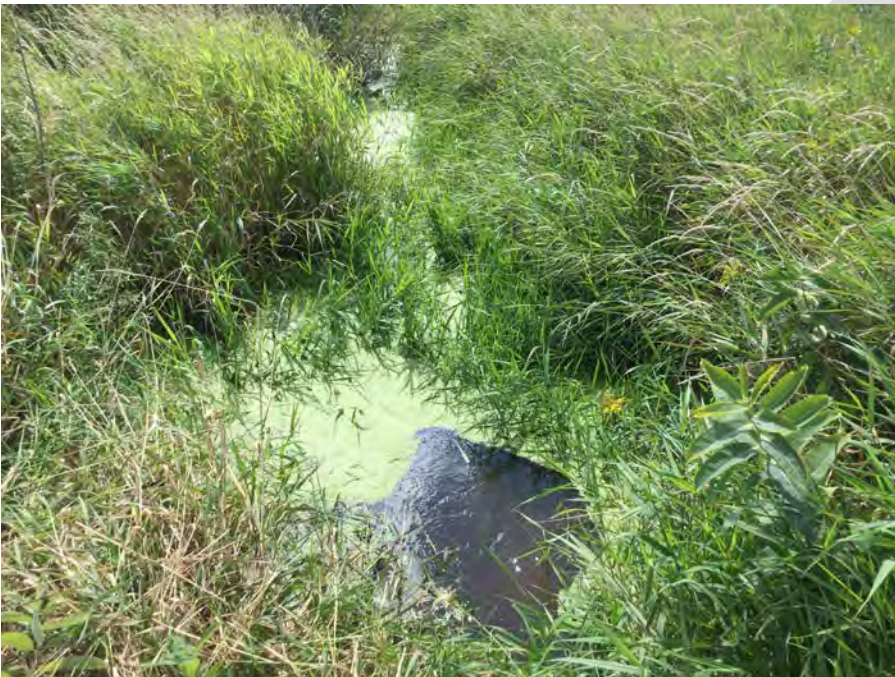
This portion of the ditch inspection was completed on a private crossing located on property PID 33.21853.0000. The culvert within the field crossing has failed. The top of the pipe has either been crushed or has rusted away, and the invert remained in place. The approach is impassible and needs to be repaired. The crossing information is as follows:

This crossing restricts the flow of the ditch and needs to be repaired.

Private Crossing looking south

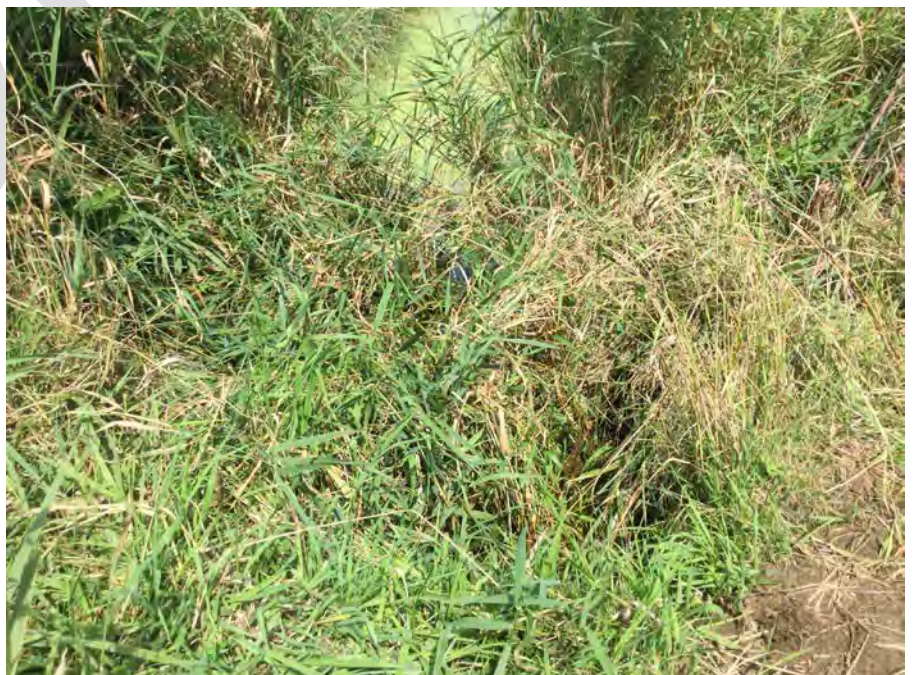
Private Crossing looking north

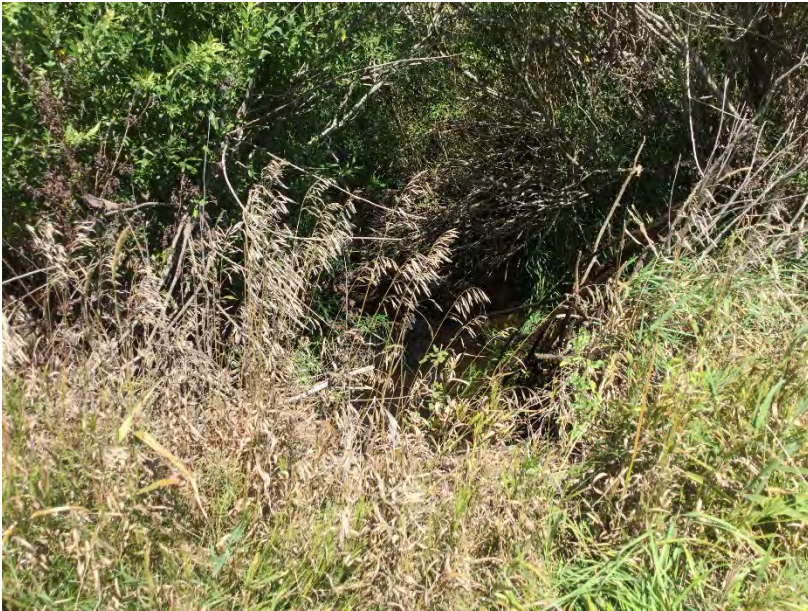
The ditch is functioning at this location; however, the culvert has 1.71 feet of drop from the north invert to the south invert and that is reason for concern. This culvert will need additional work once it fails.

Private Crossing looking north

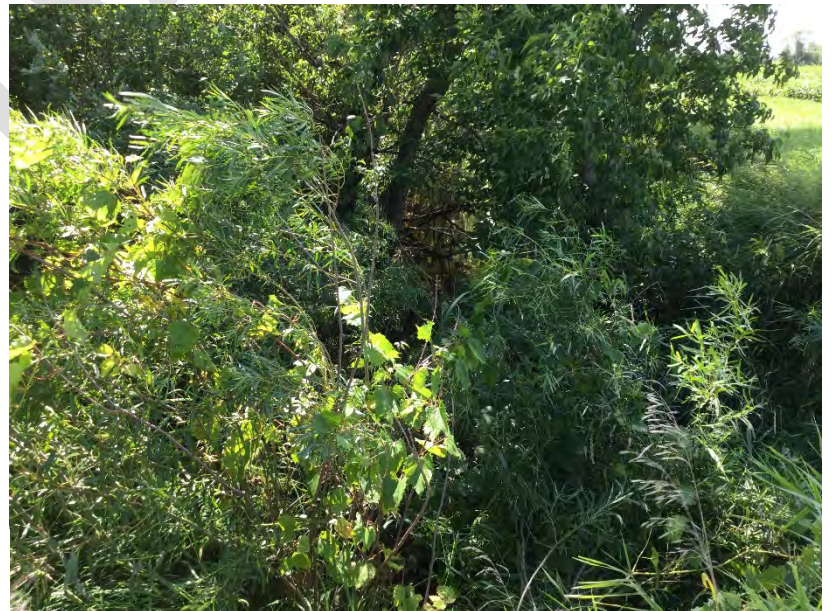
Private Crossing
looking south

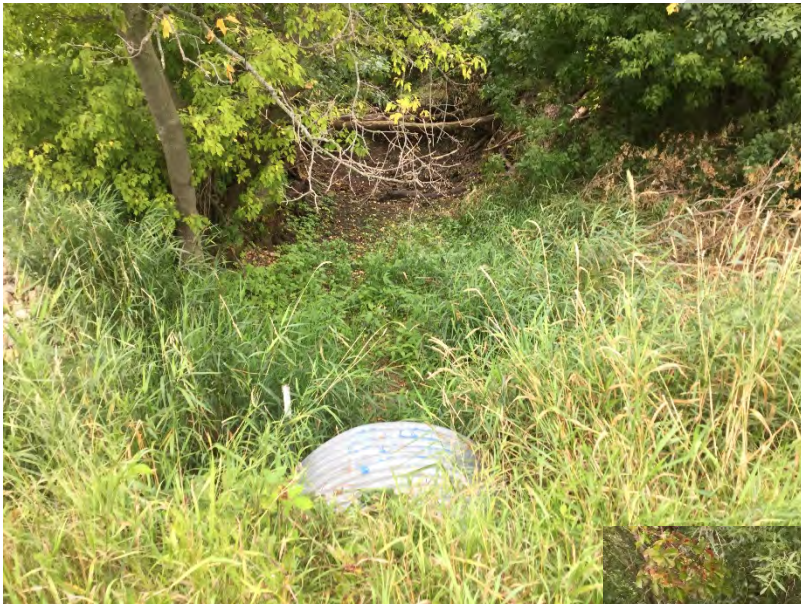
This portion of the ditch inspection was completed on the crossing under 130th Avenue, Township Road, located in the Southeast Quarter of Section 7, T125N, R29W. On August 1, 2017 there was no water in ditch. On August 16, 2017, after a seasonal rainfall, we again inspected this crossing, and we noted water on the east side but not on the west side. The engineers profile indicates the crossing is installed about 2 feet higher than engineered bottom. The culvert in combination with the wetland immediately upstream combine to give the appearance of holding water. This area should continue to be monitored. The crossing information is as follows:

130th Avenue looking west

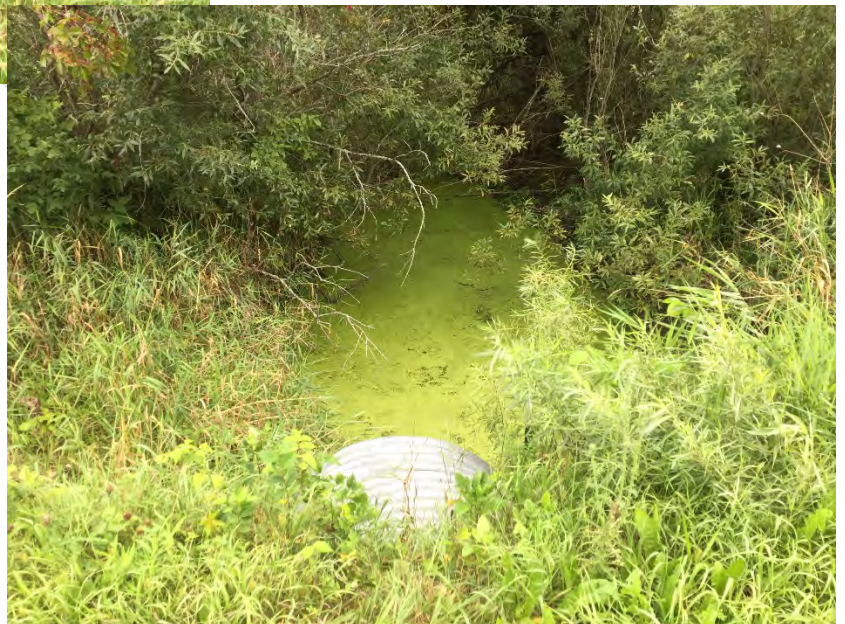
130th Avenue looking east

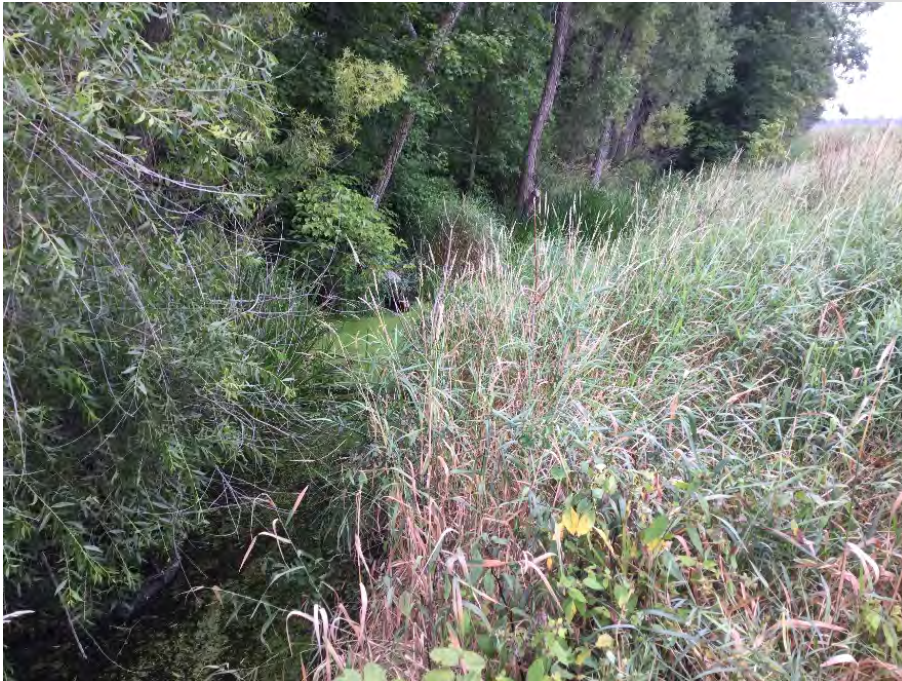
The crossing and the ditch are in working order, however, if the Highway Department ever planned work on CSAH 3, the Drainage Authority may desire to evaluate the install elevation of the culvert.

CSAH 3 looking east

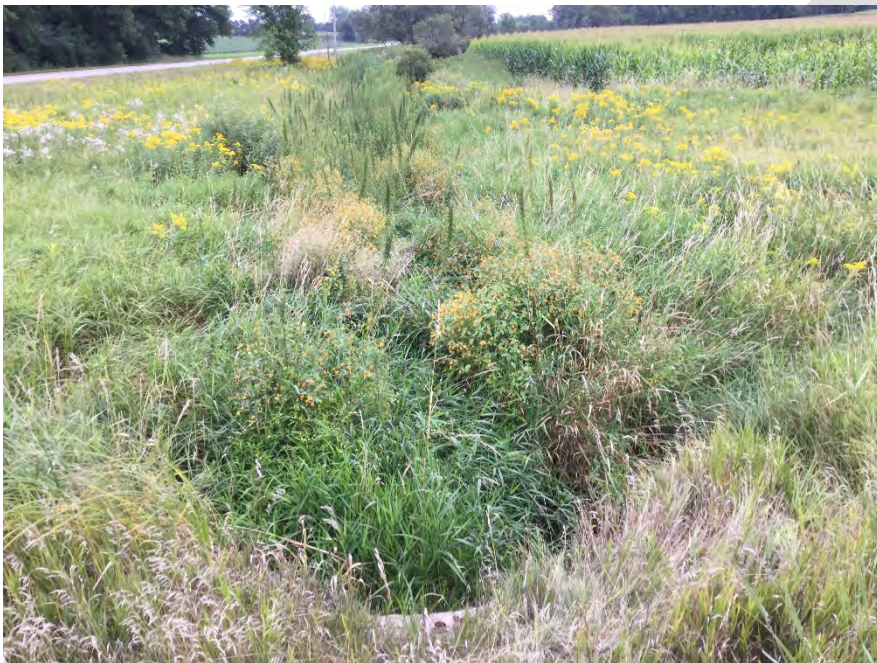
This portion of the ditch inspection was completed on crossing under County Road No. 155, located in Section 11 and 12, T125N, R30W. This inspection was completed from the road due to current conditions. There is sediment within the culvert and collection on the ends. The sediment at the end of the culvert contains growing grass. The crossing information is as follow:

County Road No. 155 looking east

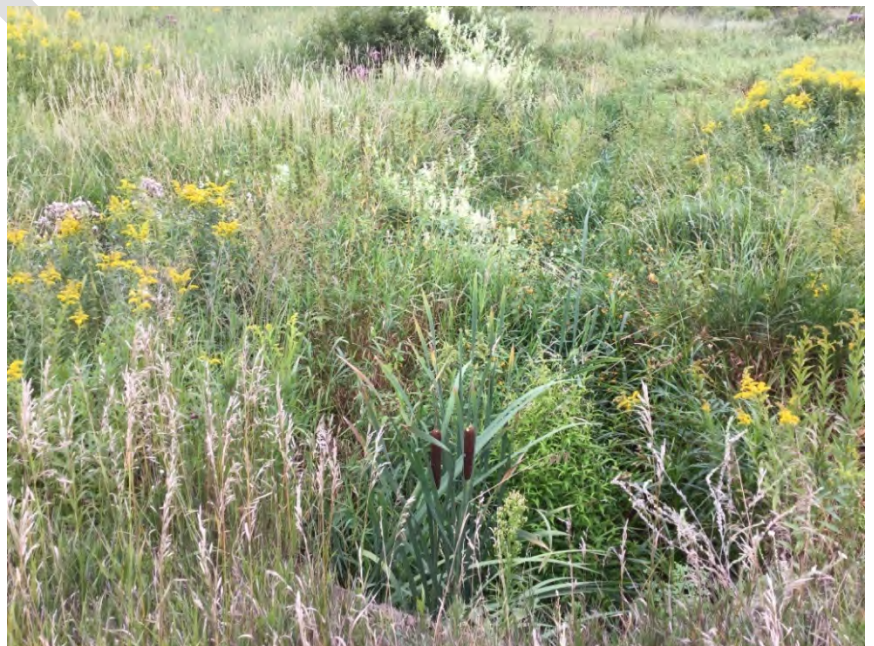
County Road No. 155 looking West

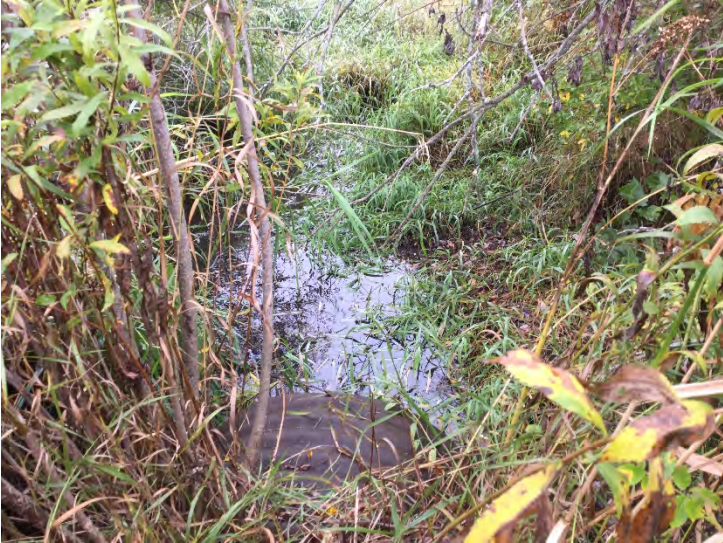
It appears that there is an issue with the culvert; however, the water still flows through the culvert.

Private crossing looking east

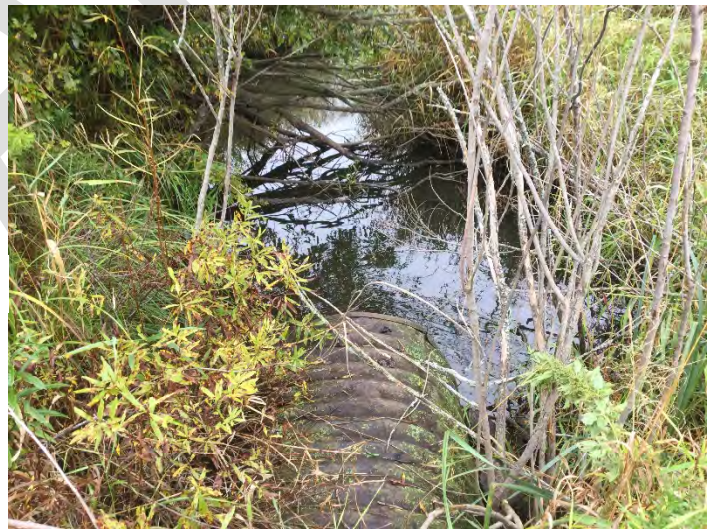
Private crossing looking west

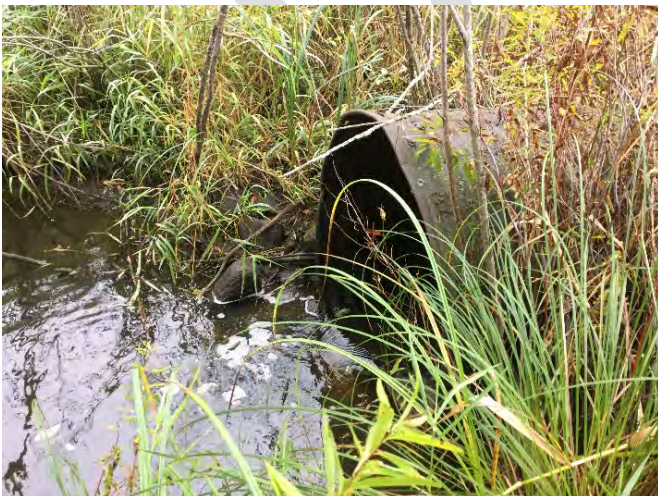
Private crossing west end of the culvert

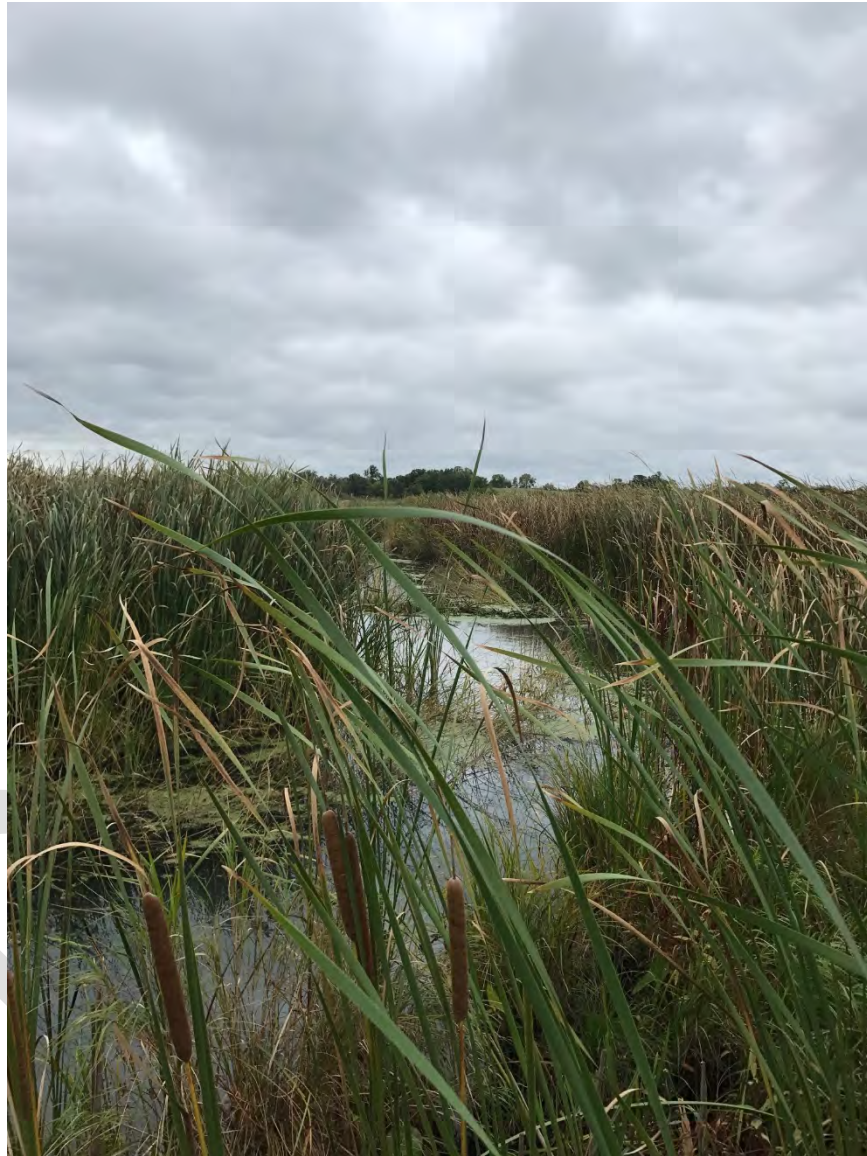
This portion of the ditch inspection was completed where the ditch flows into Spunk Creek PID: 03.00718.0000. The ditch appears to flow unimpeded into the ditch; however, there is a beaver dam downstream that should be removed.

Location where CD4 enters into Spunk Creek
