DITCH INSPECTION

CD25

STEARNS COUNTY MINNESOTA

April 12, 2017
Authored by: Martini, Chad

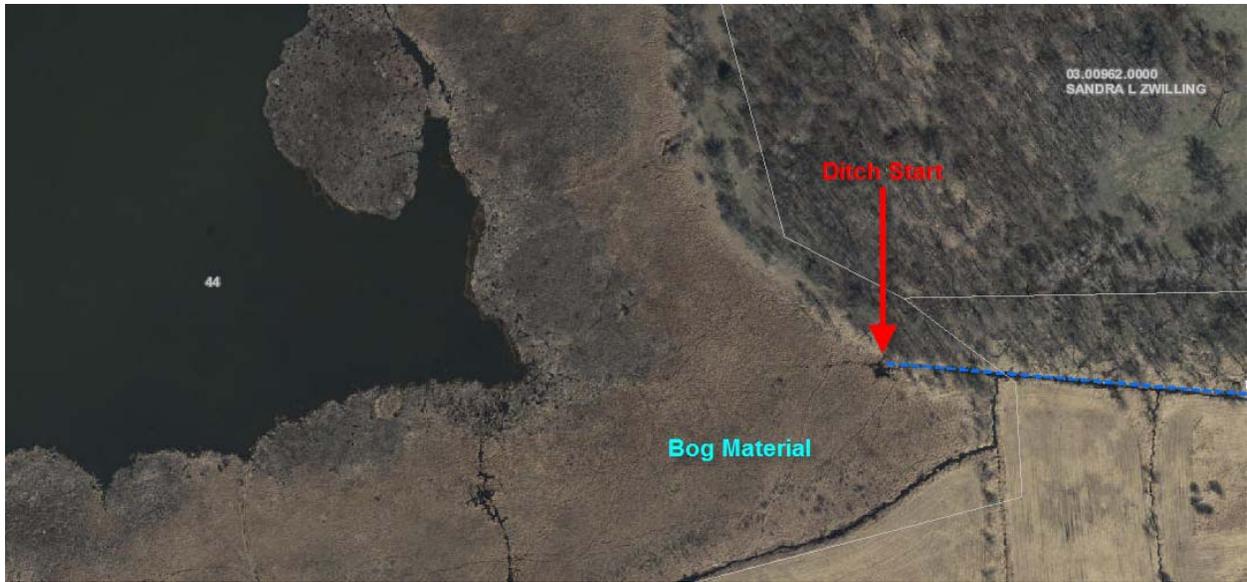
2. Although the current ditch bottom is higher than what the reestablished starting elevation calls for, field inspection shows that lowering the starting point of the ditch may not channel free flowing water from Kepper Lake into CD25 due to the earthen bog material that exists between the ditch and open lake water. The recommendation would still be to set the begin point elevation at 1119.6.

Photo showing material between ditch start point and open water

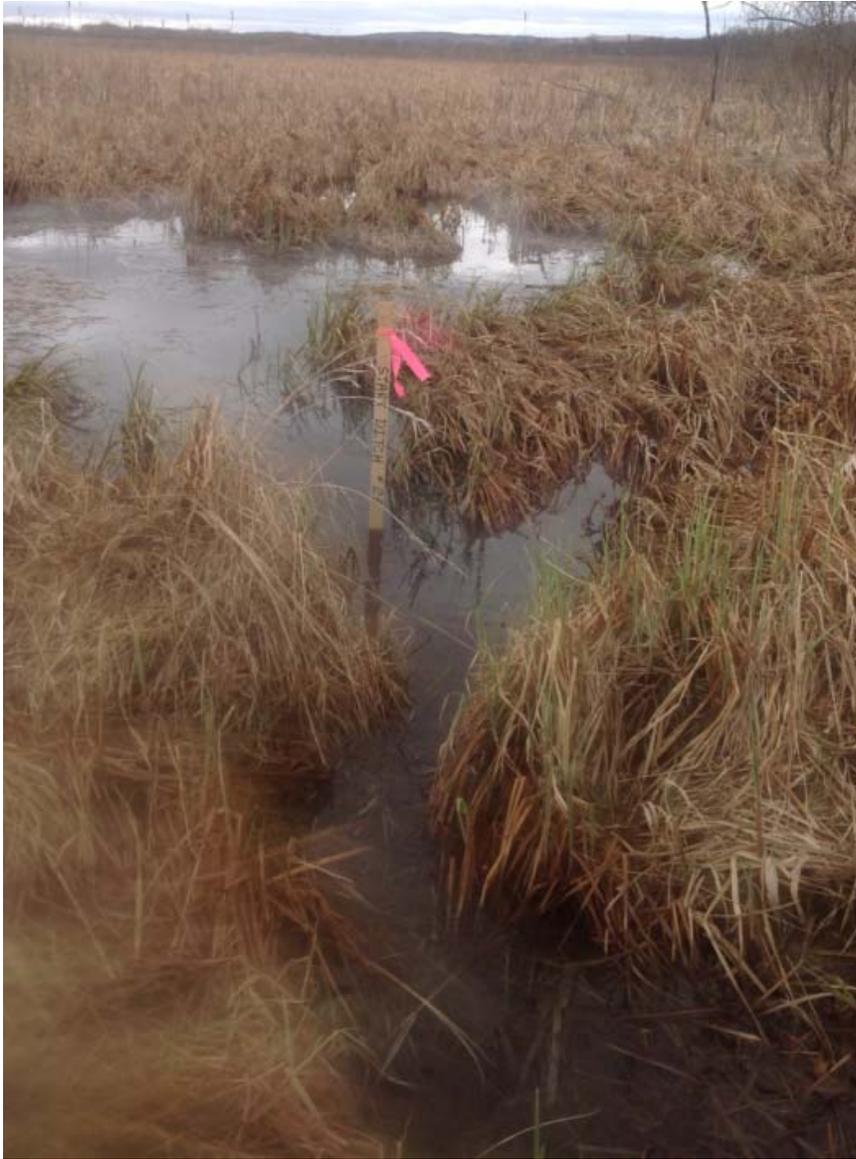
1. The original ditch design called for the ditch to extend into the lake and be at an elevation about 4 feet below the lake water elevation as it was in 1905. Current conditions show that the lake water has effectively drained to the current ditch bottom elevation. DNR states the lake run out elevation to be 1120.9 feet. Stearns County survey collection shows the current bottom to be about 1120.5. The re-established engineers starting point is 1119.6.

Two issues are created by these elevations. First, the current ditch bottom is higher than what the engineer has established as the begin elevation. Second, the DNR has indicated that they would not grant permission for the current ditch bottom at the start point to be lowered because it may affect lake water levels.

Stake marking beginning point of ditch

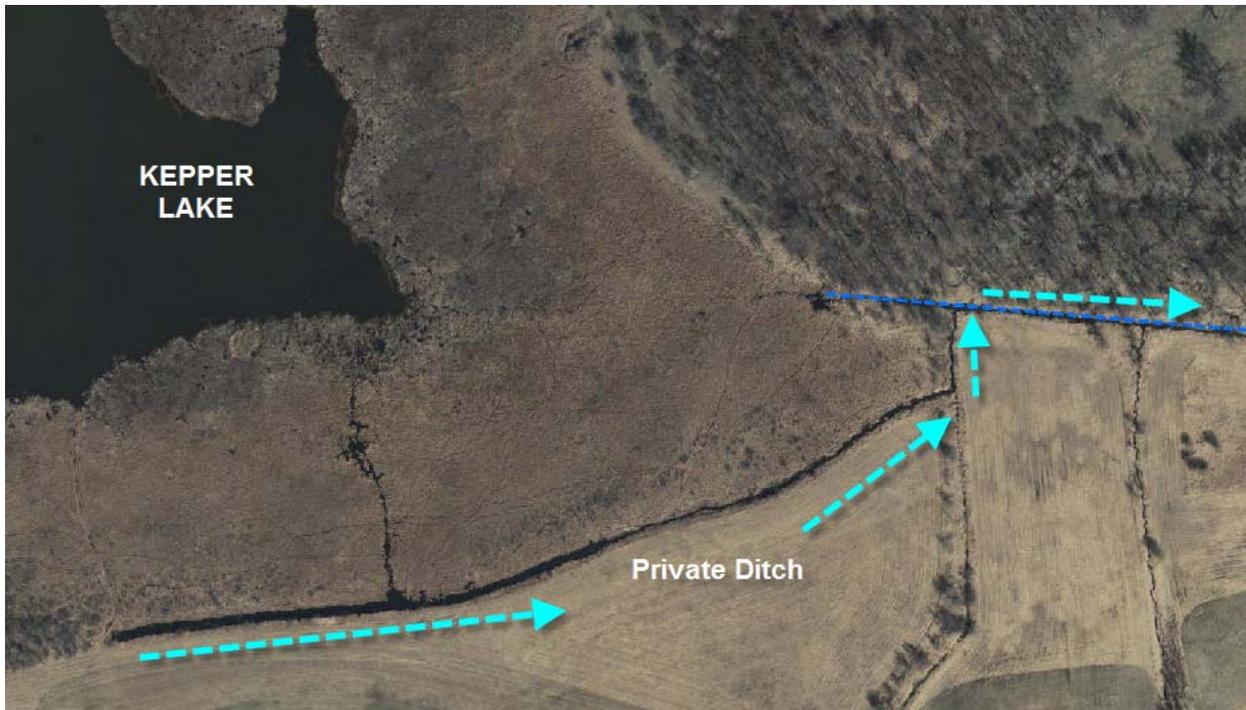
3. There is a private ditch south of Kepper Lake that flows into CD25 approximately 160 feet from the beginning point. On April 10, 2017, the flow from the private ditch was free flowing and visual inspection showed all the water in CD25 east of the point where the private ditch flows into CD25 was coming from the private ditch not the ditch beginning point. The private ditch appears to be moving water out of Kepper Lake into CD25.

Visual of private ditch flowing into CD25

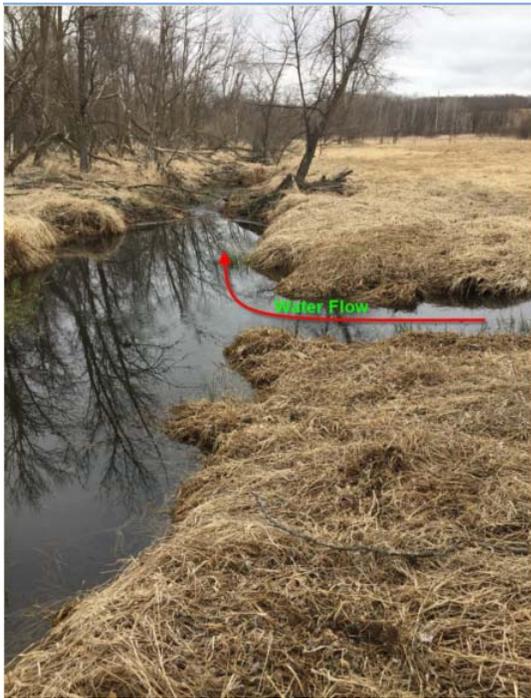
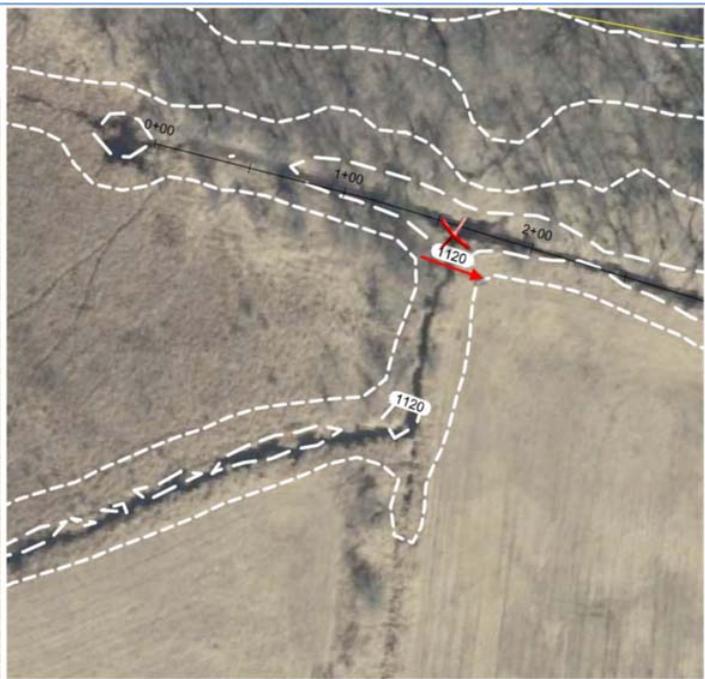
Close up of the point where private ditch enters CD25

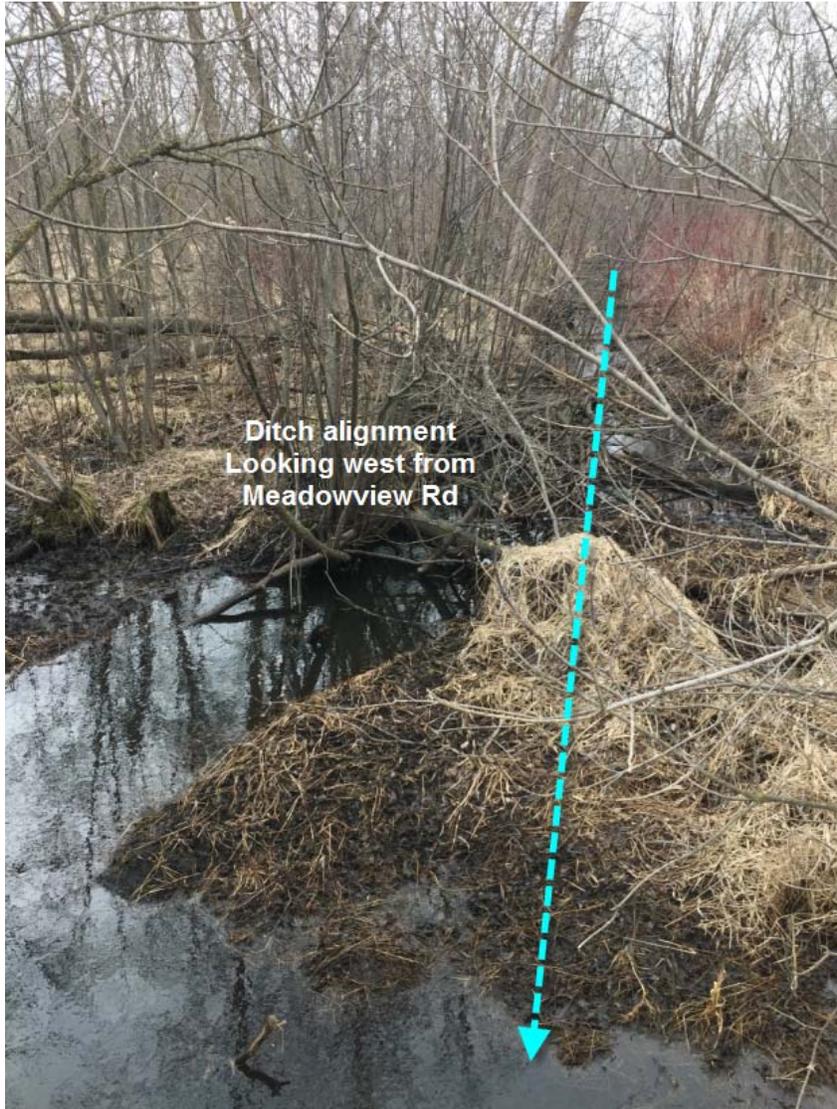
Field inspection from Meadowview Rd shows the ditch on the east and west of the road is completely overgrown with trees, obstructed with downed wood and grass mats. The water is freely flowing around a large slumped in portion of the channel, but flow is directly impacted. This is where a repair should be considered.

Photo of ditch channel filled with earth and trees

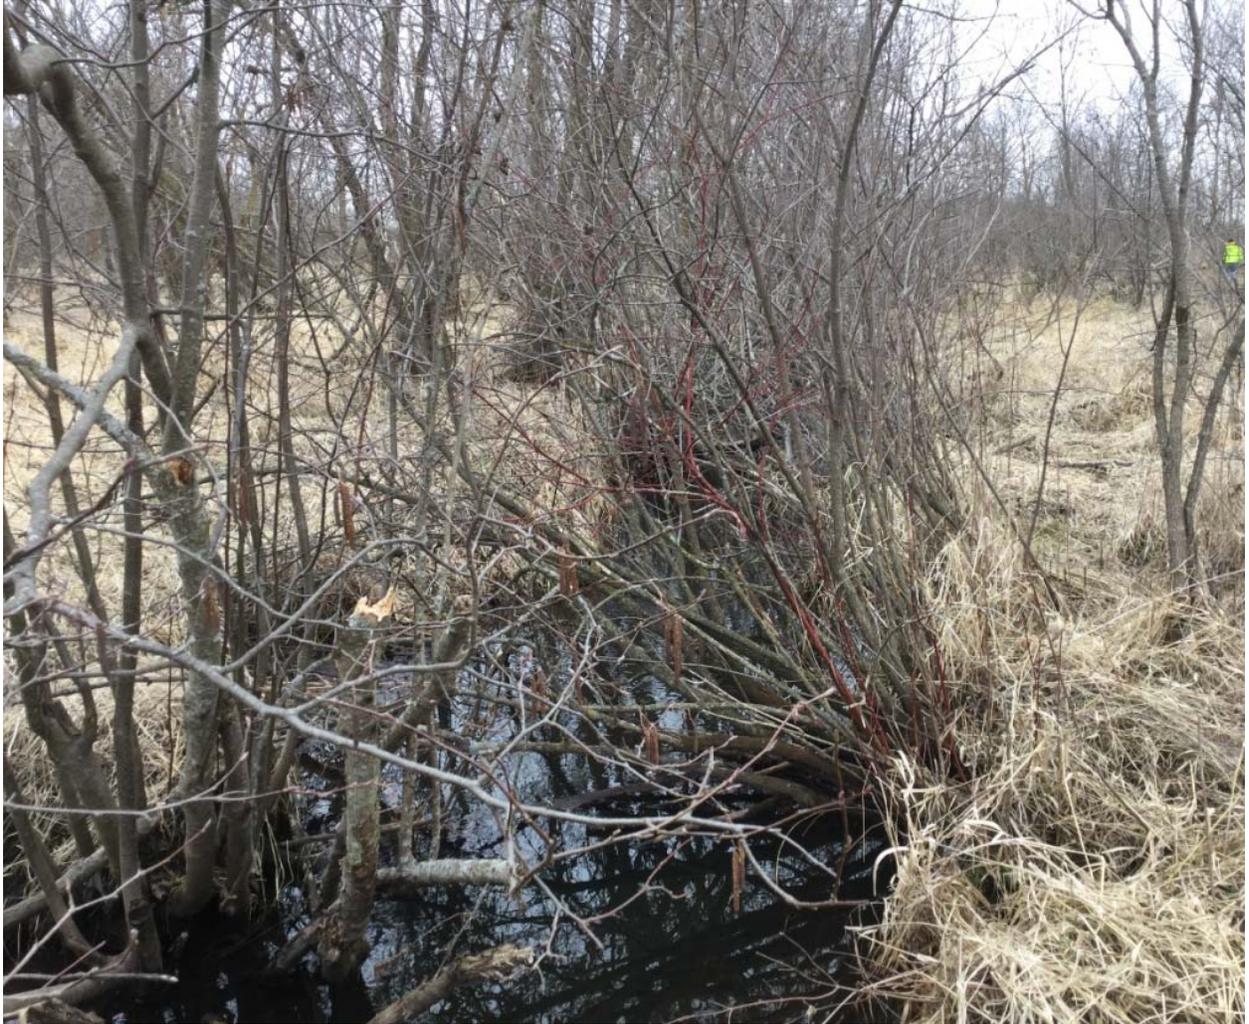
East of Meadowview Rd, the ditch has alignment problems, deposits of sediment, and the channel is greatly constricted in places.

Photo standing on Meadowview Rd looking east.

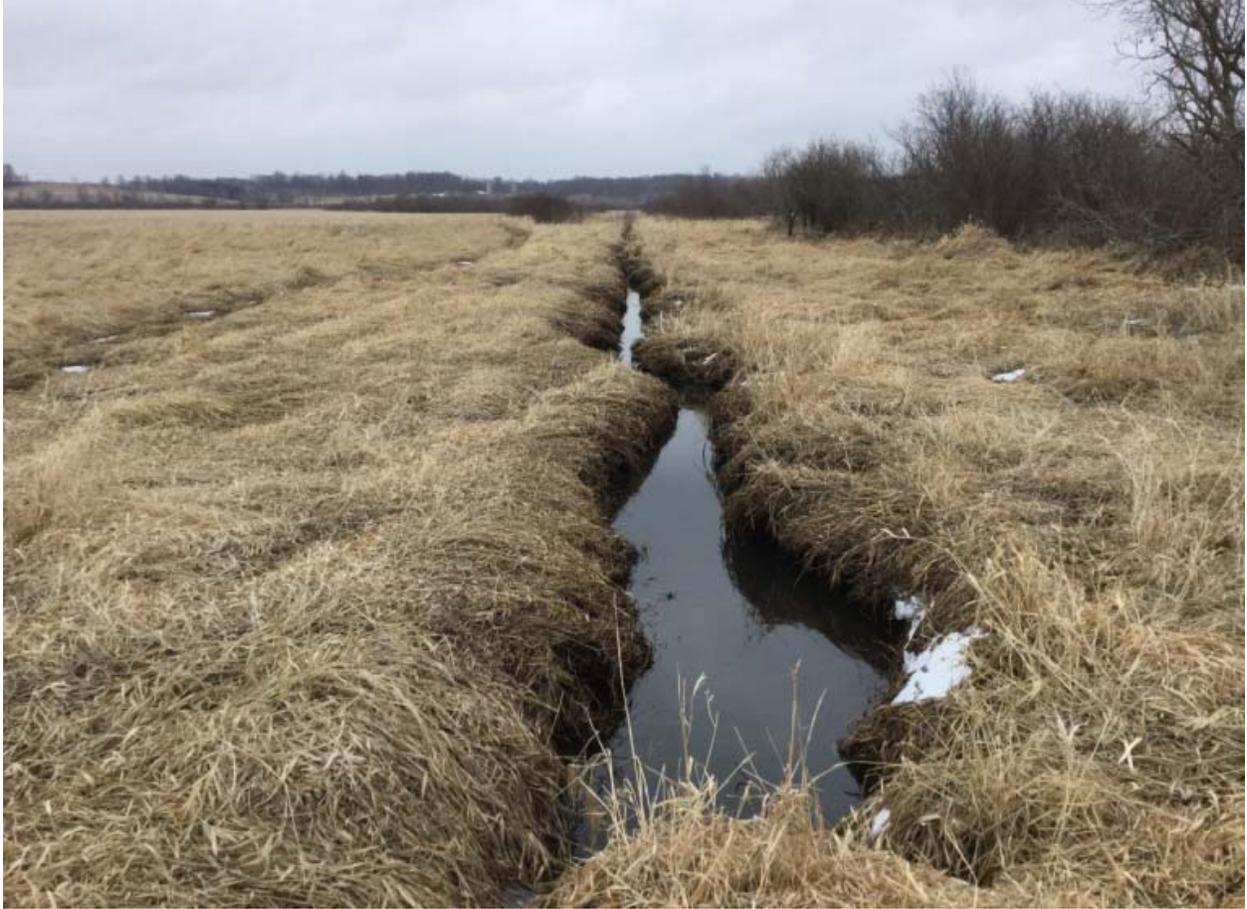
Photo from the Woods property showing slumping and narrowing of channel.

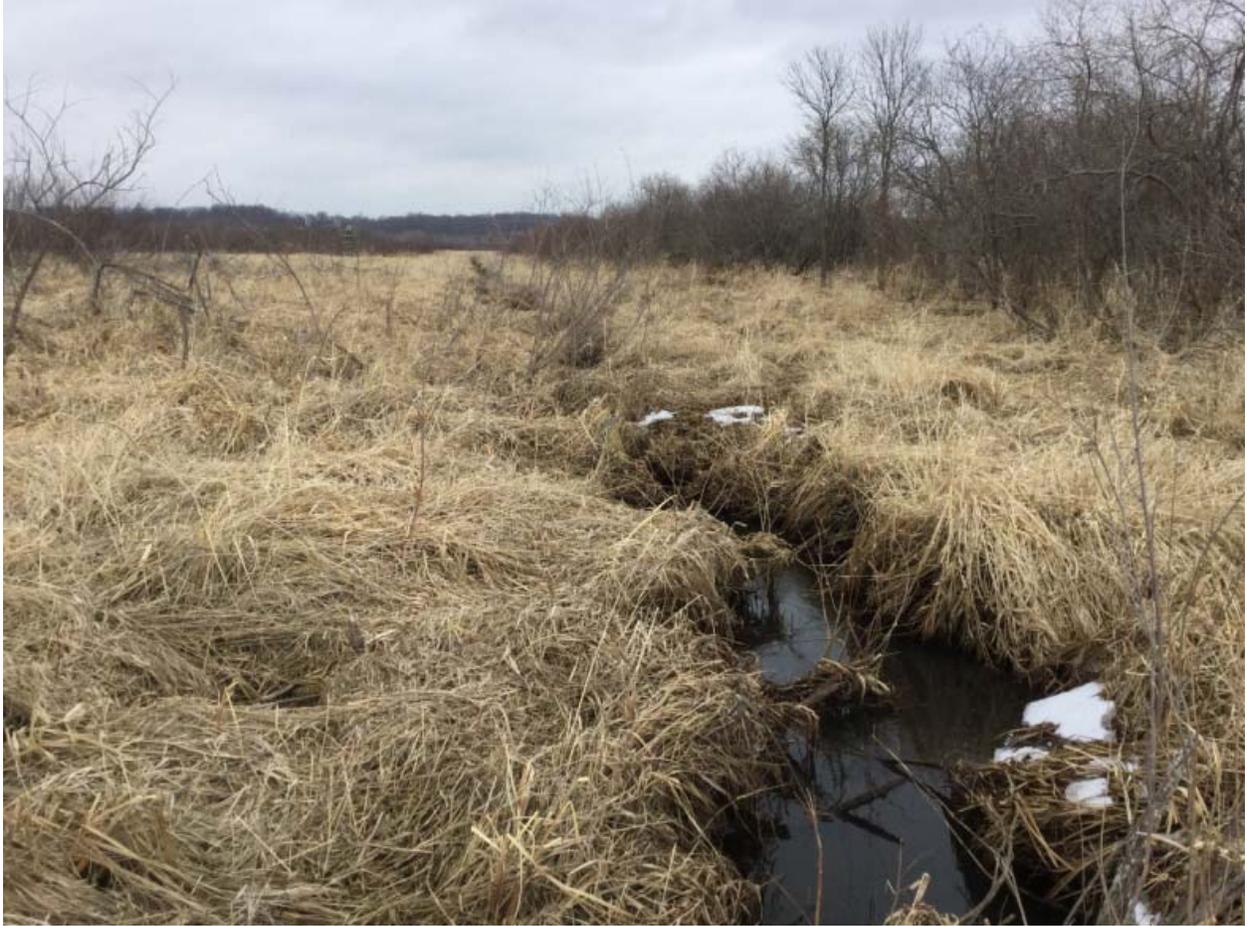
Photo showing narrowing of CD25

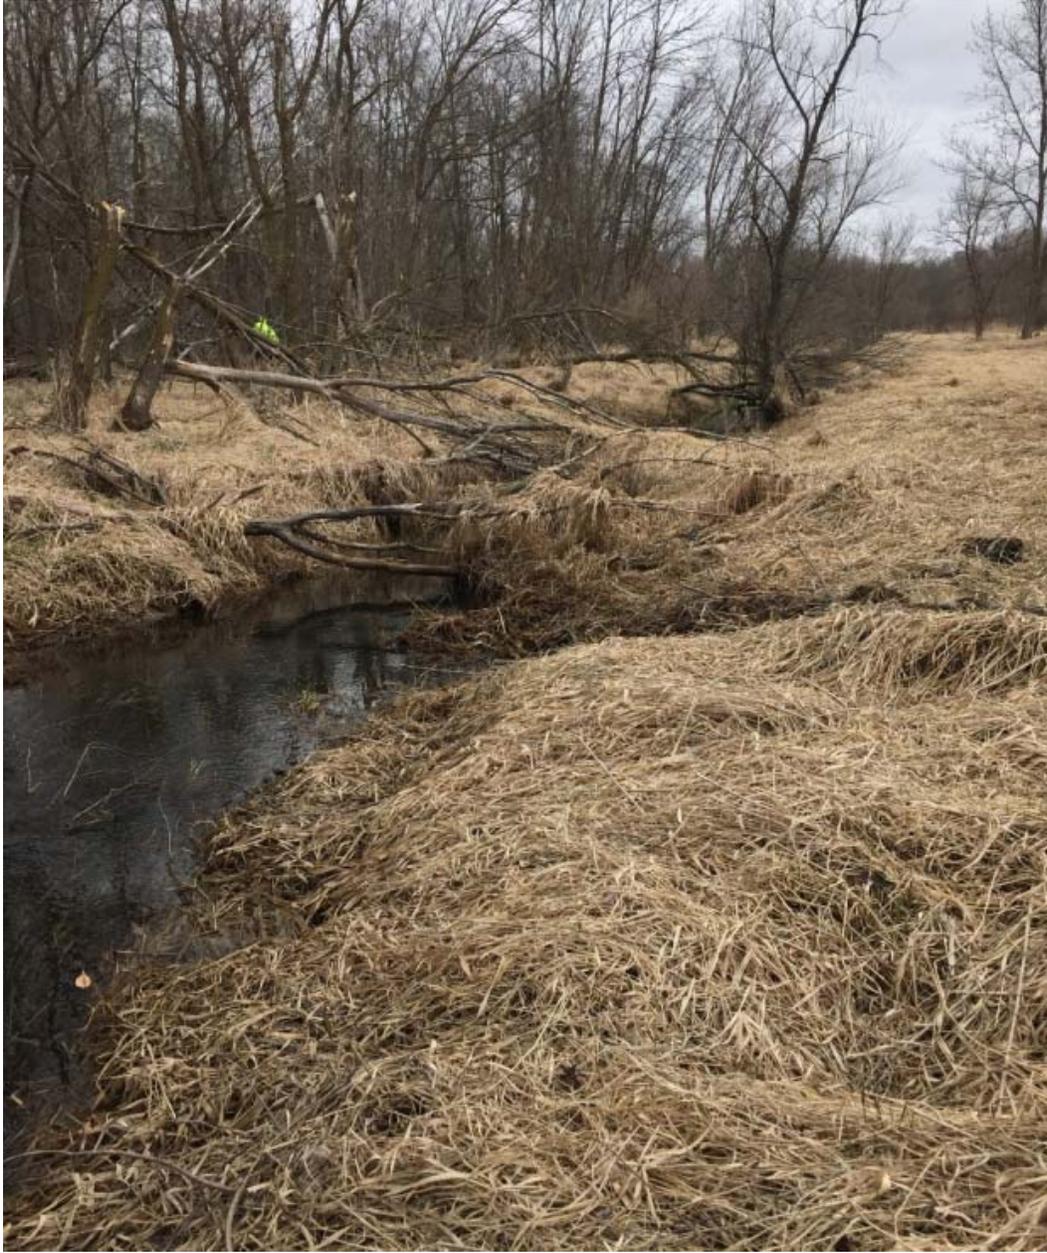
One of many examples of downed trees and grass mats in ditch channel but the width of the channel looks good

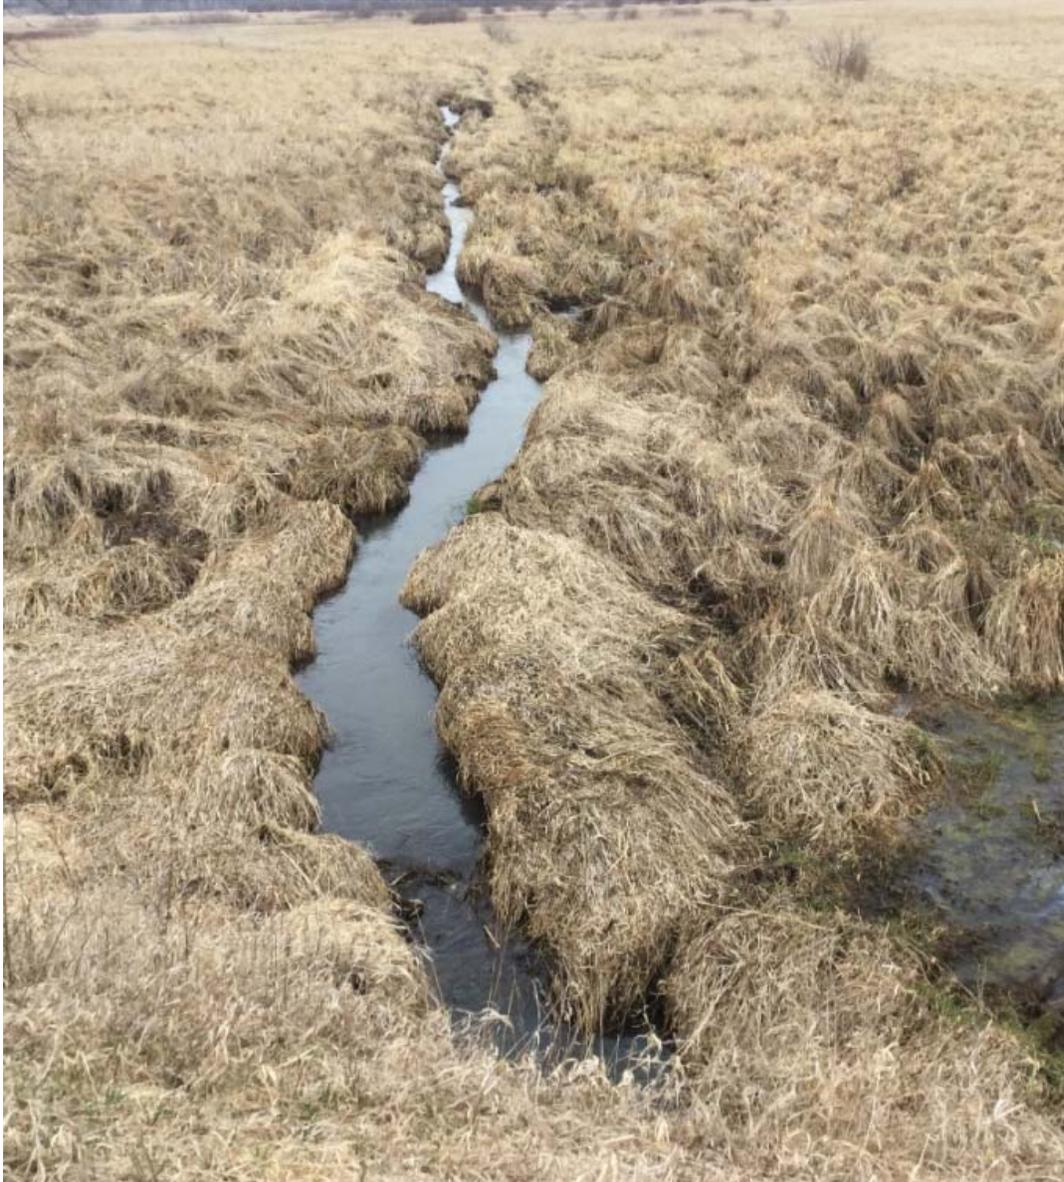
Photo from the end of the ditch in the general area of Norway Rd showing narrowing and alignment issues

Elevation data shows the ditch to be mostly at design grade but multiple locations of sediment build up can be found throughout the entire ditch with the worst build up occurring at the end of the ditch.
