# Inspection of Stearns County Ditch 14

September 30, 2022

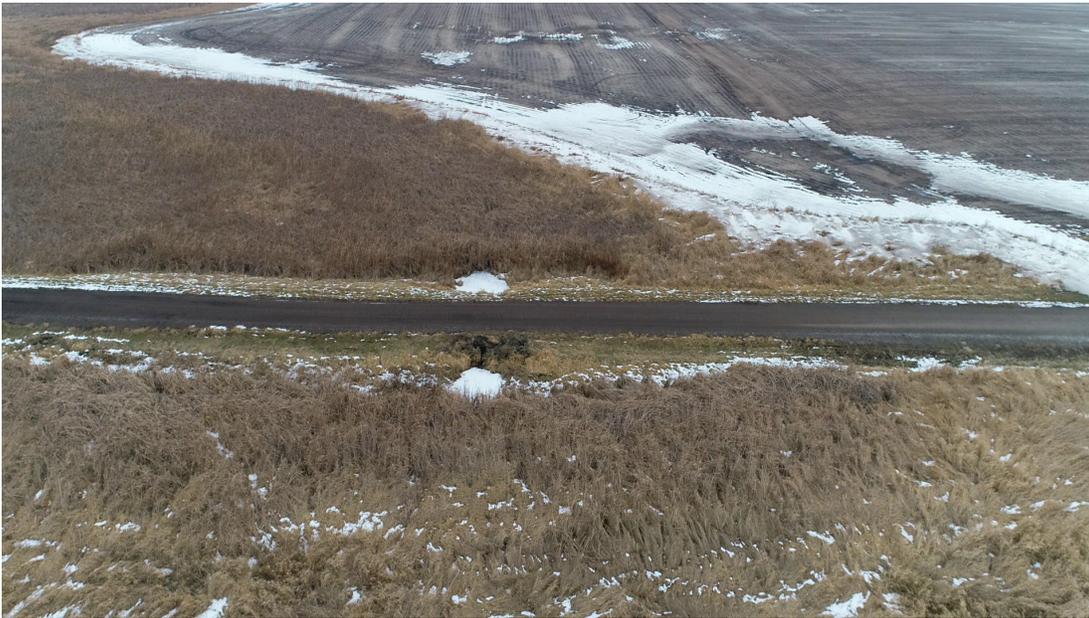
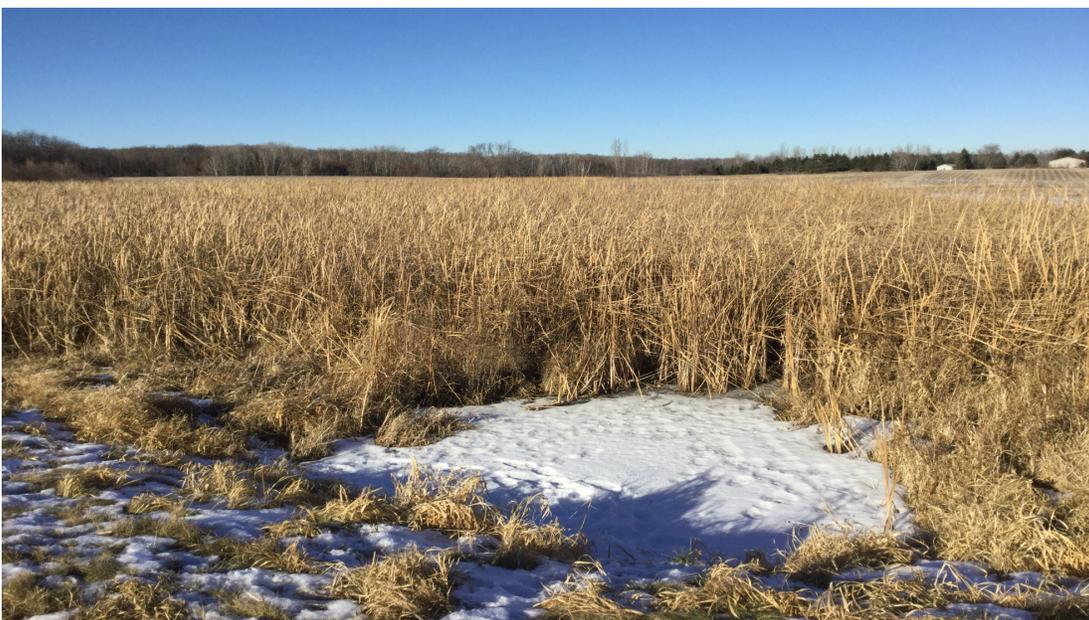
Inspection Area 1 – 81.43153.0669

This portion of the ditch inspection was completed on a private crossing located on property 81.43153.0669 in Section 18, T123N, R28W. The pipe is in good condition. The crossing information is as follows:

- Culvert: 24 inch Corrugated Metal Pipe
  - South Invert: (Upstream Invert) = 1092.29 feet
  - North Invert: (Downstream Invert) = 1092.58 feet

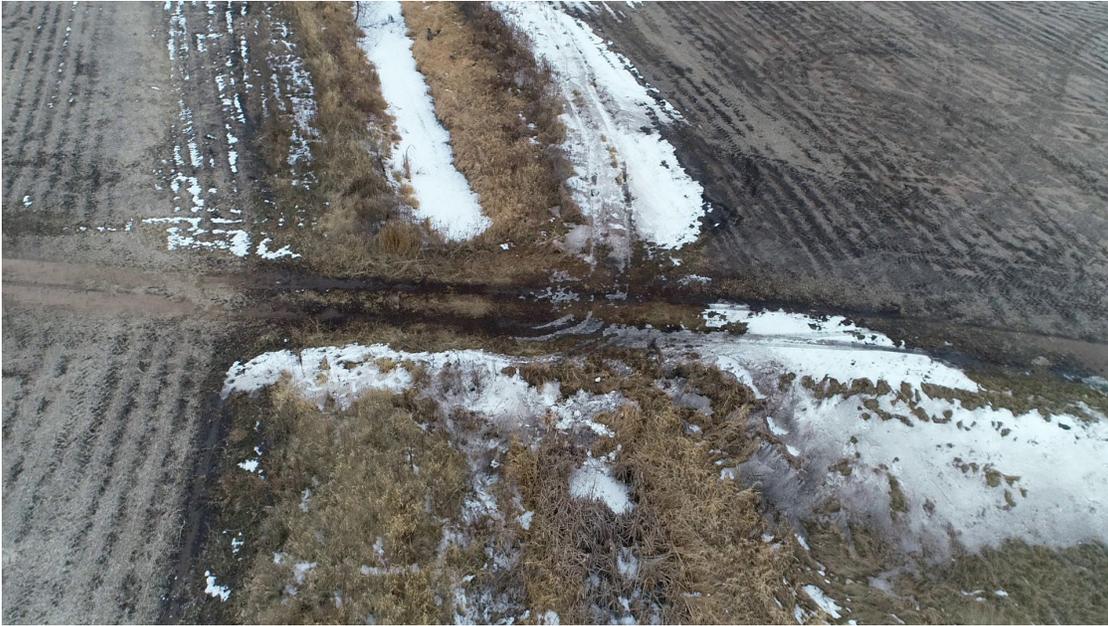
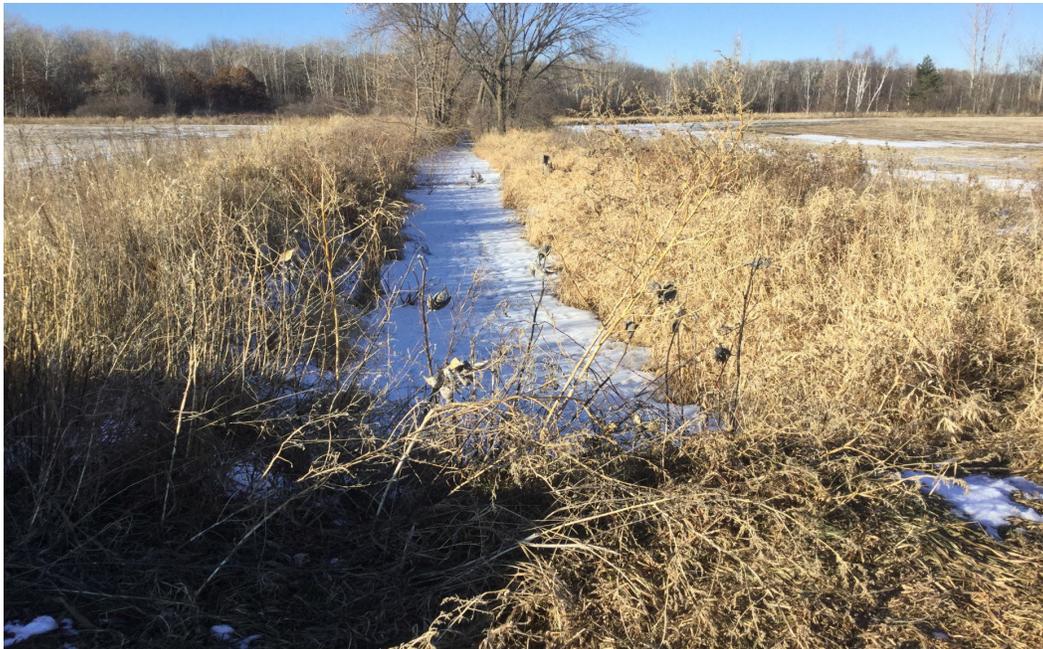
Inspection Area 2 – 81.43153.0672

This portion of the ditch inspection was completed on a private 81.43153.0672 in Section 18, T123N, R28W. The ditch and crossing are in good working condition. The crossing information is as follows:

- Culvert: 24 inch Corrugated Metal Pipe
  - South Invert: (Upstream Invert) = 1093.07 feet
  - North Invert: (Downstream Invert) = 1093.01 feet

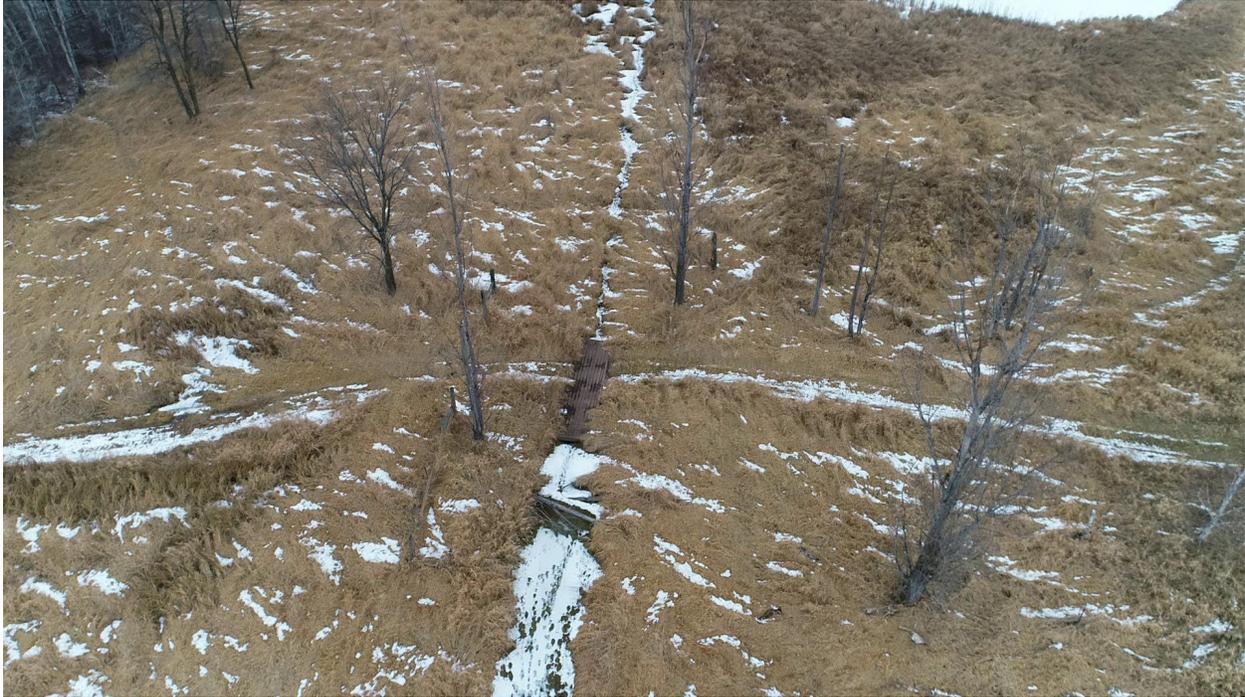
Inspection Area 3 — 81.43302.0412

This portion of the ditch inspection was completed on a private crossing owned on PID: 81.43302.0412: In Section 18, T123N, R28W. This crossing consists of a ATV or walking bridge. The bridge is in good working condition and does not restrict water flow.

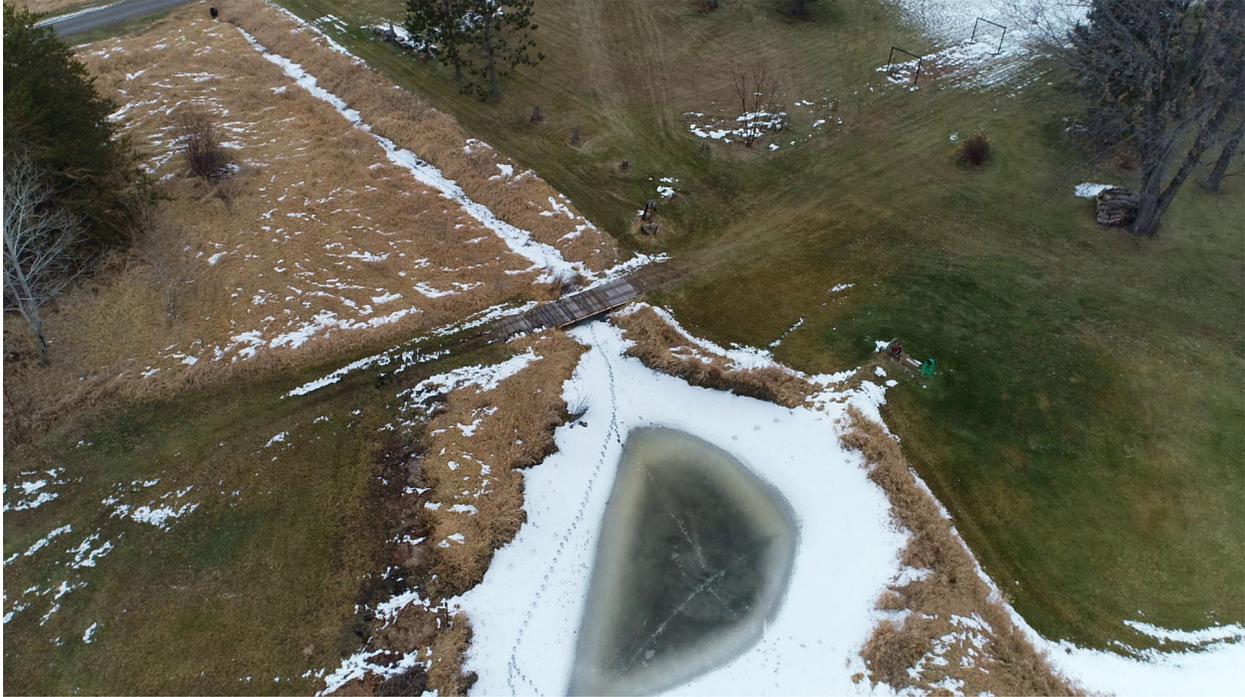
Inspection Area 5 – 81.43302.0302

This portion of the ditch inspection was completed on a private crossing PID: 81.43302.0302 in Section 18, T123N, R28W. This crossing consists of a ATV or walking bridge. The bridge is in good condition and does not restrict water flow.

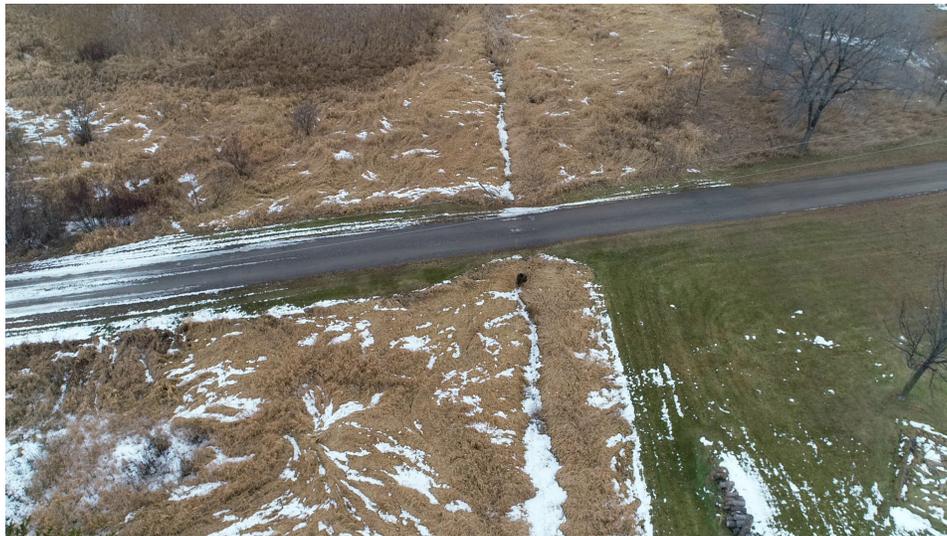
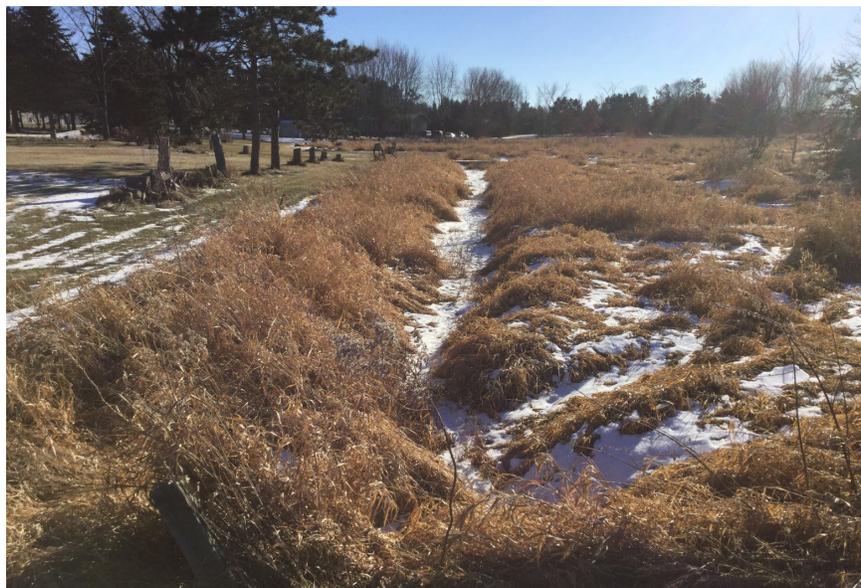
Inspection Area 6 –81.43153.0650

This portion of the ditch inspection was completed on a private crossing (239th St.) PID: 81.43153.0650 located in Section 18, T123N, R28W. The pipe is in good condition. The ditch south and north of crossing has some vegetation. The crossing information is as follows:

- Culvert: 36 Inch Plastic pipe (Good Condition)
- South Invert: (Upstream Invert): 1092.72 feet
- North Invert: (Downstream Invert): 1092.50 feet

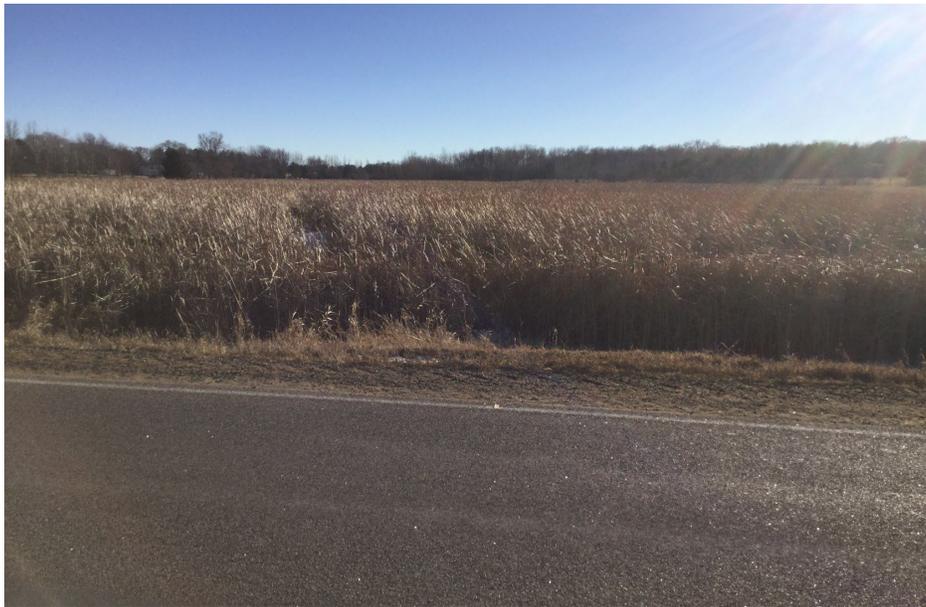
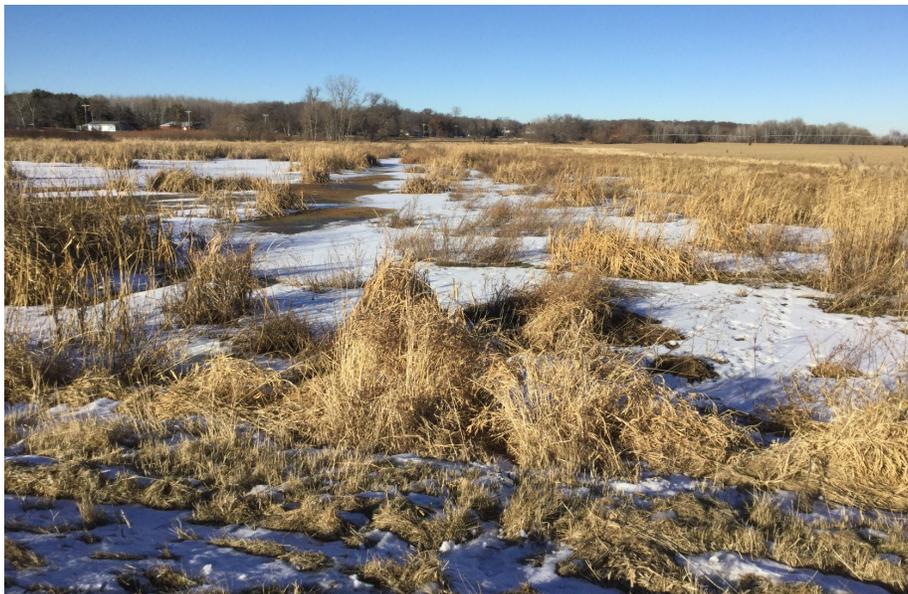
Inspection Area 7 – 81.43153.0640

This portion of the ditch inspection was completed on County State Aid Road #47. The culvert is in good working condition. The ditch channel south and north of the crossing has sediment and vegetation. The crossing information is as follows:

- Culvert: 36 inch Reinforced Concrete Pipe (Good Condition)
- South Invert: (Upstream Invert): 1090.65 feet
- North Invert: (Downstream Invert): 1091.07 feet

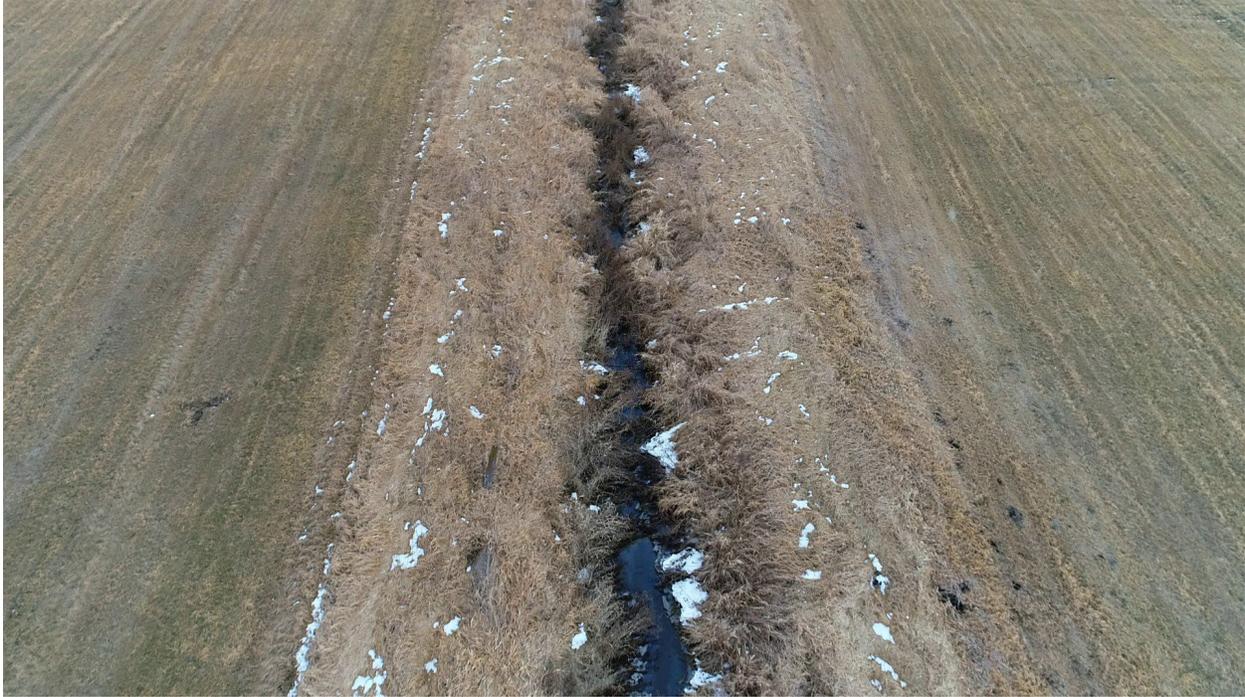
Inspection Area 9 – 81.43150.0345

This portion of the ditch inspection was completed on parcel PID: 81.43150.0345 located in Section 7, T123N, R28W. The ditch channel between Inspection section #9 and Inspection #10 has vegetation and sediment in it. The water remains to flow good under these conditions.

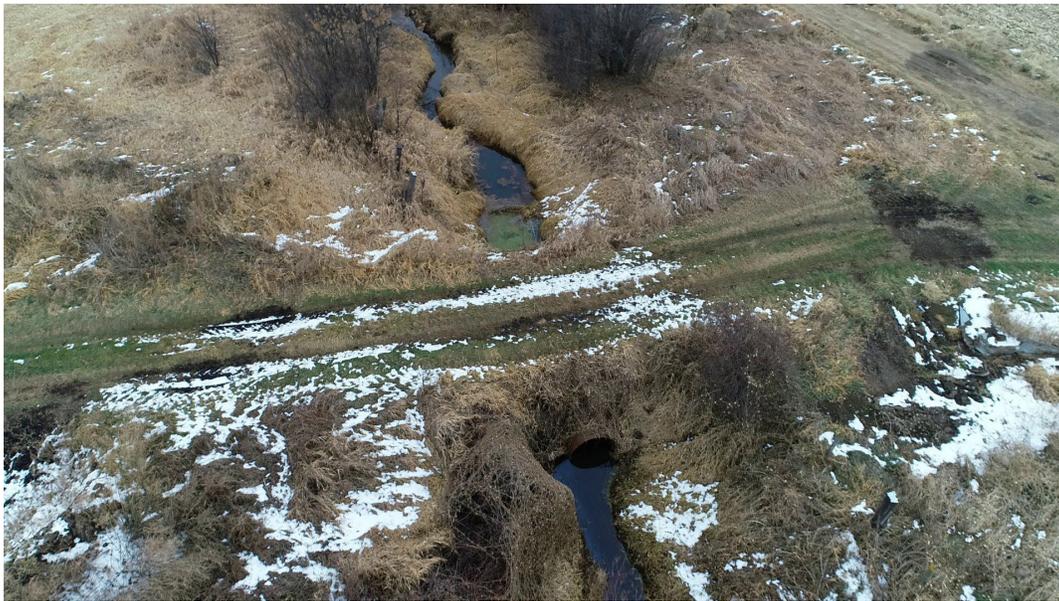
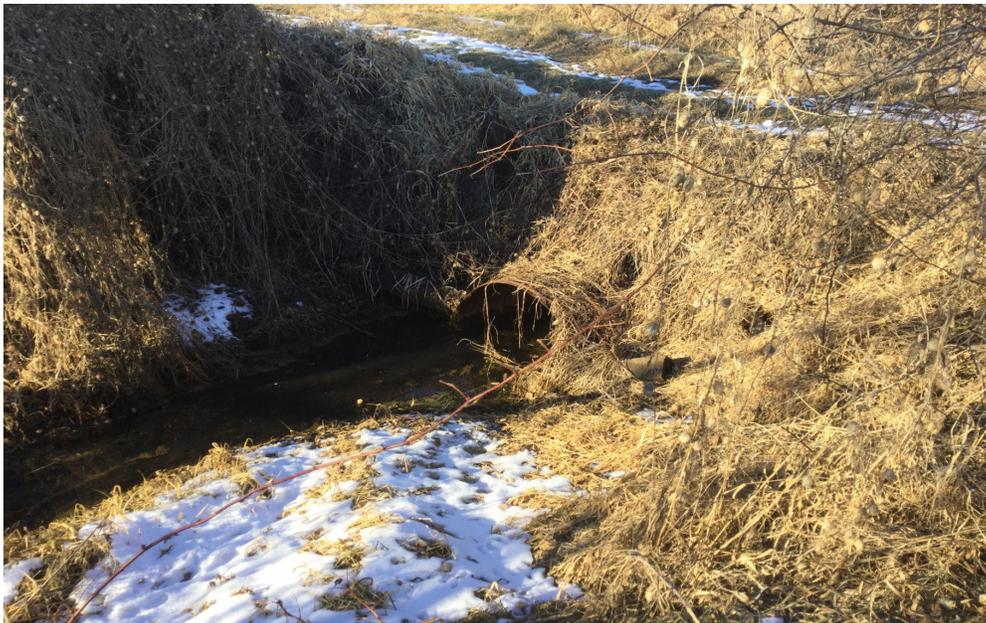
Inspection Area 10 – 81.431.50.0315

This portion of the ditch inspection was completed on a private crossing PID: 81.431.50.0315 located in Section 7, T123N, R28W. The culvert is in fair condition. The channel is a little narrow but is functioning under the current conditions. The crossing information is as follows:

- Culvert: 48 inch Corrugated Metal Pipe (Fair Condition)
- South Invert: (Upstream Invert): 1086.01 feet
- North Invert: (Downstream Invert): 1086.28 feet

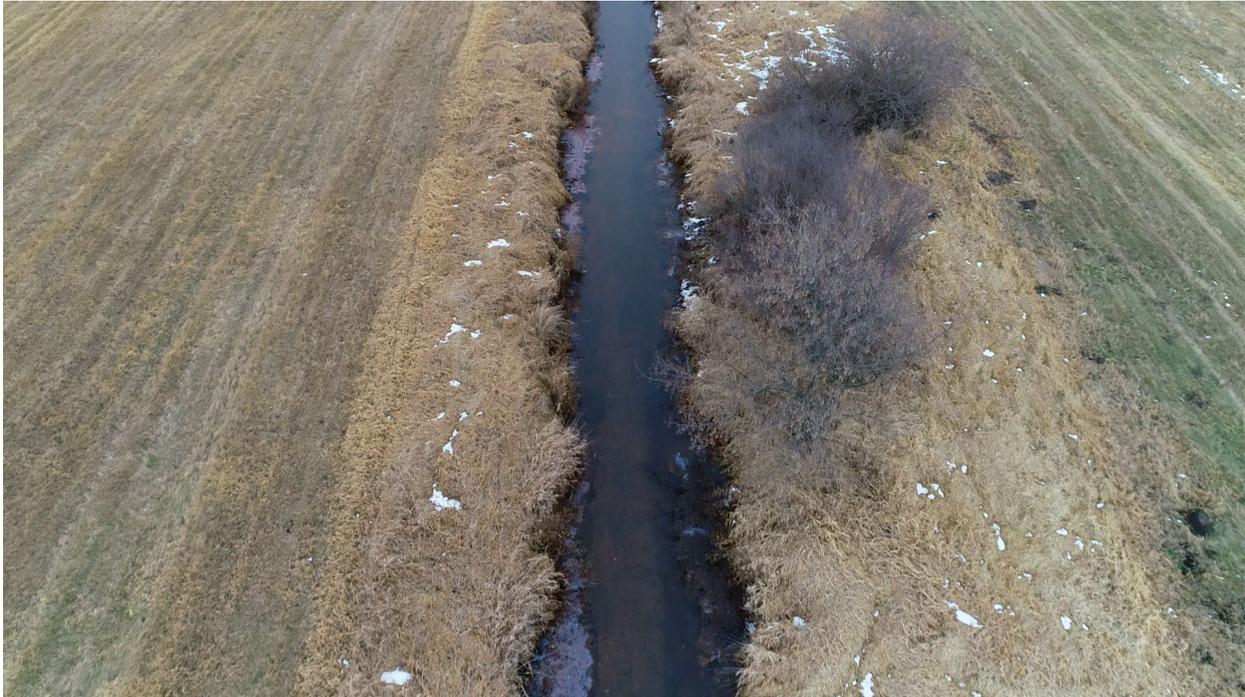
Inspection Area 11 – 82.43656.0000

This portion of the ditch inspection was completed on. PID: 82.43656.0000 located in Section 6, T123N, R28W. This portion of the ditch is open and free of debris and vegetation.

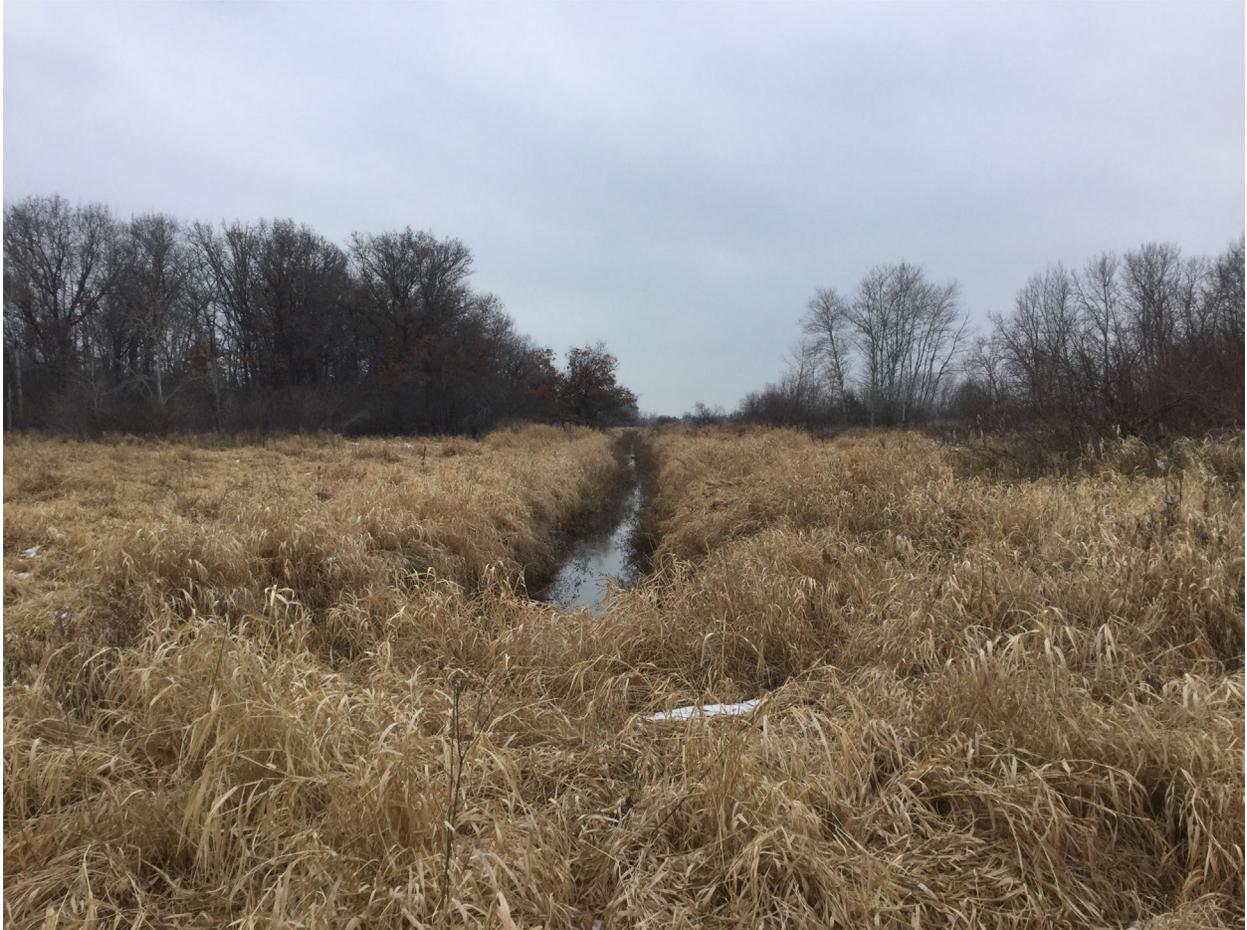
Inspection Area 12 – 82.43653.0000

This portion of the ditch inspection was completed on property PID: 82.43653.0000 in Section 6, T123N, R28W. This portion of the ditch is open and free of vegetation and de-bris.

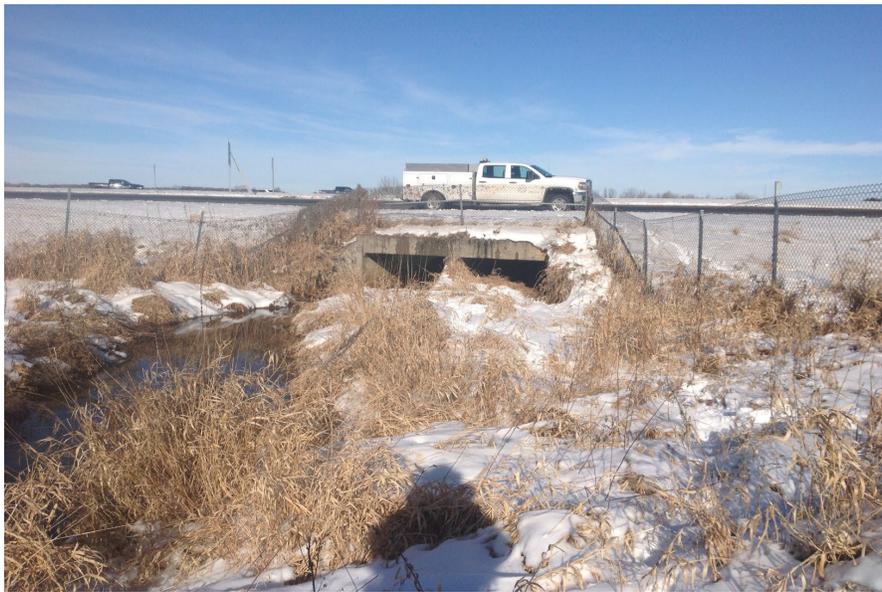
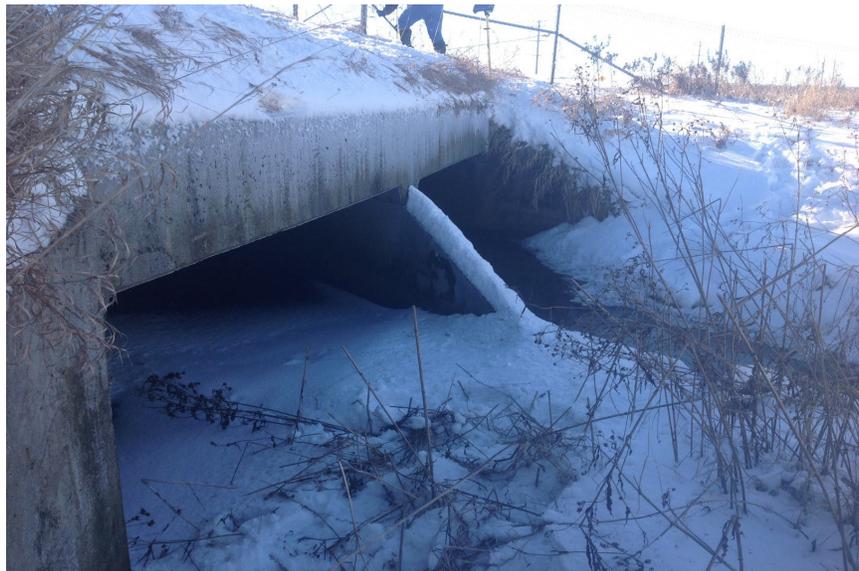
## Inspection Area 13 – I-94 Intersection

This portion of the ditch inspection was completed on the crossing of I-94 located in Section 6, T123N, R28W. The culverts are in good condition. There is vegetation and sediment on the upstream easterly culvert and the downstream easterly culvert. This culvert is 640ft long, there is a minimal of sediment in the culverts. The crossing information is as follows:

- Culvert: 2– 6ft X 8ft Reinforced Concrete Pipes (Good Condition)
- Southwest Invert: (Upstream Invert): 1082.26 feet
- Southeast Invert: (Upstream Invert): 1082.28 feet
- Northwest Invert: (Downstream Invert): 1081.56 feet

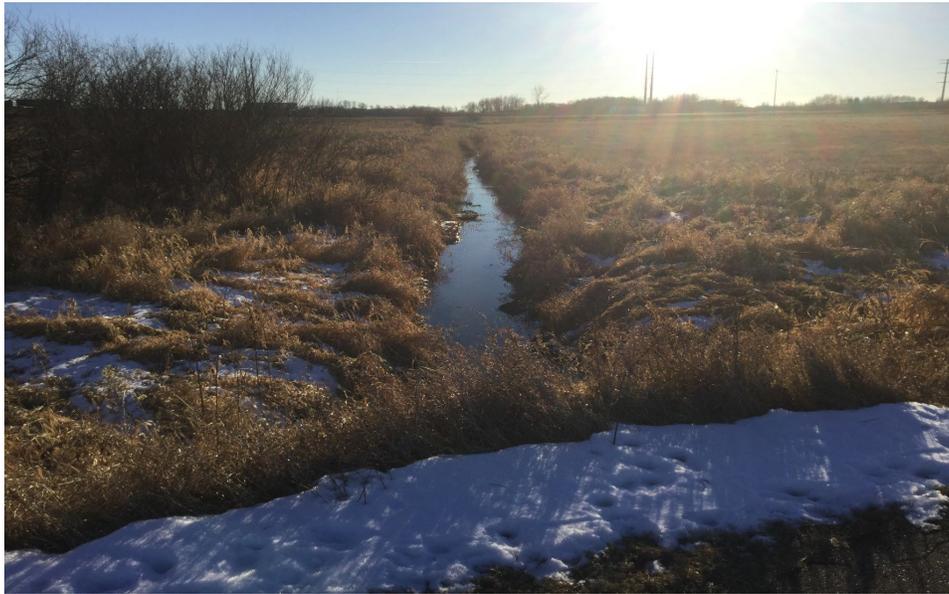
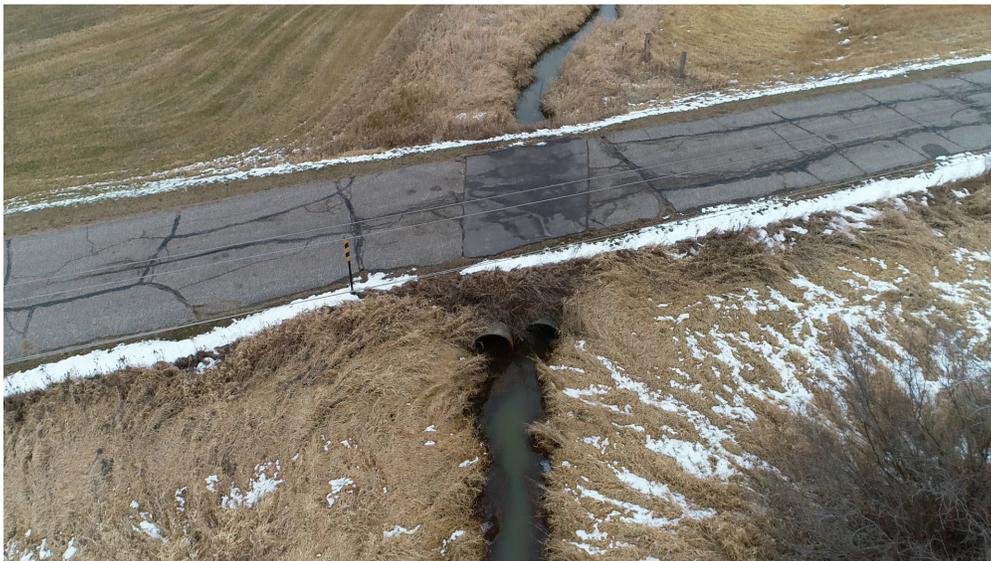
Inspection Area 14 – Old Co Rd 6

This portion of the ditch inspection was completed on the crossing under Old County RD #6 located in Section 6, T123N, R28W. At this crossing there a 2-48 inch Reinforced Concrete Pipes in fair condition. Under current conditions the water is flowing good. The crossing information is as follows:

- Culvert: 2-48 inch Reinforced Concrete Pipe (Fair Condition)
- Southwest Invert: (Upstream Invert): 1081.33 feet
- Southeast Invert: (Upstream Invert): 1081.61 feet
- Northwest Invert: (Downstream Invert): 1081.72 feet
- Northeast Invert: (Downstream Invert): 1081.99 feet

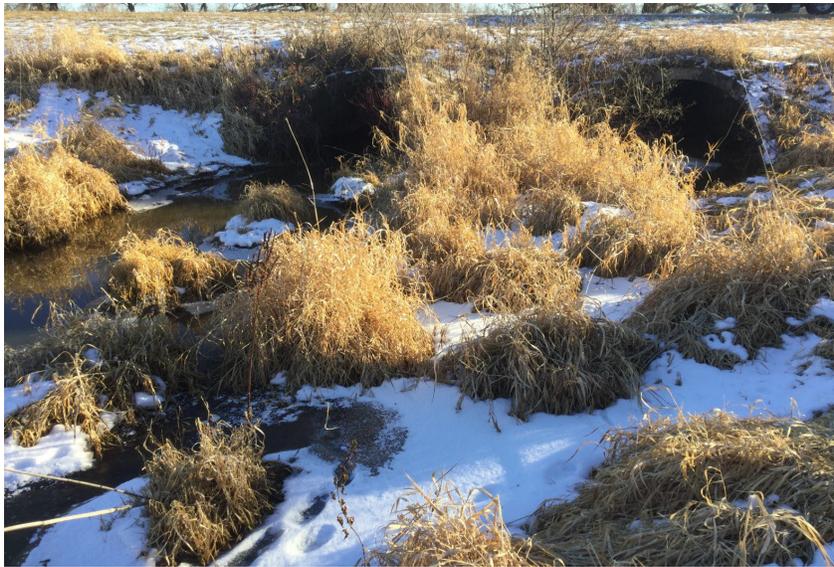
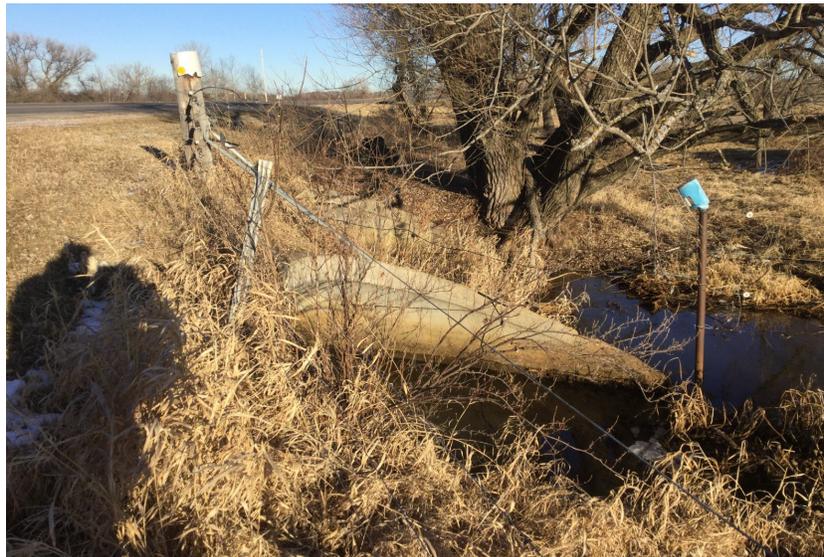
Inspection Area 15 – County State Aid 6

This portion of the ditch inspection was completed on a crossing under County State Aid Road #6 located in Section 31. T124N, R28W. There are 2-84 inch Reinforced Concrete Pipes at this crossing. The culverts are in good repair and good working condition. There is some vegetation upstream and downstream slightly restricting the water flow. The crossing information is as follows:

- Culvert: 2-84 inch Reinforced Concrete Pipes (Good Condition)
- Southwest Invert: (Upstream Invert) 1080.16 feet
- Southeast Invert: (Upstream Invert) 1080.04 feet
- Northwest Invert: (Downstream Invert) 1080.78 feet
- Northeast Invert: (Downstream Invert) 1080.52 feet

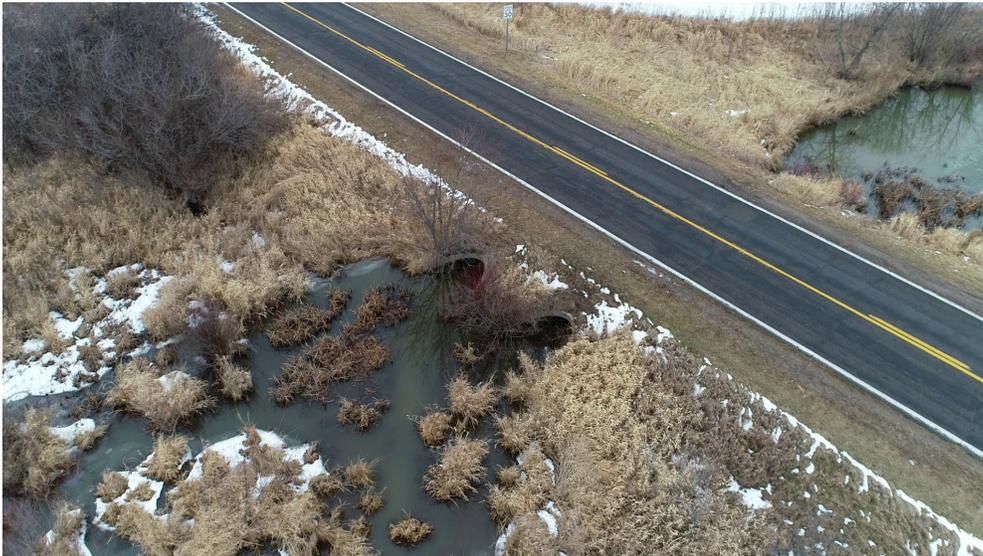
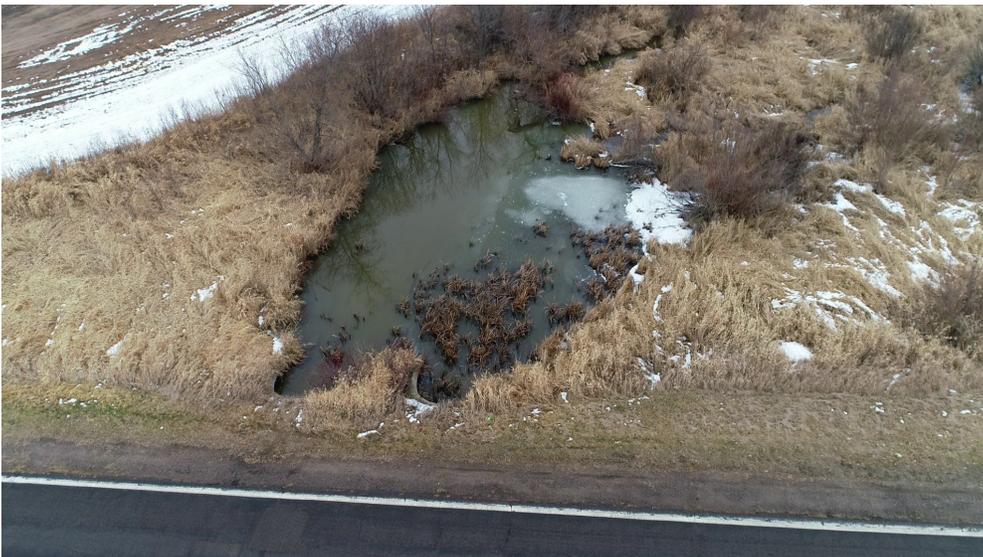
Inspection Area 16 – Granite View Dr

This portion of the ditch inspection was completed on the crossing under Graniteview Dr. in Section 32, T124N, R28W. The culvert is in good condition with some vegetation in the upstream and downstream channel. The crossing information is as follows:

- Culvert: 2–72 inch Reinforced Concrete Pipes (Good Condition)
- Southwest Invert: (Upstream Invert): 1078.89 feet
- Northwest Invert: (Upstream Invert): 1078.74 feet
- Northeast Invert: (Downstream Invert): 1079.31 feet
- Southeast Invert: (Downstream Invert): 1079.30 feet

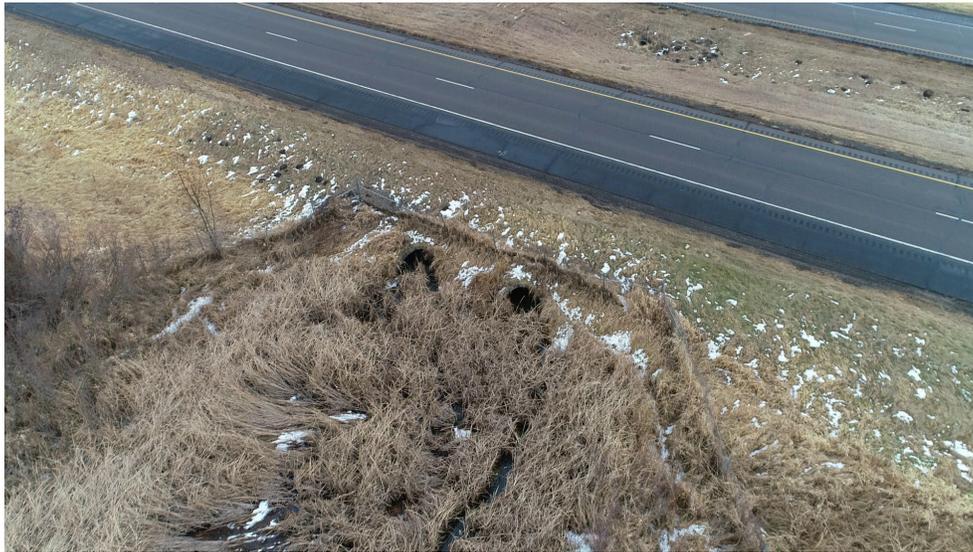
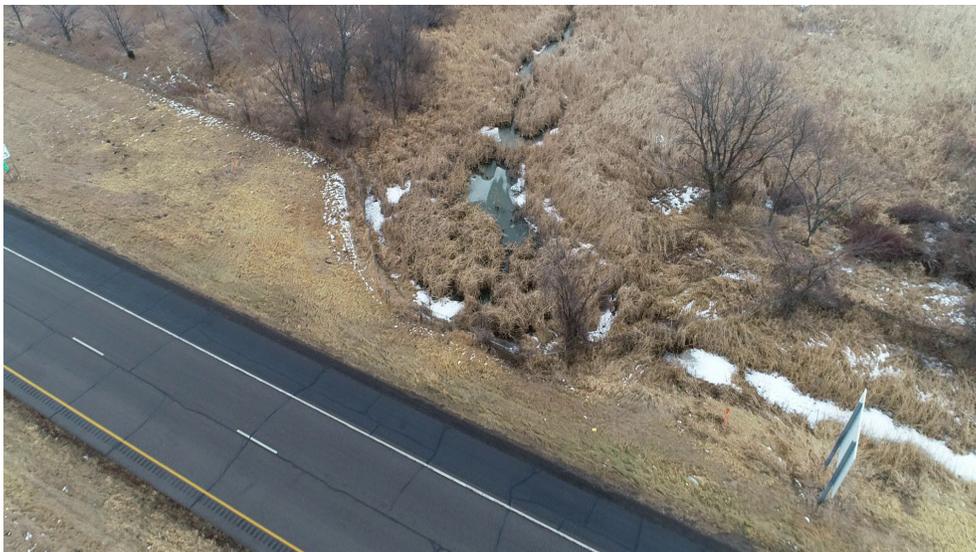
## Inspection Area 17 – MN Hwy 15

This portion of the ditch inspection was completed on the crossing of State Highway #15 located in Section 32, T123N, R28W. The culverts are restricting water flow. The crossing information is as follows:

- Culvert: 2 – 72 inch Reinforced Concrete Pipes
- Southwest Invert: (Upstream Invert) = 1076.35 feet
- Northwest Invert: (Upstream Invert) = 1076.18 feet
- Southeast Invert: (Downstream Invert) = 1076.06 feet
- Northeast Invert: (Downstream Invert) = 1076.12 feet
