# DITCH INSPECTION 39

CD39

**STEARNS COUNTY MINNESOTA**

August 17, 2017

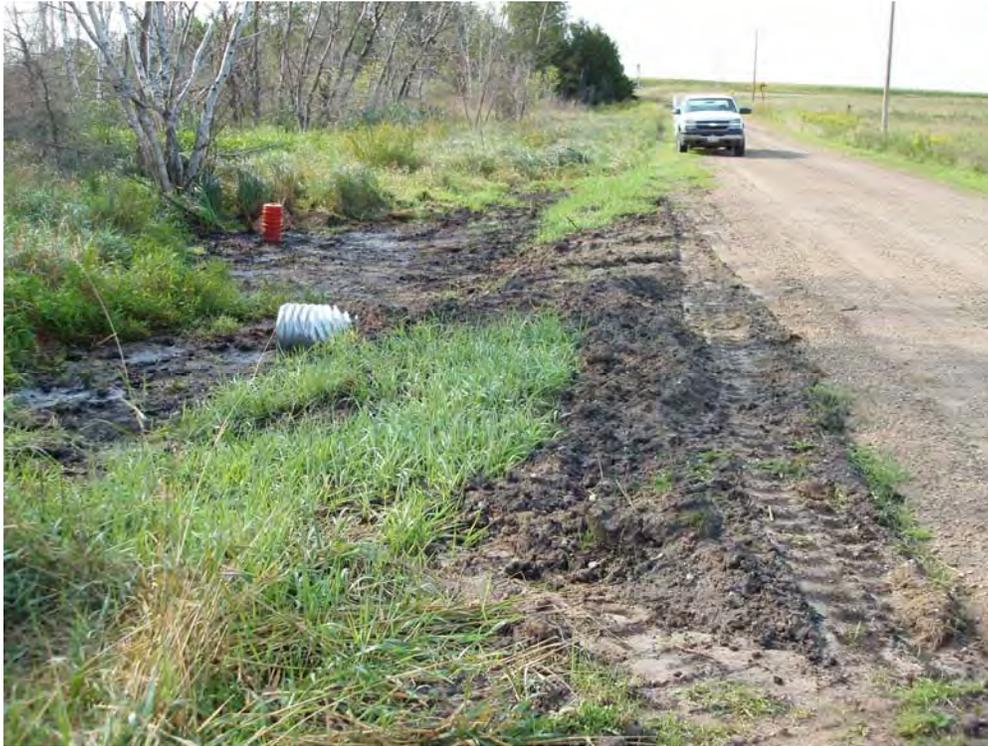
CD39 crosses 8<sup>th</sup> Ave where a repair was completed in 2015 to add a drain stack to allow water into the clay tile. This area is functioning without blowouts or any other visible issues.

8<sup>th</sup> Ave Crossing – As Constructed shown due to current vegetation

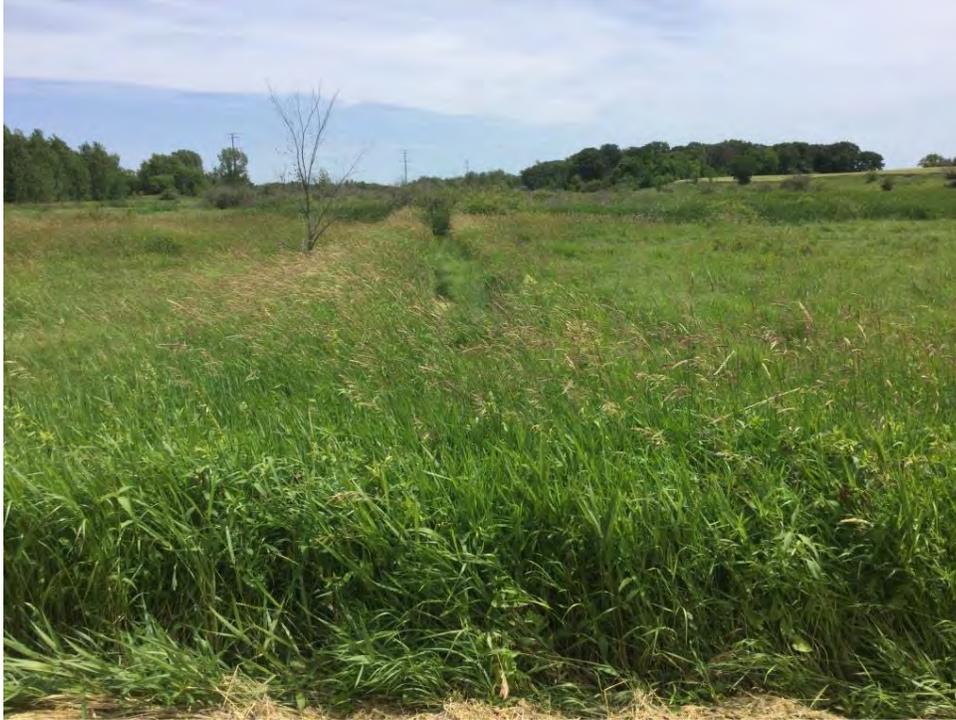
Observation was done from Fairfax Rd looking up and downstream. This section of the ditch is clay tile. No blowouts or other indications of problems on CD39 were observed.

Looking southeast from Fairfax Rd

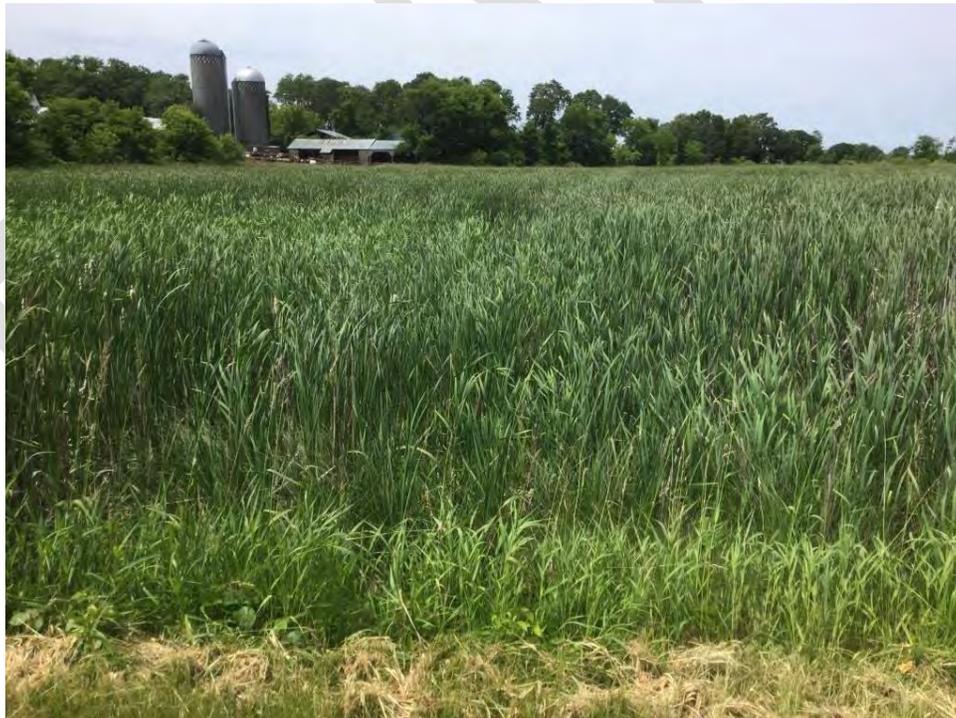
Looking northwest from Fairfax Rd

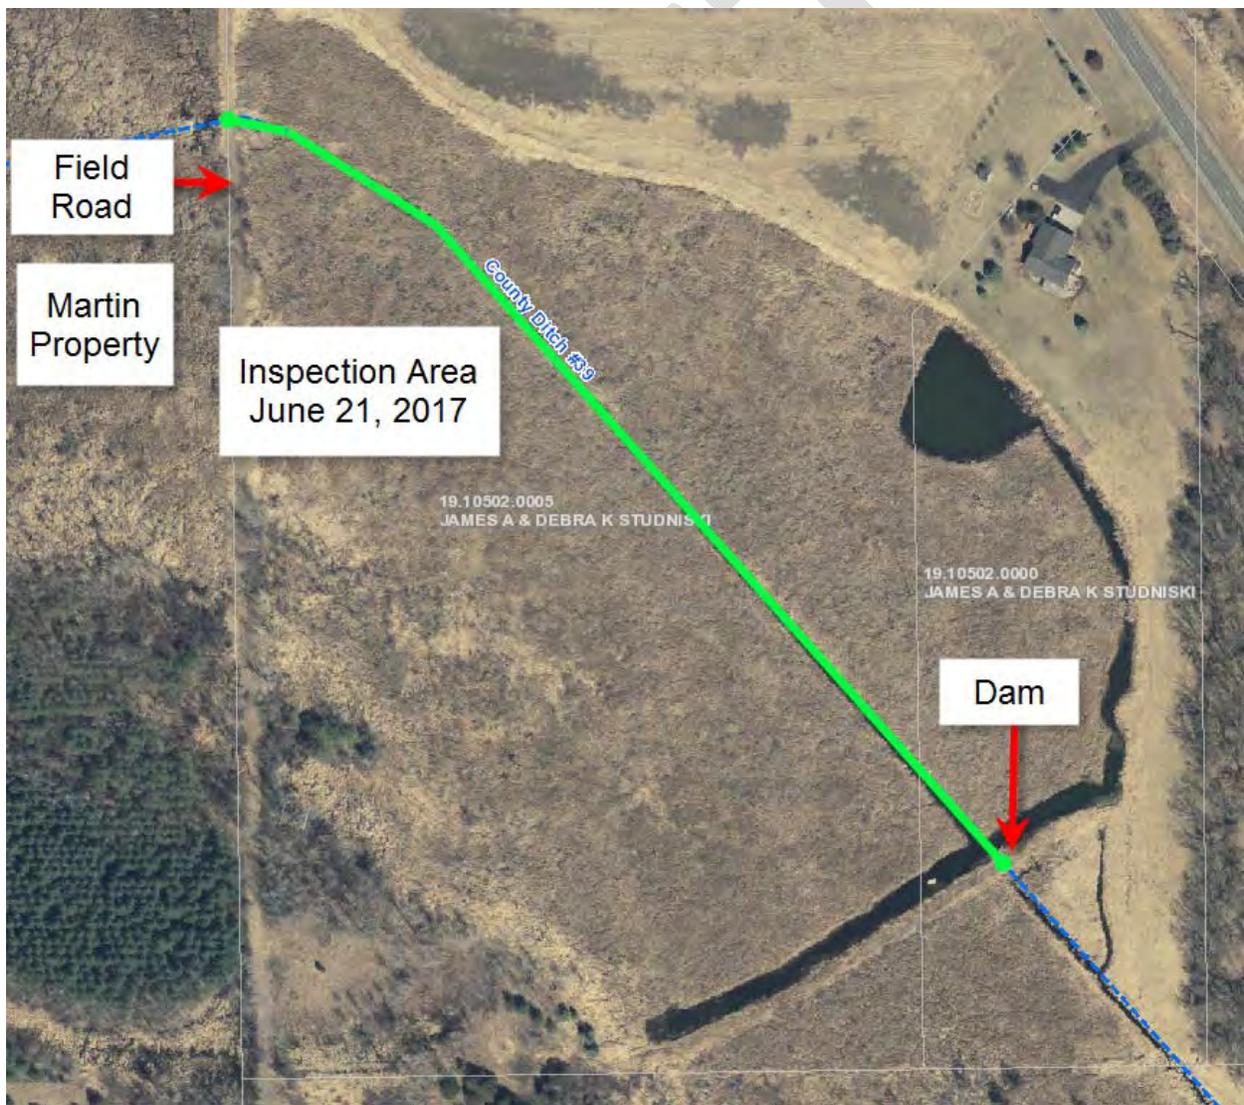
Traveling Northwest upstream of the ditch, the channel was clearly defined and contained little water. Tall grass made it difficult to see the channel but the Marsh Master allowed for travel in water and along the channel for a better view. The water was observed to be flowing slowly. The channel remains open for roughly 850 feet from the dam.

The channel narrows and eventually closes for about 400 feet until reaching the field road. Water was observed flowing from culvert under the field road. Visual inspection of the area immediately east of the field road show minimal standing water. The water works its way southeast into the ditch channel. The area around the culverts where no ditch channel was clearly defined was wetter than areas on either side of the open channel.

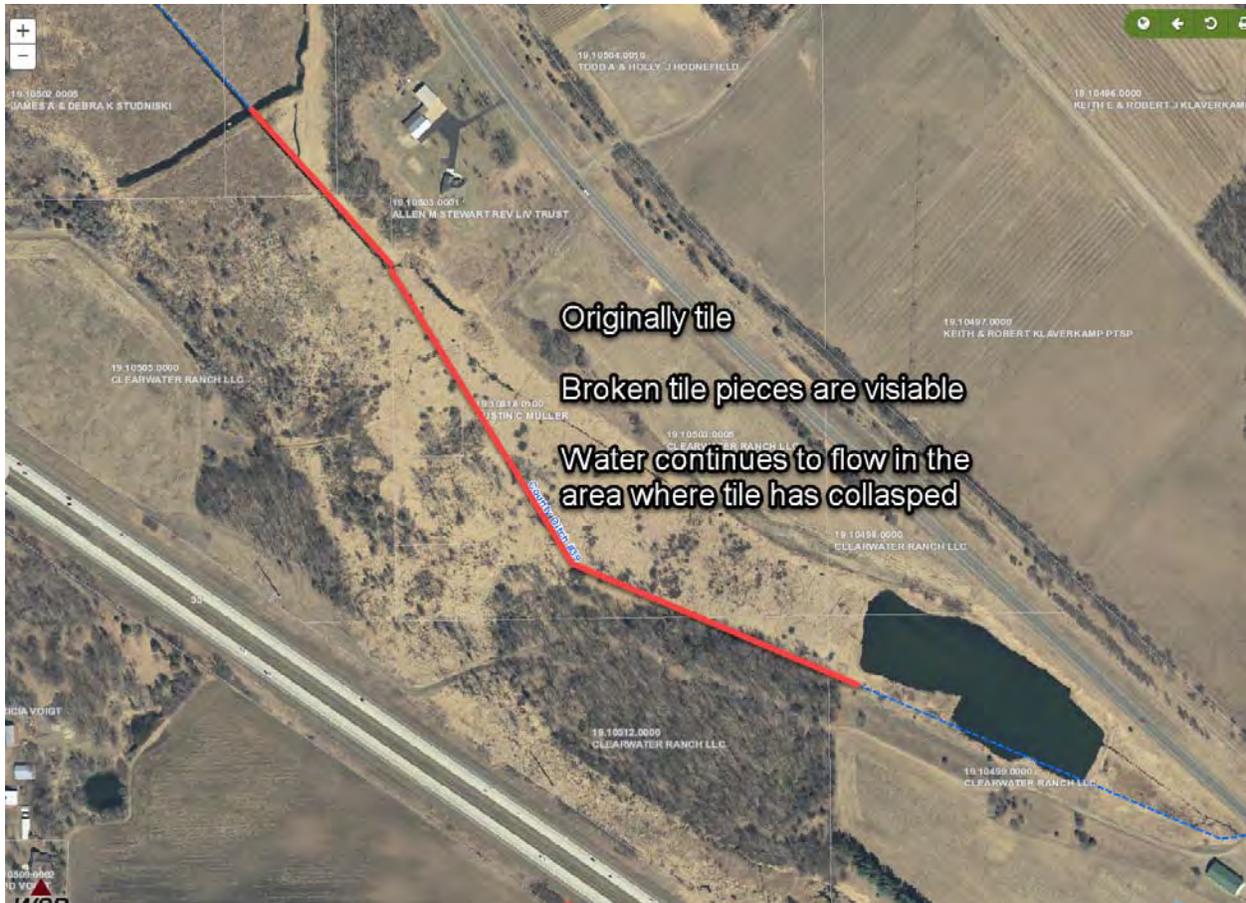
The section of ditch from the dam to the pond was originally clay tile. Broken tile pieces are observed along this stretch indicating a complete failure of the original tile. Water continues to flow through the area either in newly formed water ways or over the depression left by collapsed tile. It is unclear whether the ditch is flowing along the original alignment or a new path created by overland water continuing to flow. There is no evidence of water backing up or pooling, however, the ditch function in this area cannot be considered ideal.

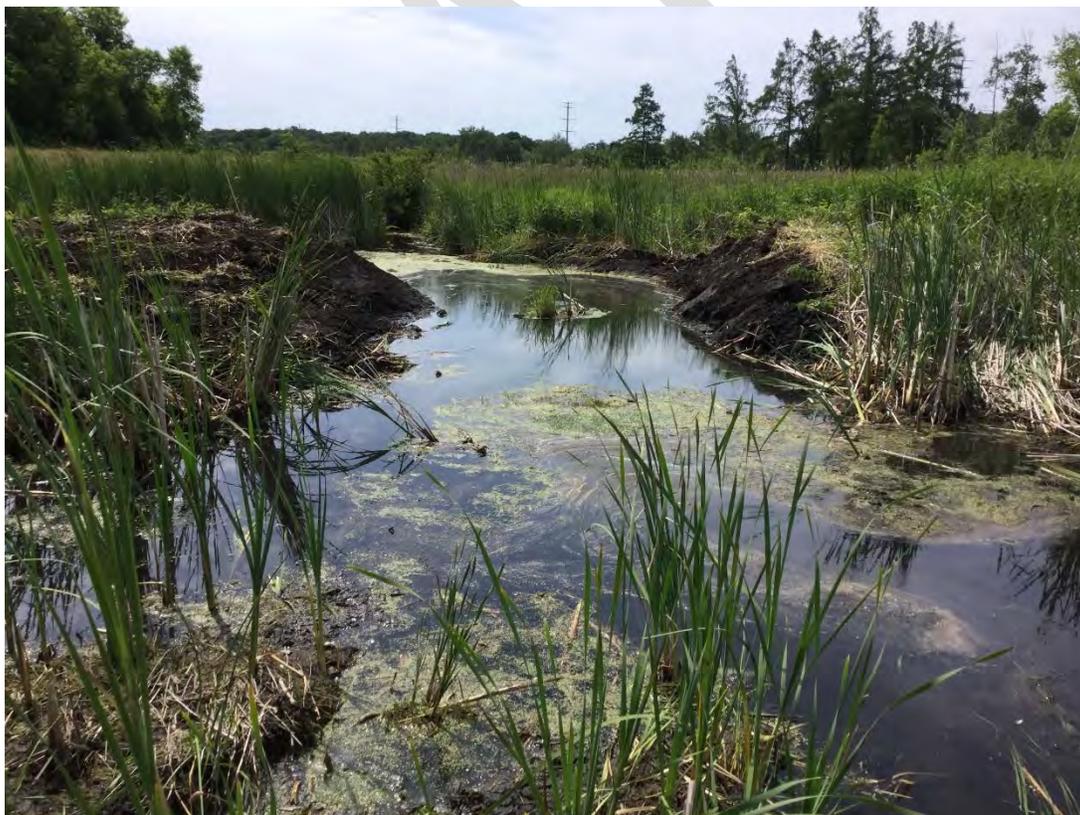
Using an excavator, the US Fish and Wildlife staff removed portions of the dam to allow CD39 to flow. Under supervision of Stearns County staff using GPS equipment, the ditch channel was reestablished at the location of the dam. Seeding of exposed soil was done when the work was complete.

Upon completion of the excavating, water could be seen flowing through opening in the dam. Once the ditch channel was reestablished, inspection of the ditch upstream from the dam was performed.

Photo 2 –View of dam opening where ditch channel was reestablished.

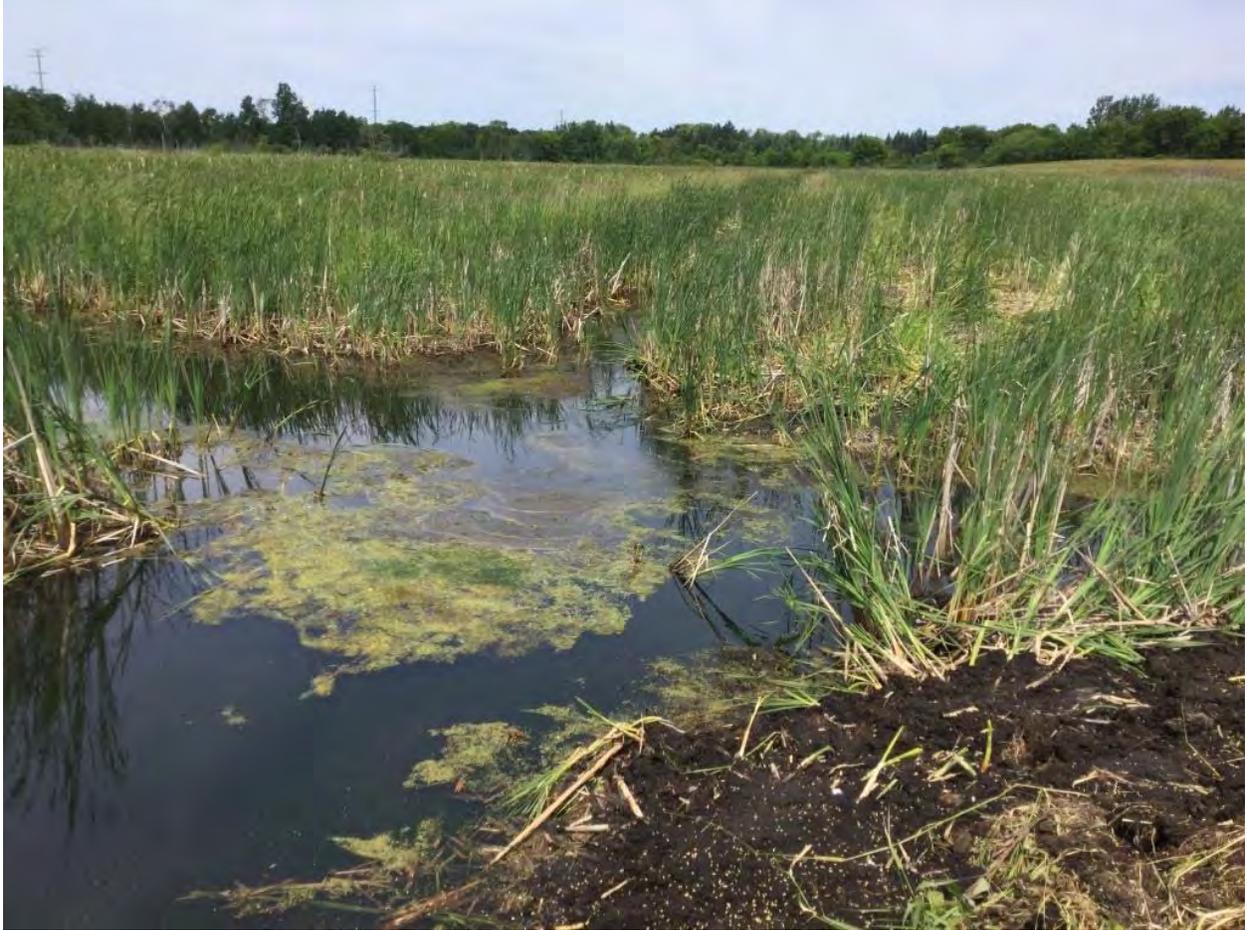
Photo 3 – Standing on dam looking upstream at ditch channel

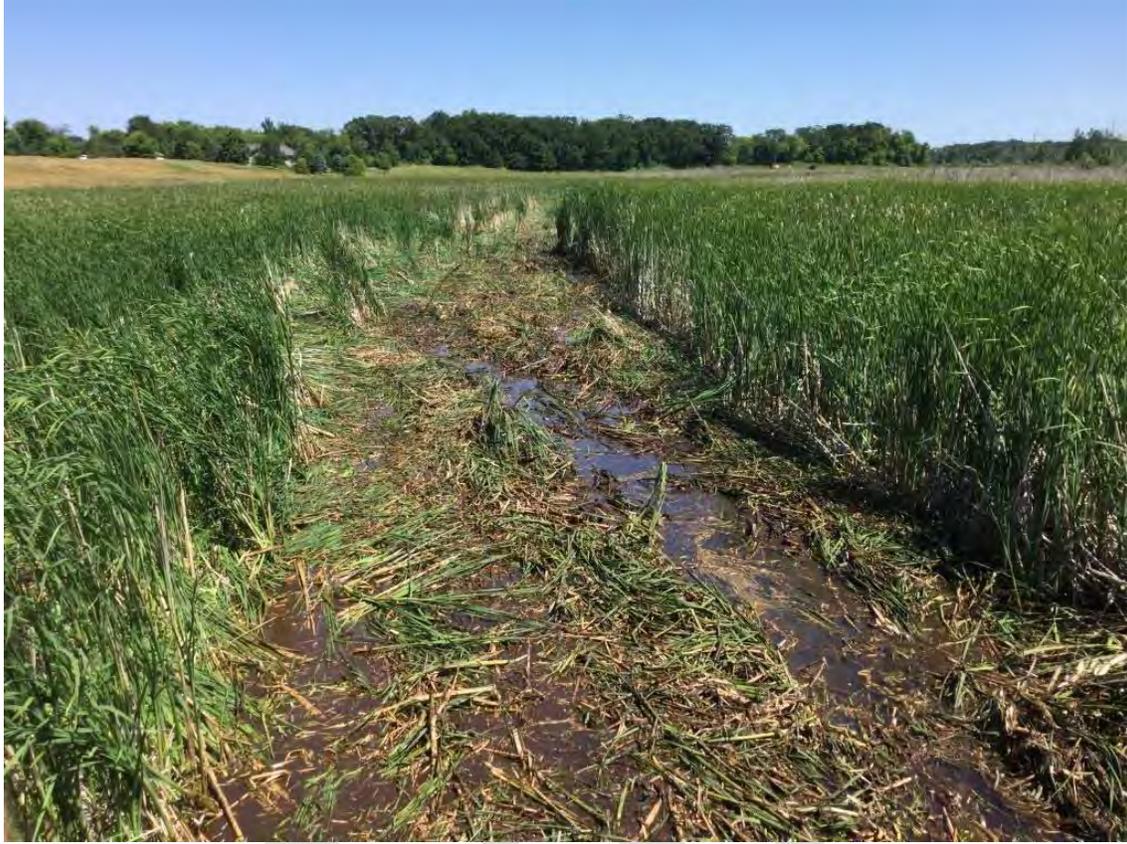
The area of the ditch from the Studniski field road to the old dam moves water but the flow and capacity are negatively impacted by the condition of the ditch and the field road. Specifically, there is no defined channel immediately downstream of the field road and the road itself is a clear obstruction to ditch flow.

The lack of a defined ditch channel in the area of the field road allows water to collect. During times of high water, it should be expected that the wetland in the area east of the field road would hold water for a time until it makes its way to the defined channel downstream. A repair to the ditch from the location of the old dam to the field road should be considered by the Drainage Authority. The area between the old dam and the pond on the Clearwater Ranch property should be considered for repair based on visible evidence of broken tile that cannot be functioning as designed.

Photo 4 – Area east of field road. Water moves towards the defined channel, but clearly spreads throughout the immediate area.

The condition of the field road culverts greatly impacts the ability of the ditch to move water downstream. In accordance with MN103E.075, the obstruction at the field road should be considered by the Drainage Authority.
