# Stearns County Ditch 25 Profile Evaluation

Stearns County, Minnesota  
December 13, 2016

REVISED 1/23/2017

REVISED 4/25/2017

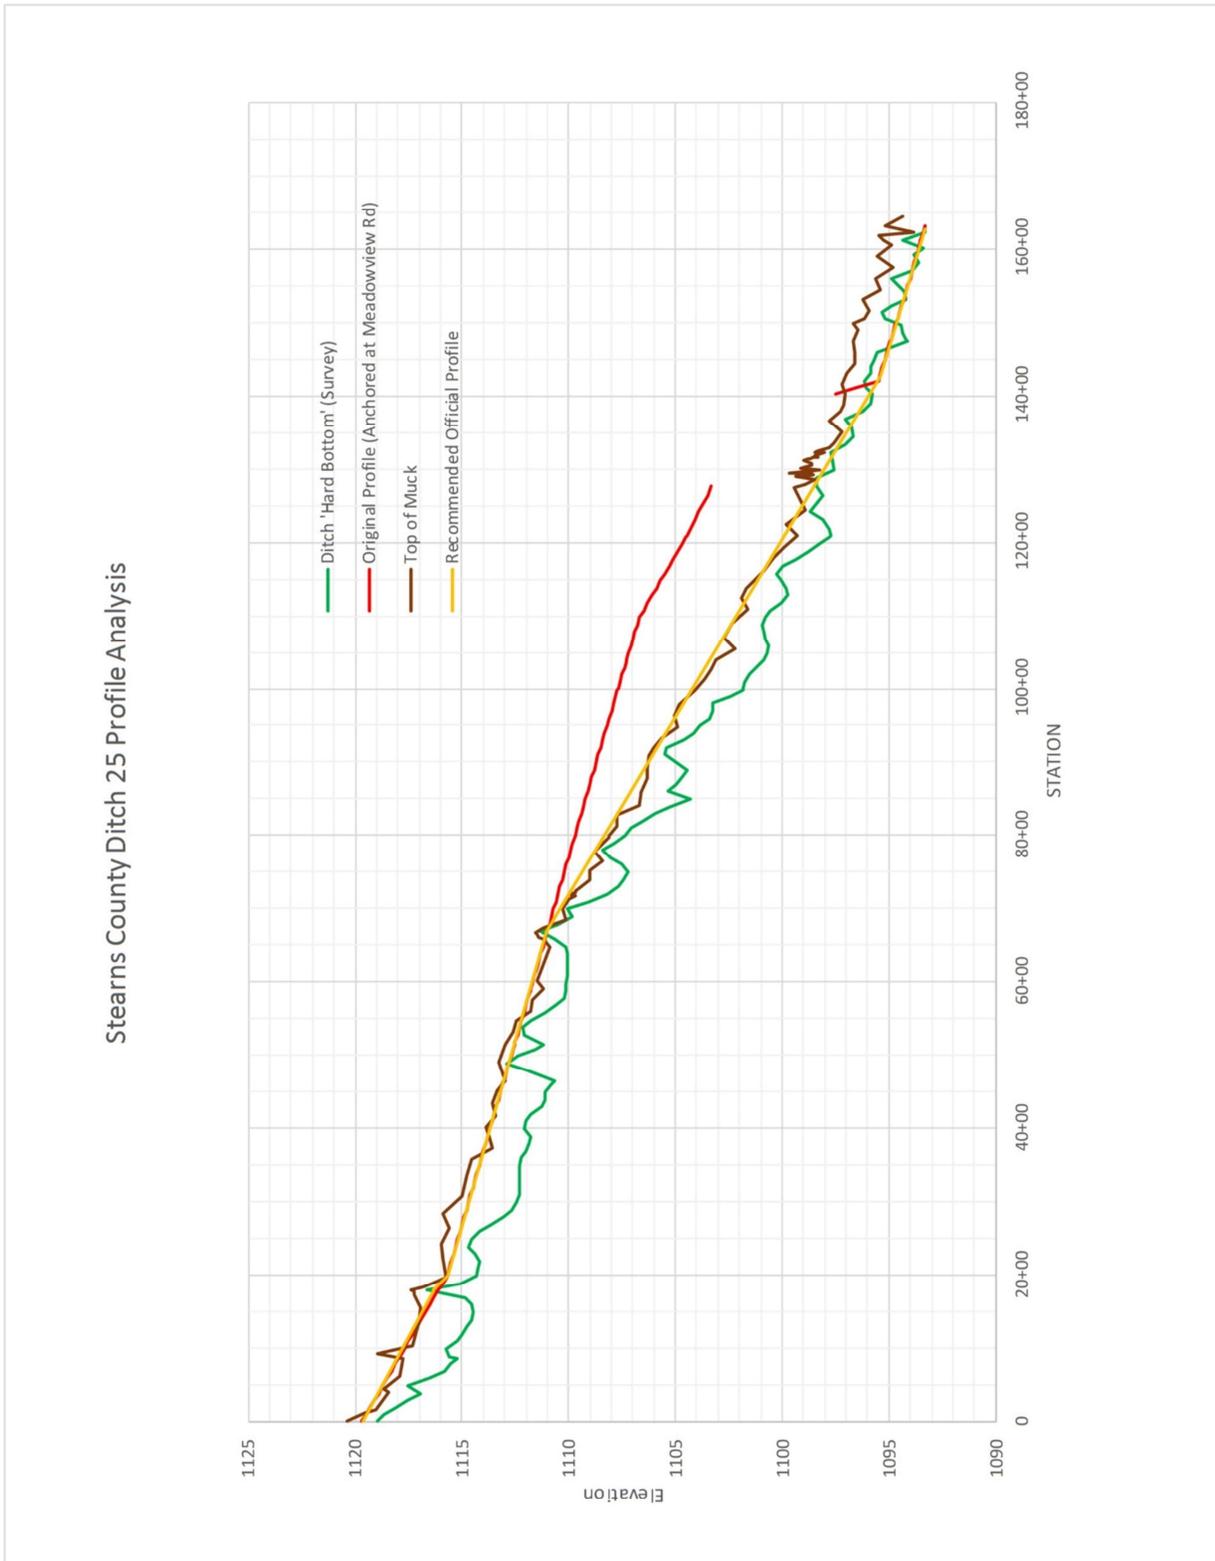
Figure 2. Comparison of Analyzed Profiles

Figure 2 illustrates the hard-bottom profile relative to the “top of muck” survey, the profile from the original ditch records, and the recommended profile.

A graph showing the current ditch bottom (survey), top of sediment (survey), adjusted original design profile, and recommended official profile is provided on the following page.

As described above, the surveyed inverts of the Meadowview Road Culvert (among other data points) were used to set the elevations of the recommended profile. Currently, the runout elevation of the lake (according to the same survey) is approximately 4' higher in elevation than the culvert inverts. This indicates that water levels in the lake are being controlled at the ditch inlet, and not by the Meadowview Road culvert.

Downstream of the culvert, the recommended profile follows the original design profile slope, which places the recommended profile just below the current top-of-muck elevations over most of the next ~3000 ft. However, as can be seen in the profile chart, cleaning the ditch down to the recommended profile anywhere east of the Meadowview Road culvert would not change the controlling runout elevation of the lake, and in fact would not impact anything west of Meadowview Road. Even if potential long-term effects of ditch maintenance east of Meadowview Road are considered, the presence of the roadway and culvert at that location would prevent any potential erosive action (head cutting) from lowering the ditch bottom elevations at the lake outlet.

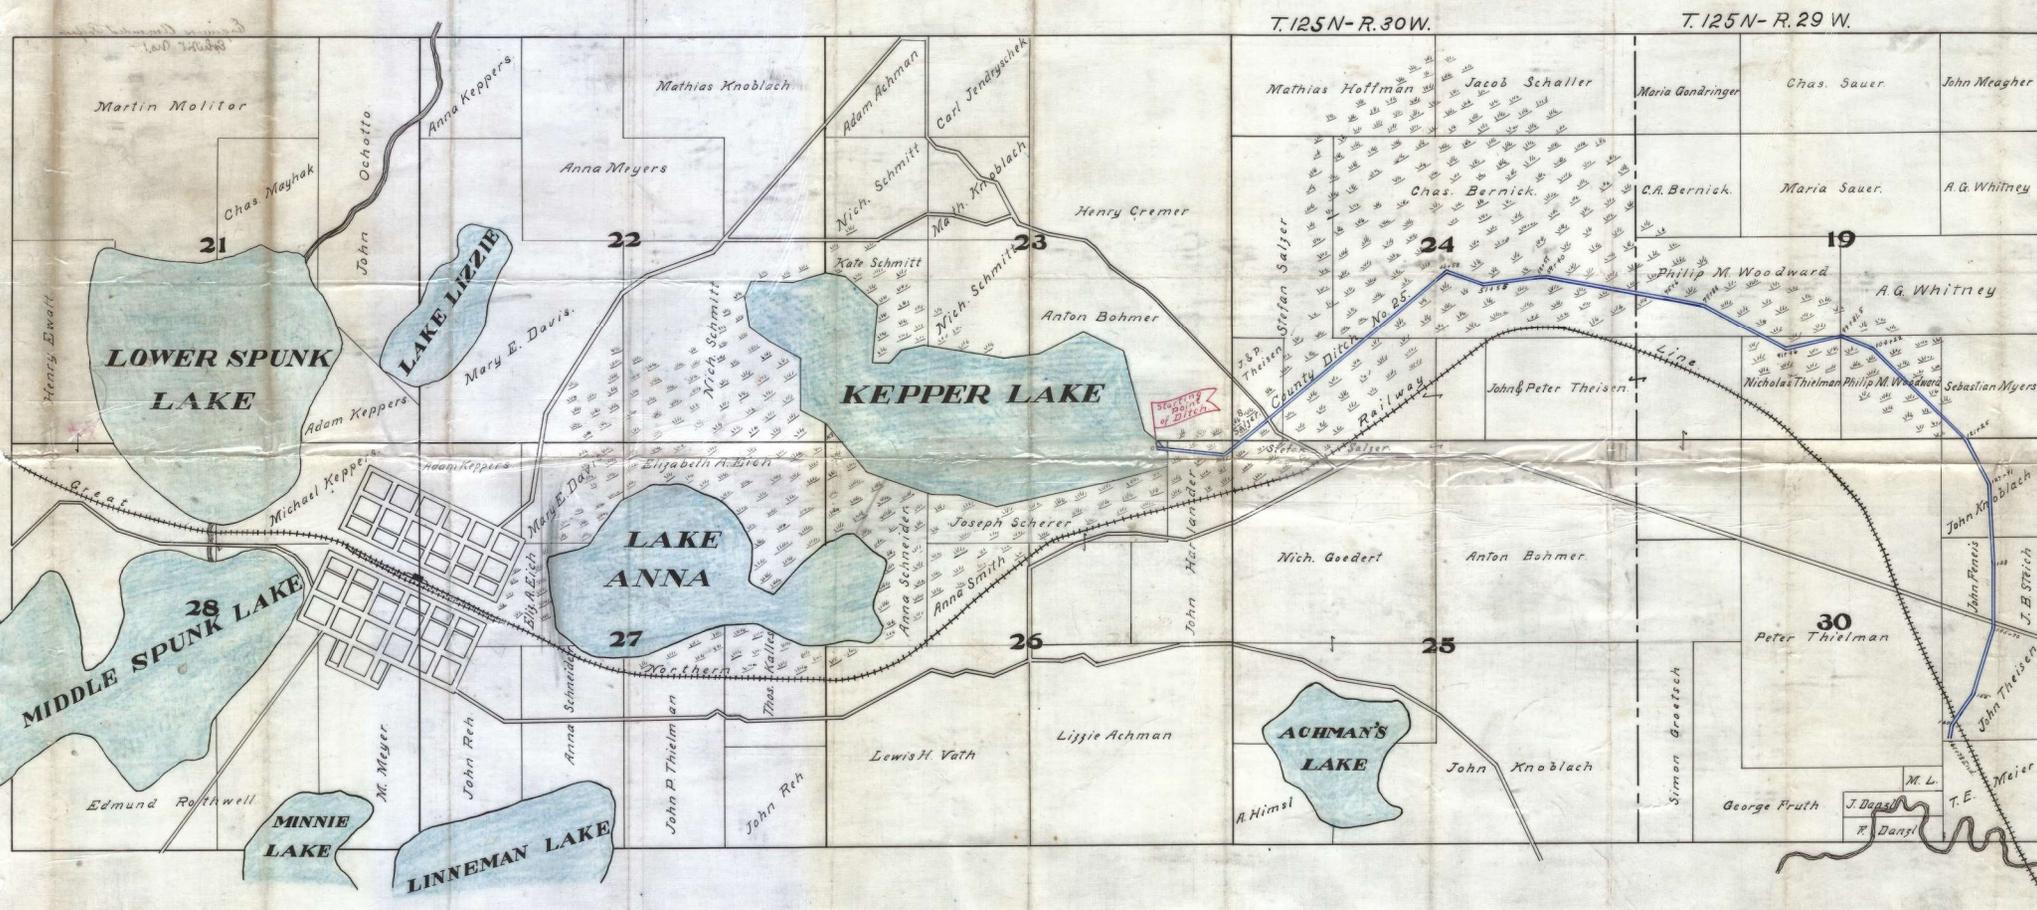
# MAP OF COUNTY DITCH NO. 25

STEARNS CO., MINN.

Nov. 1905. Arthur E. Morgan, C.E.

The Original Ditch Records are included in Appendix A. The records consist of the “Map of County Ditch 25” as well as the “Engineer’s Report in Ditch Proceedings,” the latter of which contains detailed construction records. Stationing along the ditch is identified in each document, allowing the information from the to be correlated.

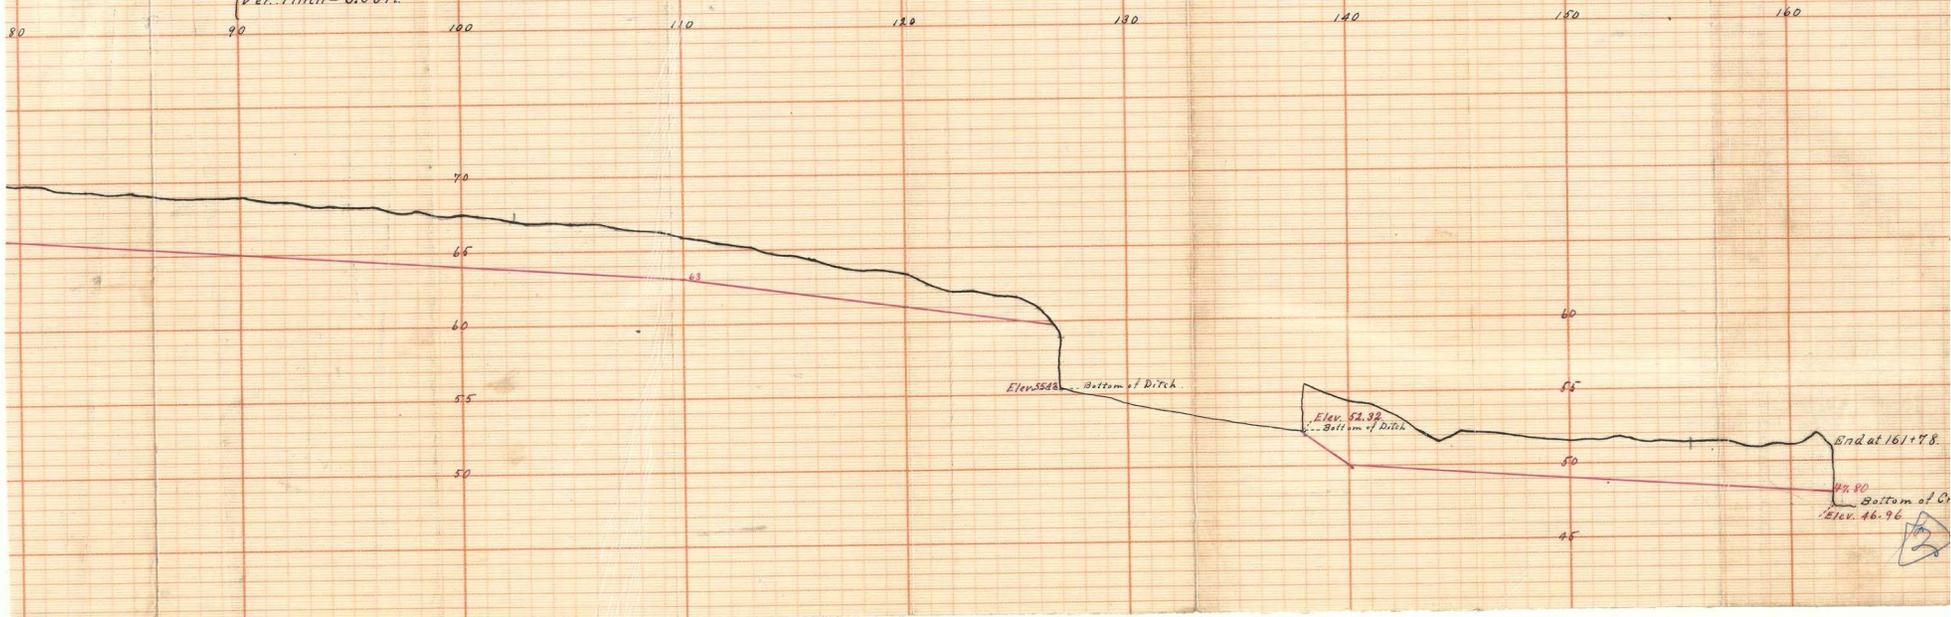
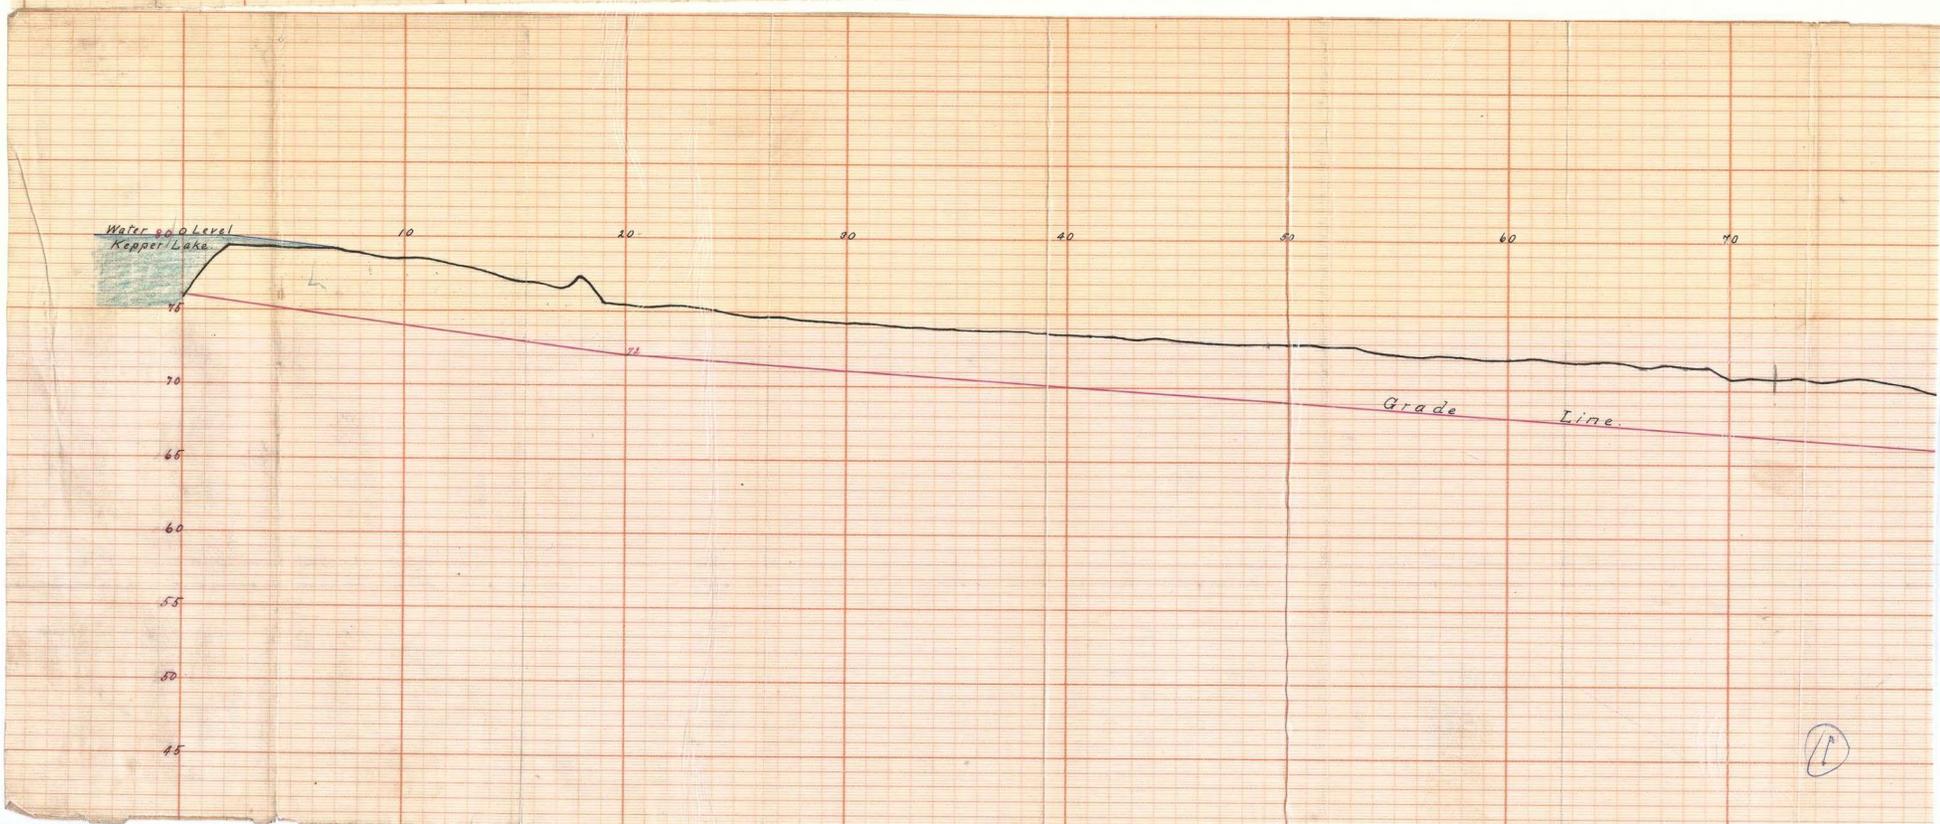
# PROFILE OF DITCH No. 25

STEARNS CO. MINN

November 1905. Arthur E. Morgan, C.E.

Scale { Hor. inch = 400 ft  
Ver. inch = 6.00 ft

The original design, as reflected in Exhibit 2 of the 1905 Engineer's Report (see Appendix A), is the best information available regarding the intended ditch construction. However, there would be a variety of potential circumstances in which field conditions would result in the actual construction varying from the design. It is important to understand that the builders would be guided primarily by the design, but would also make practical adjustments in the field, provided that any modifications do not fundamentally alter the functionality of the ditch.

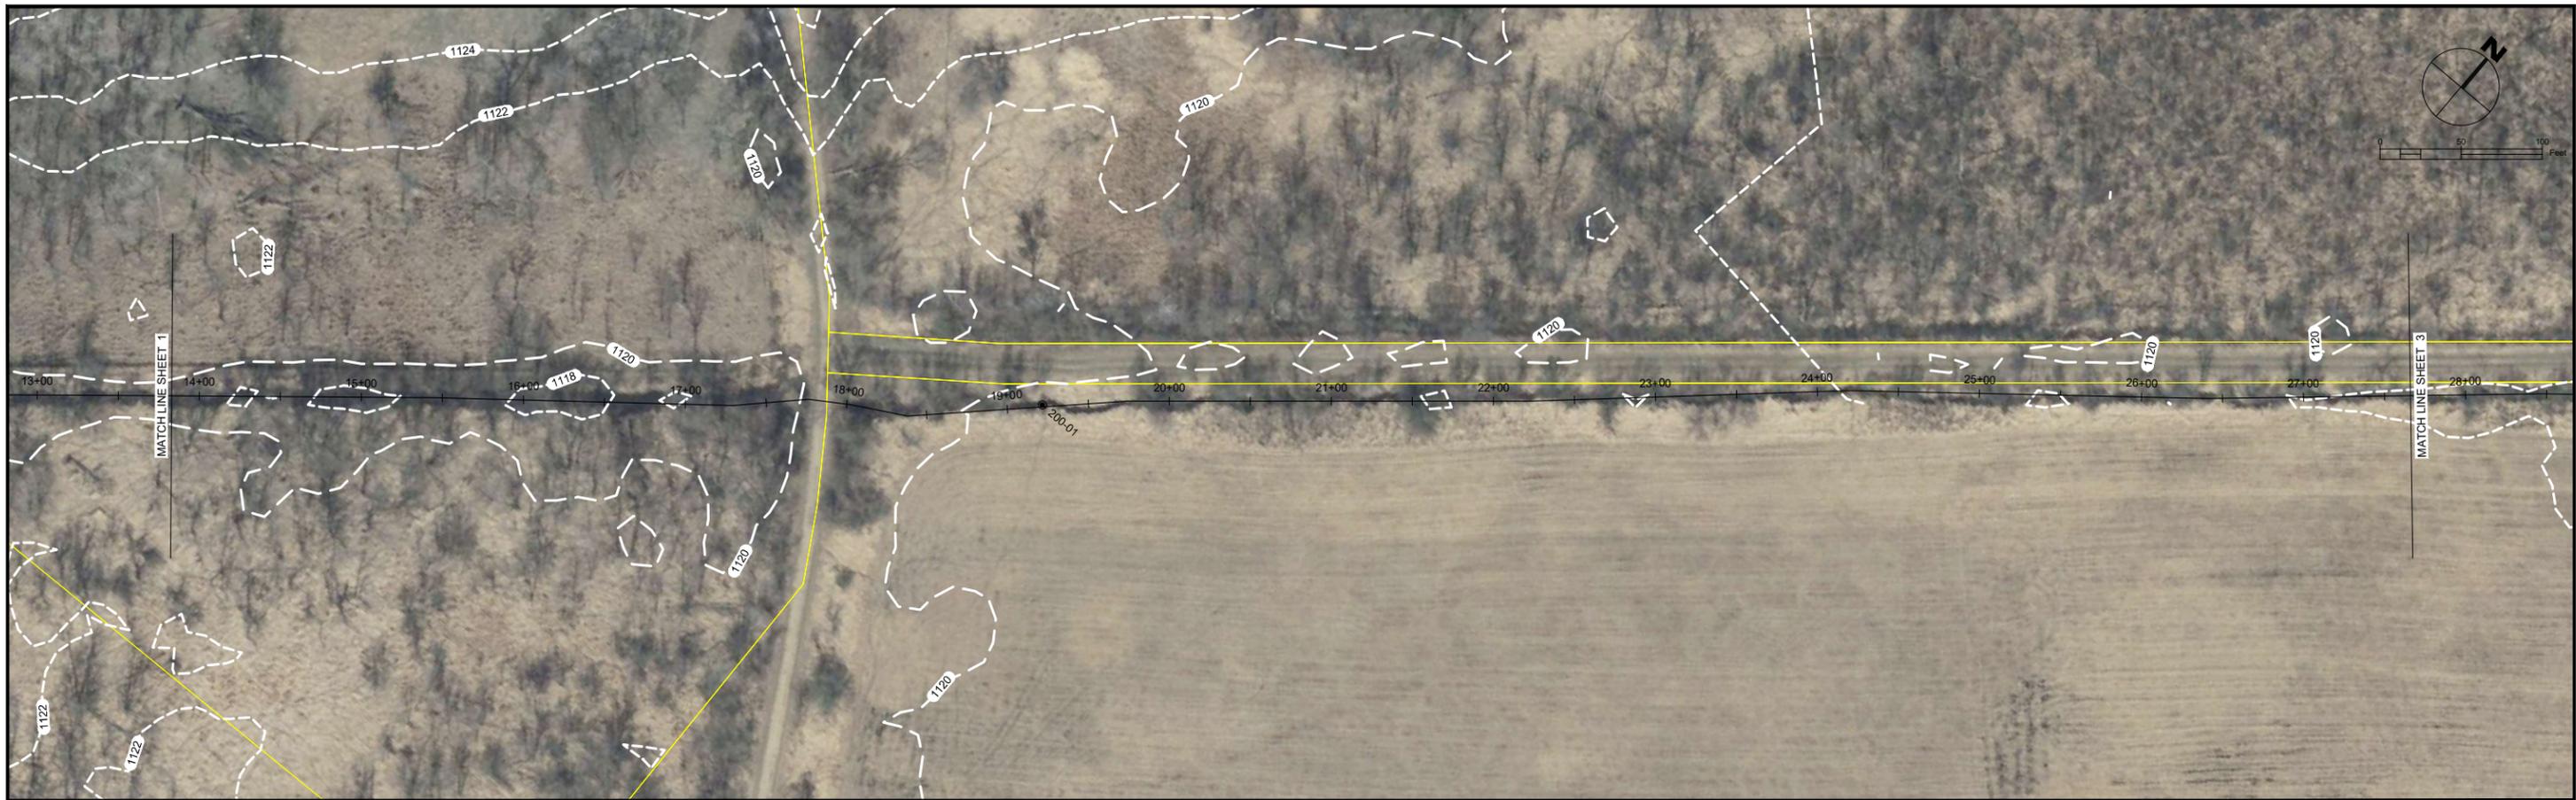
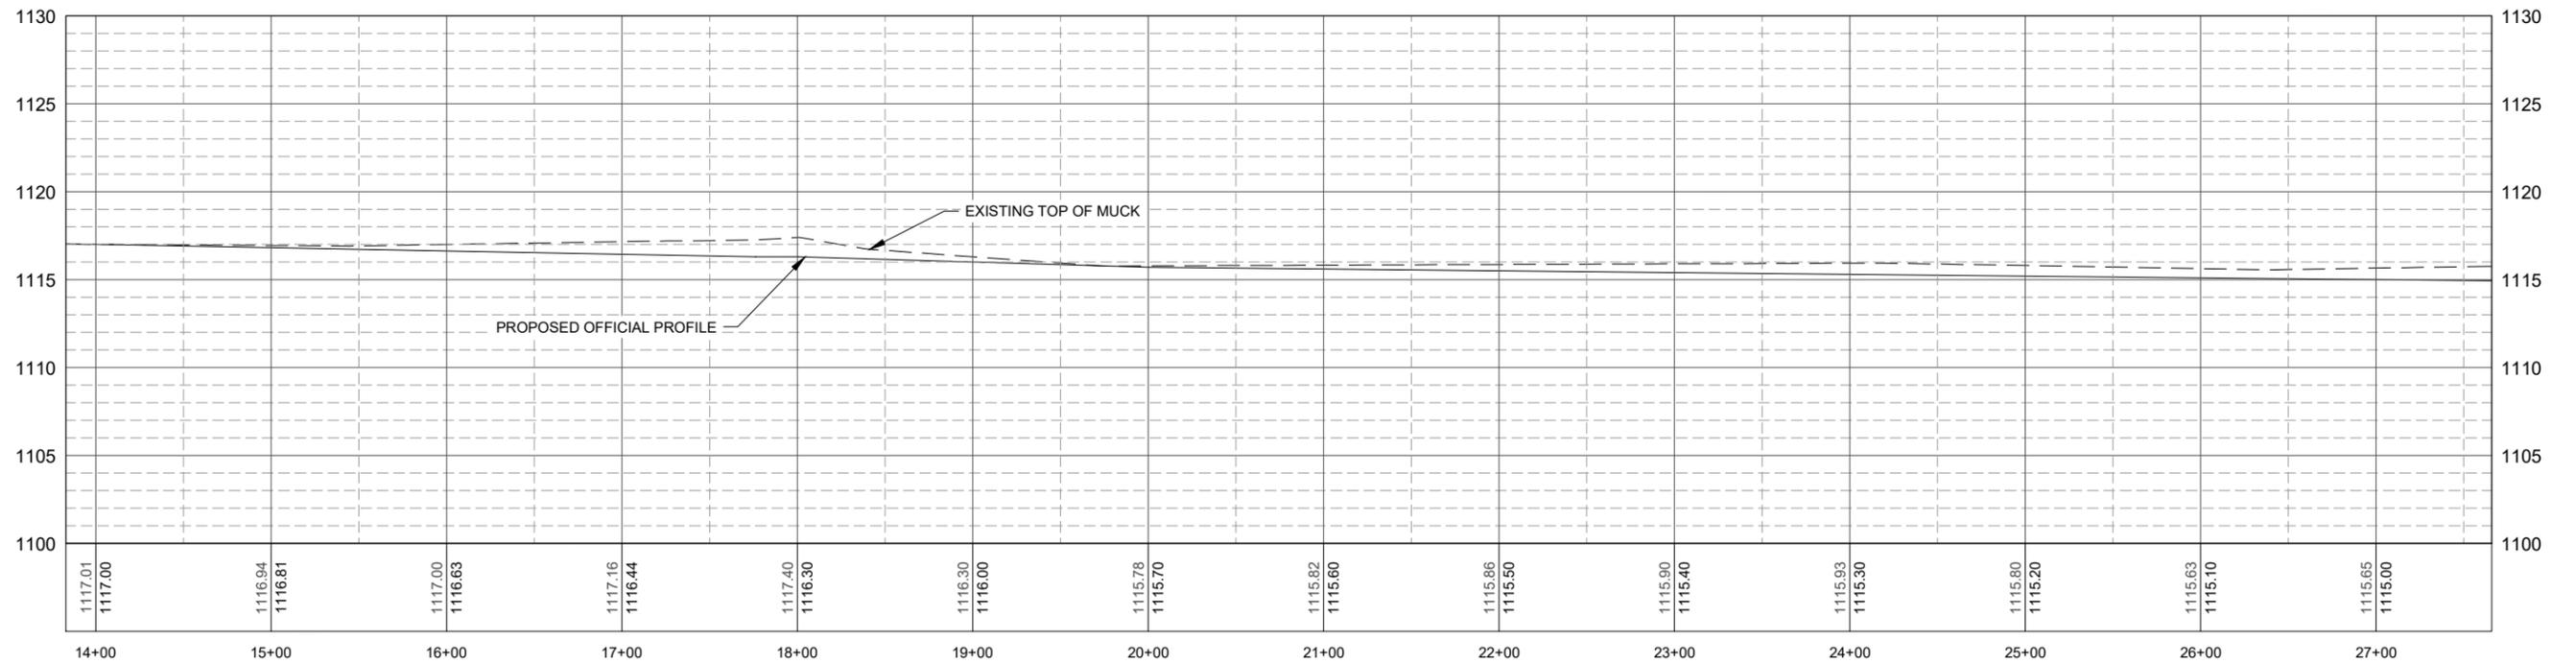
SHEET NO:  
**2**

TITLE:  
**DITCH PLAN & PROFILE**  
 STEARNS COUNTY DITCH #25 PROFILE EVALUATION  
 AVON & ST. WENDEL TOWNSHIPS, STEARNS COUNTY, MN
