Inspection of Stearns County Ditch 30

August 5, 2022

Staff is presenting this report to the Stearns County Board of Commissioners, acting as the Drainage Authority for Stearns County Ditch 30 (CD30), as required by Minnesota Statute 103E. The purpose of this report is to share the results of the inspection.

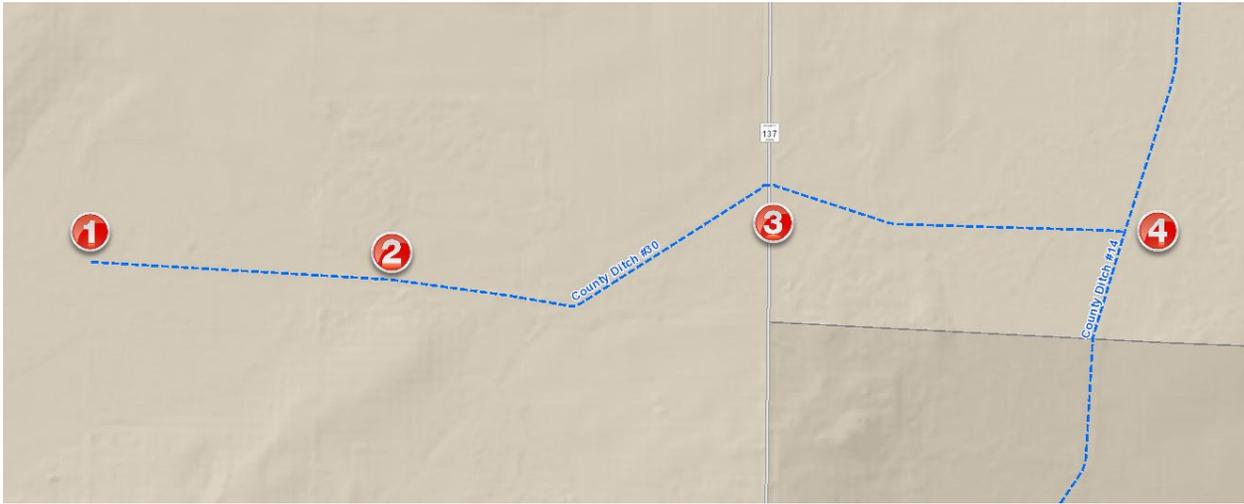
Inspection Locations

The inspection was performed using a combination of drone video, aerial photography, historical drainage records, and on-site visits. The inspection is broken into 4 locations. CD30 was field visited in 2018 and aerial photography from 2021 used for the inspection. Wetland locations come from the National Wetlands Inventory.

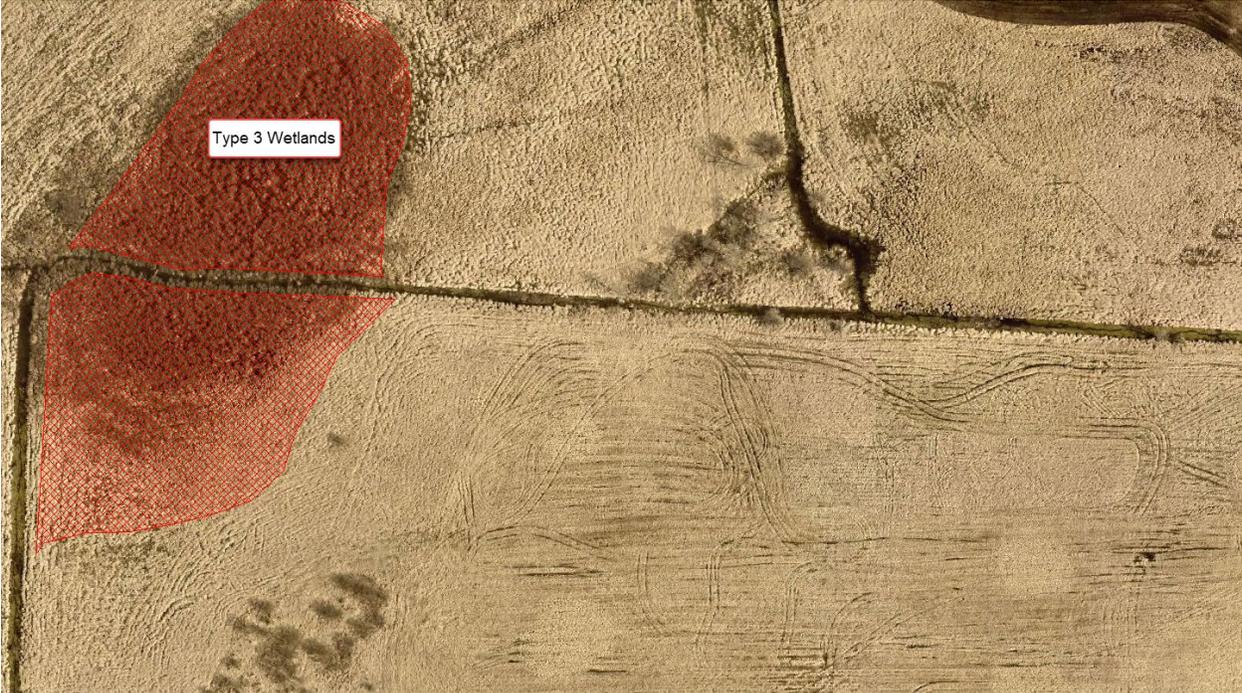
Photo 1 – April 2021 Stearns County Aerial Photography

This area represents the legal beginning of the ditch. The channel in this area is defined has good width. There is vegetation in and around the channel with the ditch running through Type 3 wetlands.

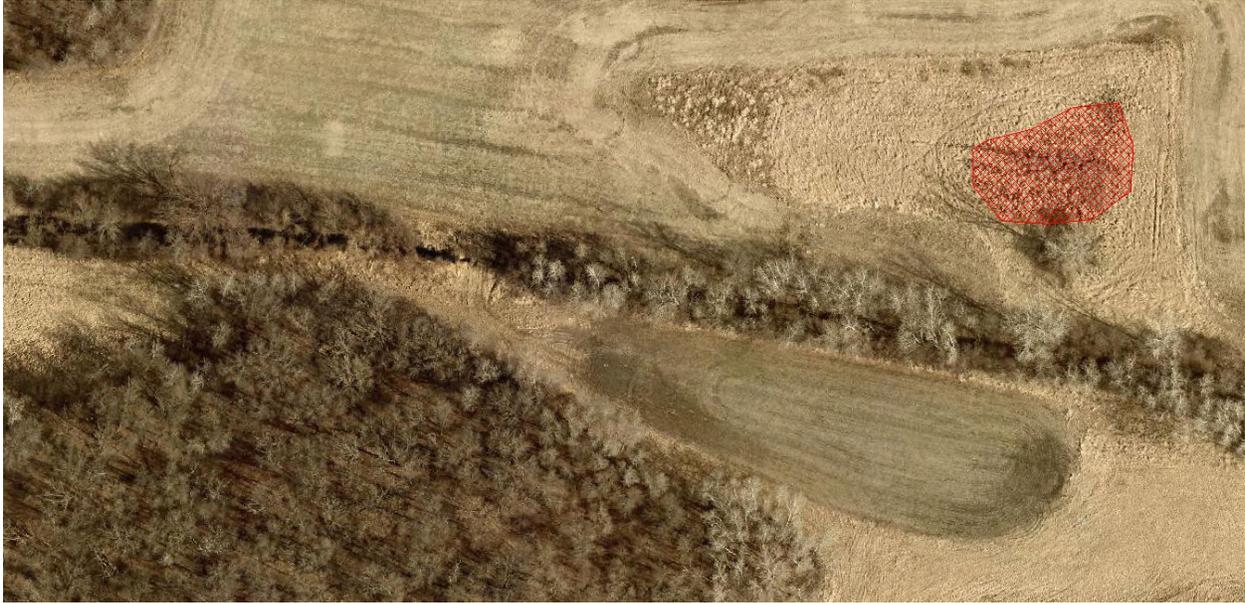
Photo 3 – April 2021 Stearns County Aerial Photography

This photo shows tree and vegetation growth on the banks of the ditch. The channel looks open and free of debris.

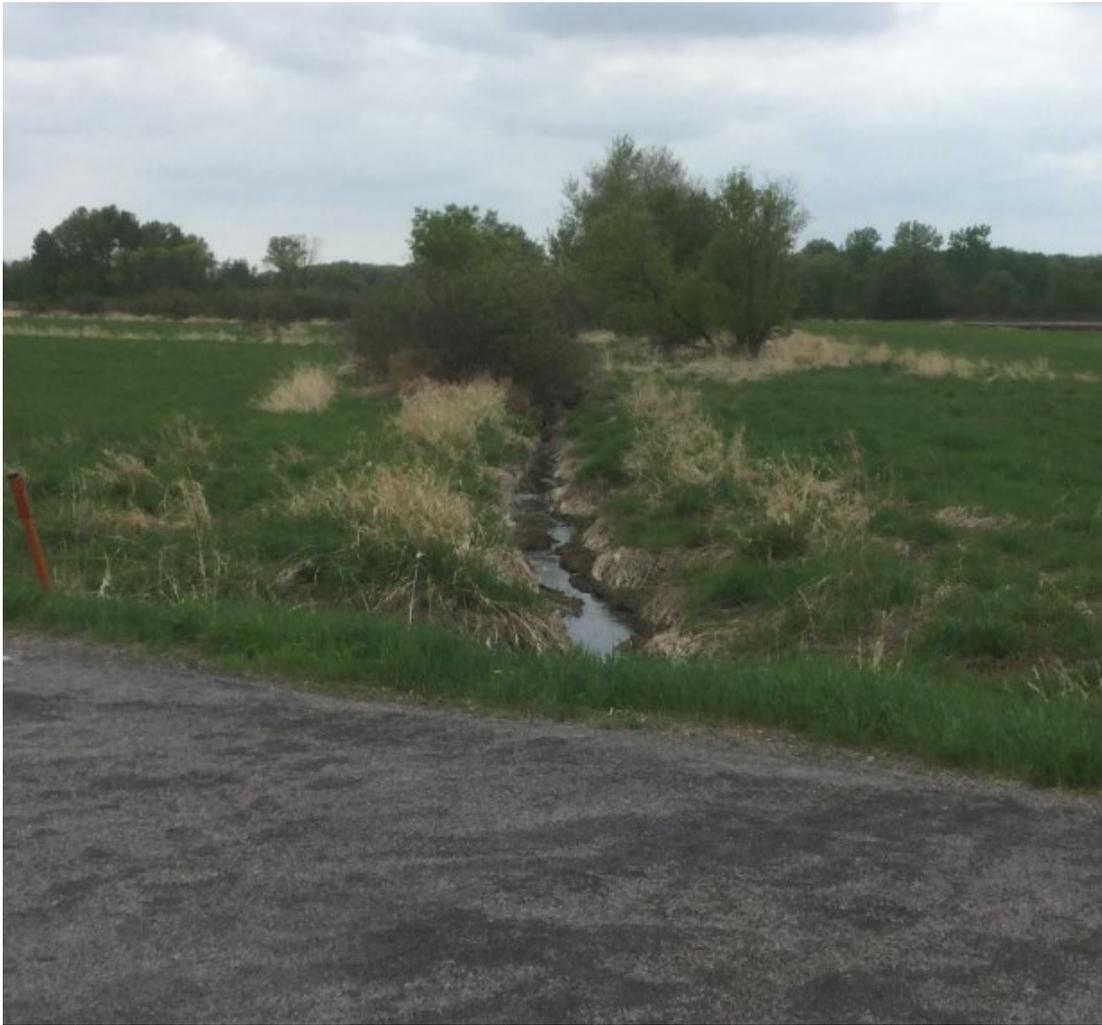
Photo 5 –2018 on site photo

This picture is taken from Co Rd 137 looking west. There are some trees on the banks obscuring the channel, but the ditch appears free from obstruction.

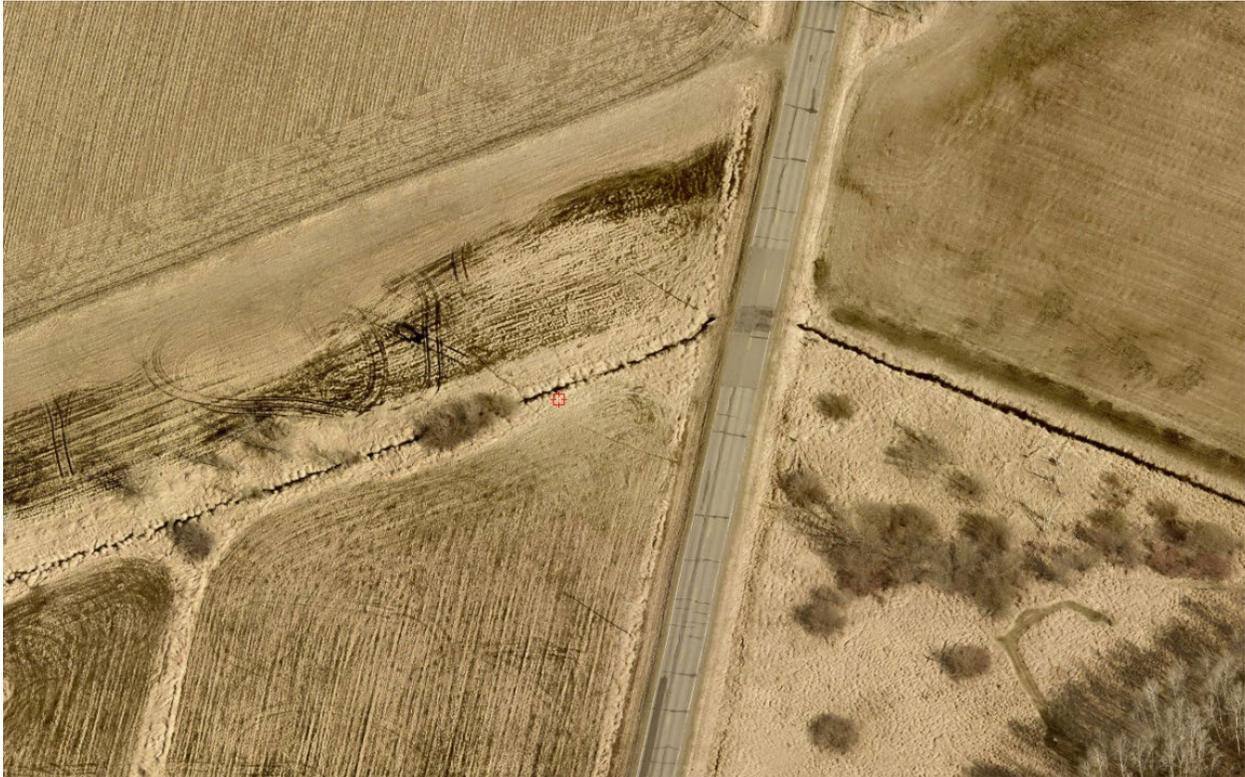
Photo 6 – April 2021 Stearns County oblique photography

The ditch west of Co Rd 137 has vegetation constriction compared to the east side but is generally free of obstruction.

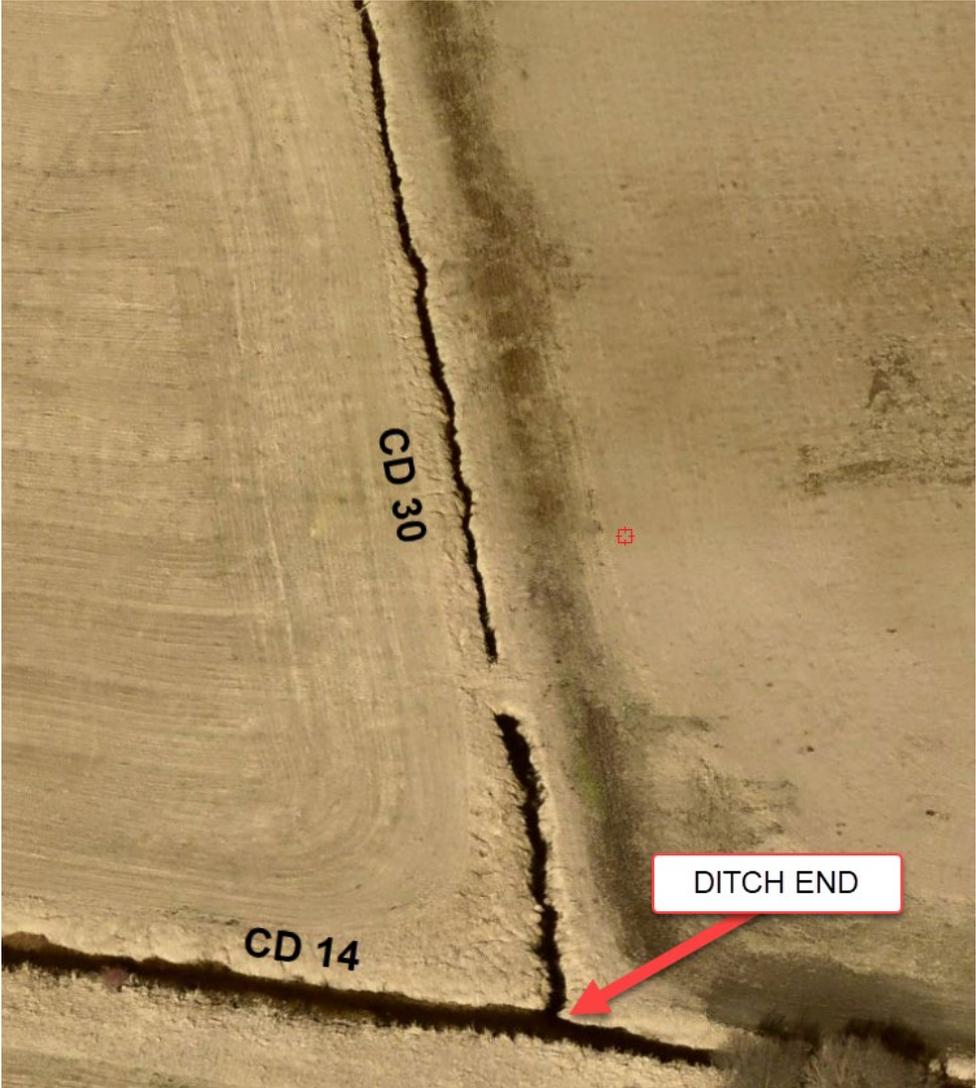
Photo – 7 April 2021 Stearns County oblique photography

The end of the ditch intersects with County Ditch 14. The channel in this area is open and free of obstruction.
