# Stearns County Ditch 04 Repair Proposal

April 22, 2022

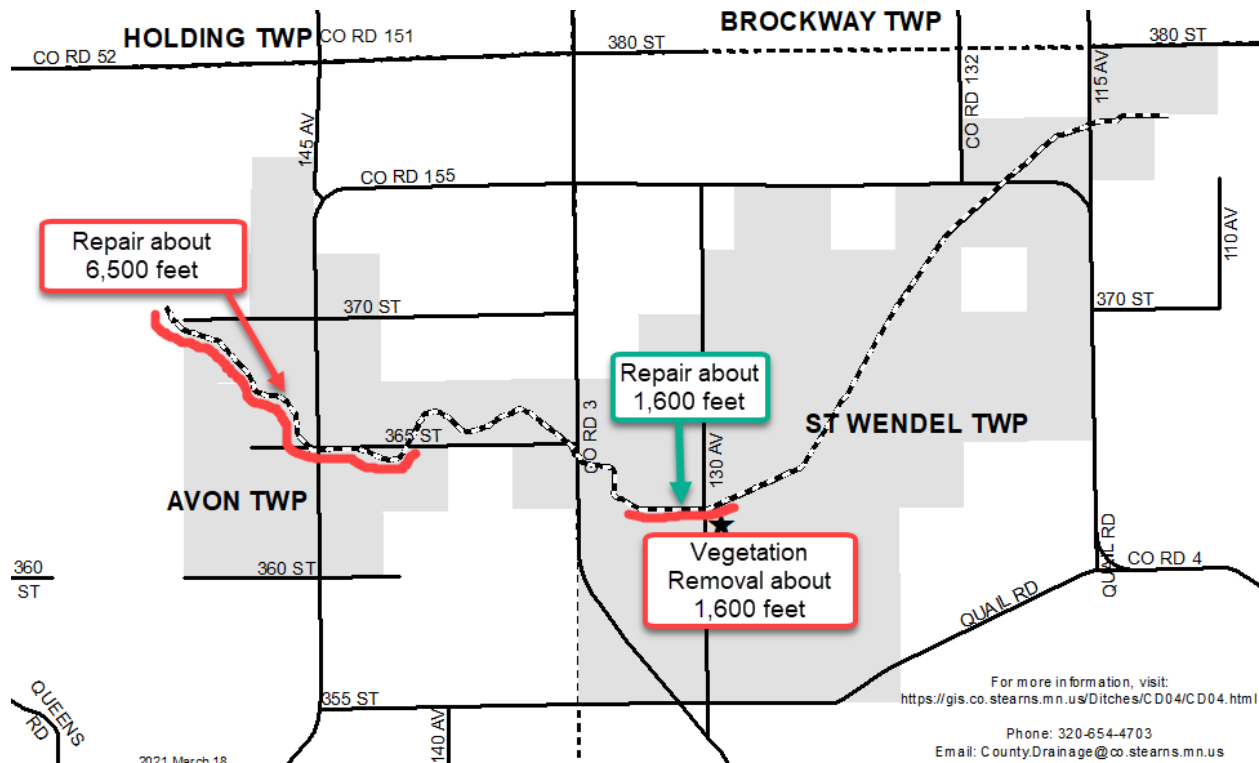
The proposed project work includes about 1,600 feet of vegetation removal and ditch repair west of 130<sup>th</sup> Ave in St. Wendel Township and ditch repair of about 6,500 feet from 365<sup>th</sup> St to County Road 155 to ditch end in Avon Township. The culvert on 130<sup>th</sup> Ave is also considered to be obstructing County Ditch 04. Lowering the road culvert requires discussion with St. Wendel Township and may require additional investigation.
