# Inspection of Stearns County Ditch 14

September 30, 2022

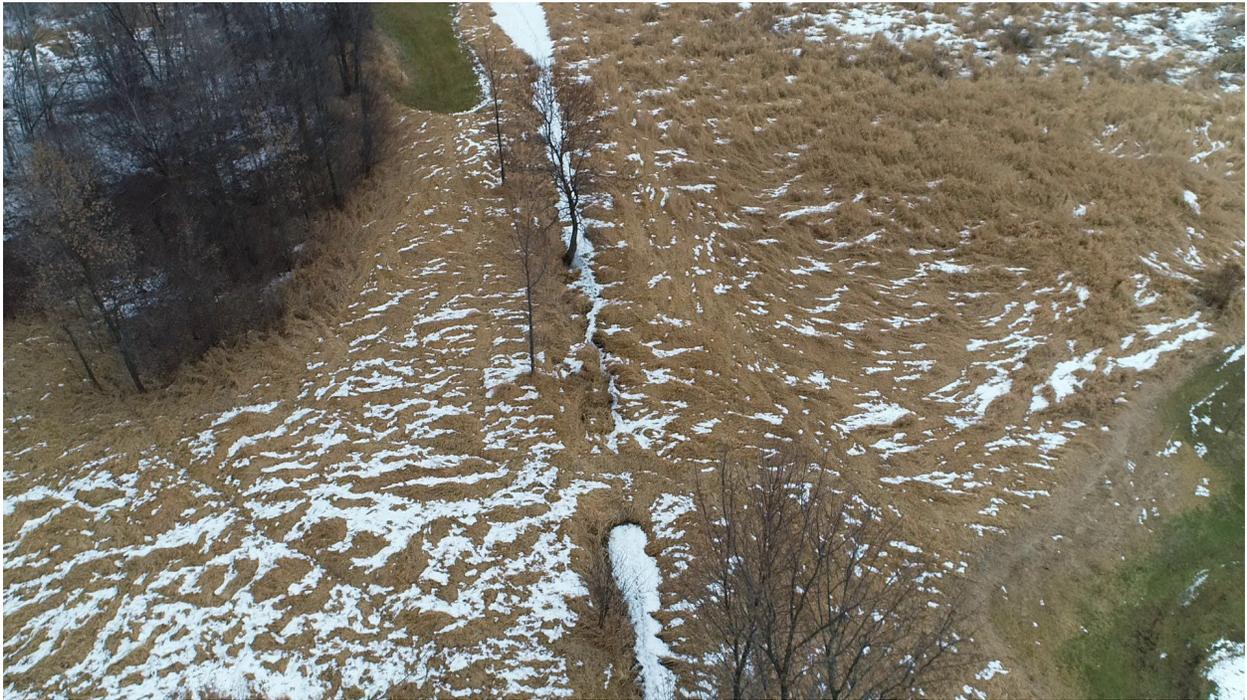
Inspection Area 4 –81.43153.0650

This portion of the ditch inspection was completed on parcel 81.43153.0650.

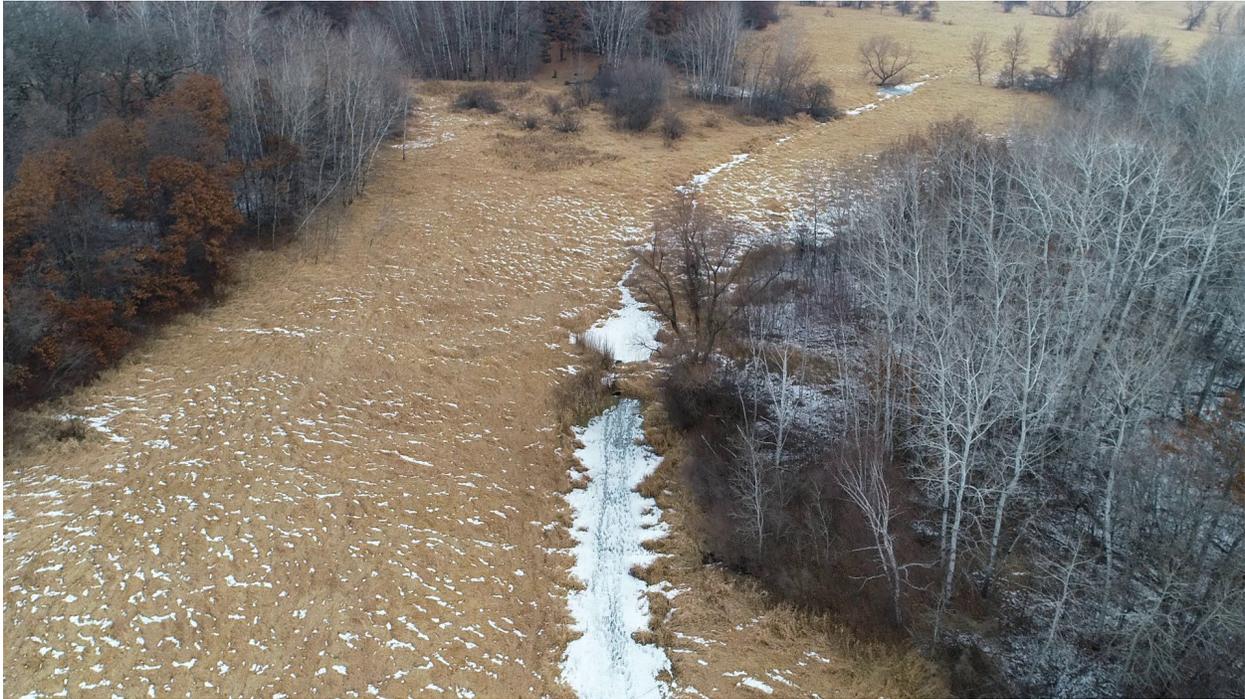
Drone Photo

This portion of the ditch inspection was completed on a private crossing PID: 81.43150.0345 located in Section 7, T123N, R28W.
