Technical Memorandum

Subject: Reestablishment of Stearns County Ditch 4
Public Drainage System Records

Project: 6364-008

The purpose of this report is to provide Stearns County with the results of the investigation and analysis of the Stearns County Ditch 4 (CD 4) public drainage system. This report contains the necessary description of alignment; cross-section; profile; hydraulic structure locations, materials, dimensions, elevations; and right-of-way of the drainage system to reestablish records as requested by the Board.

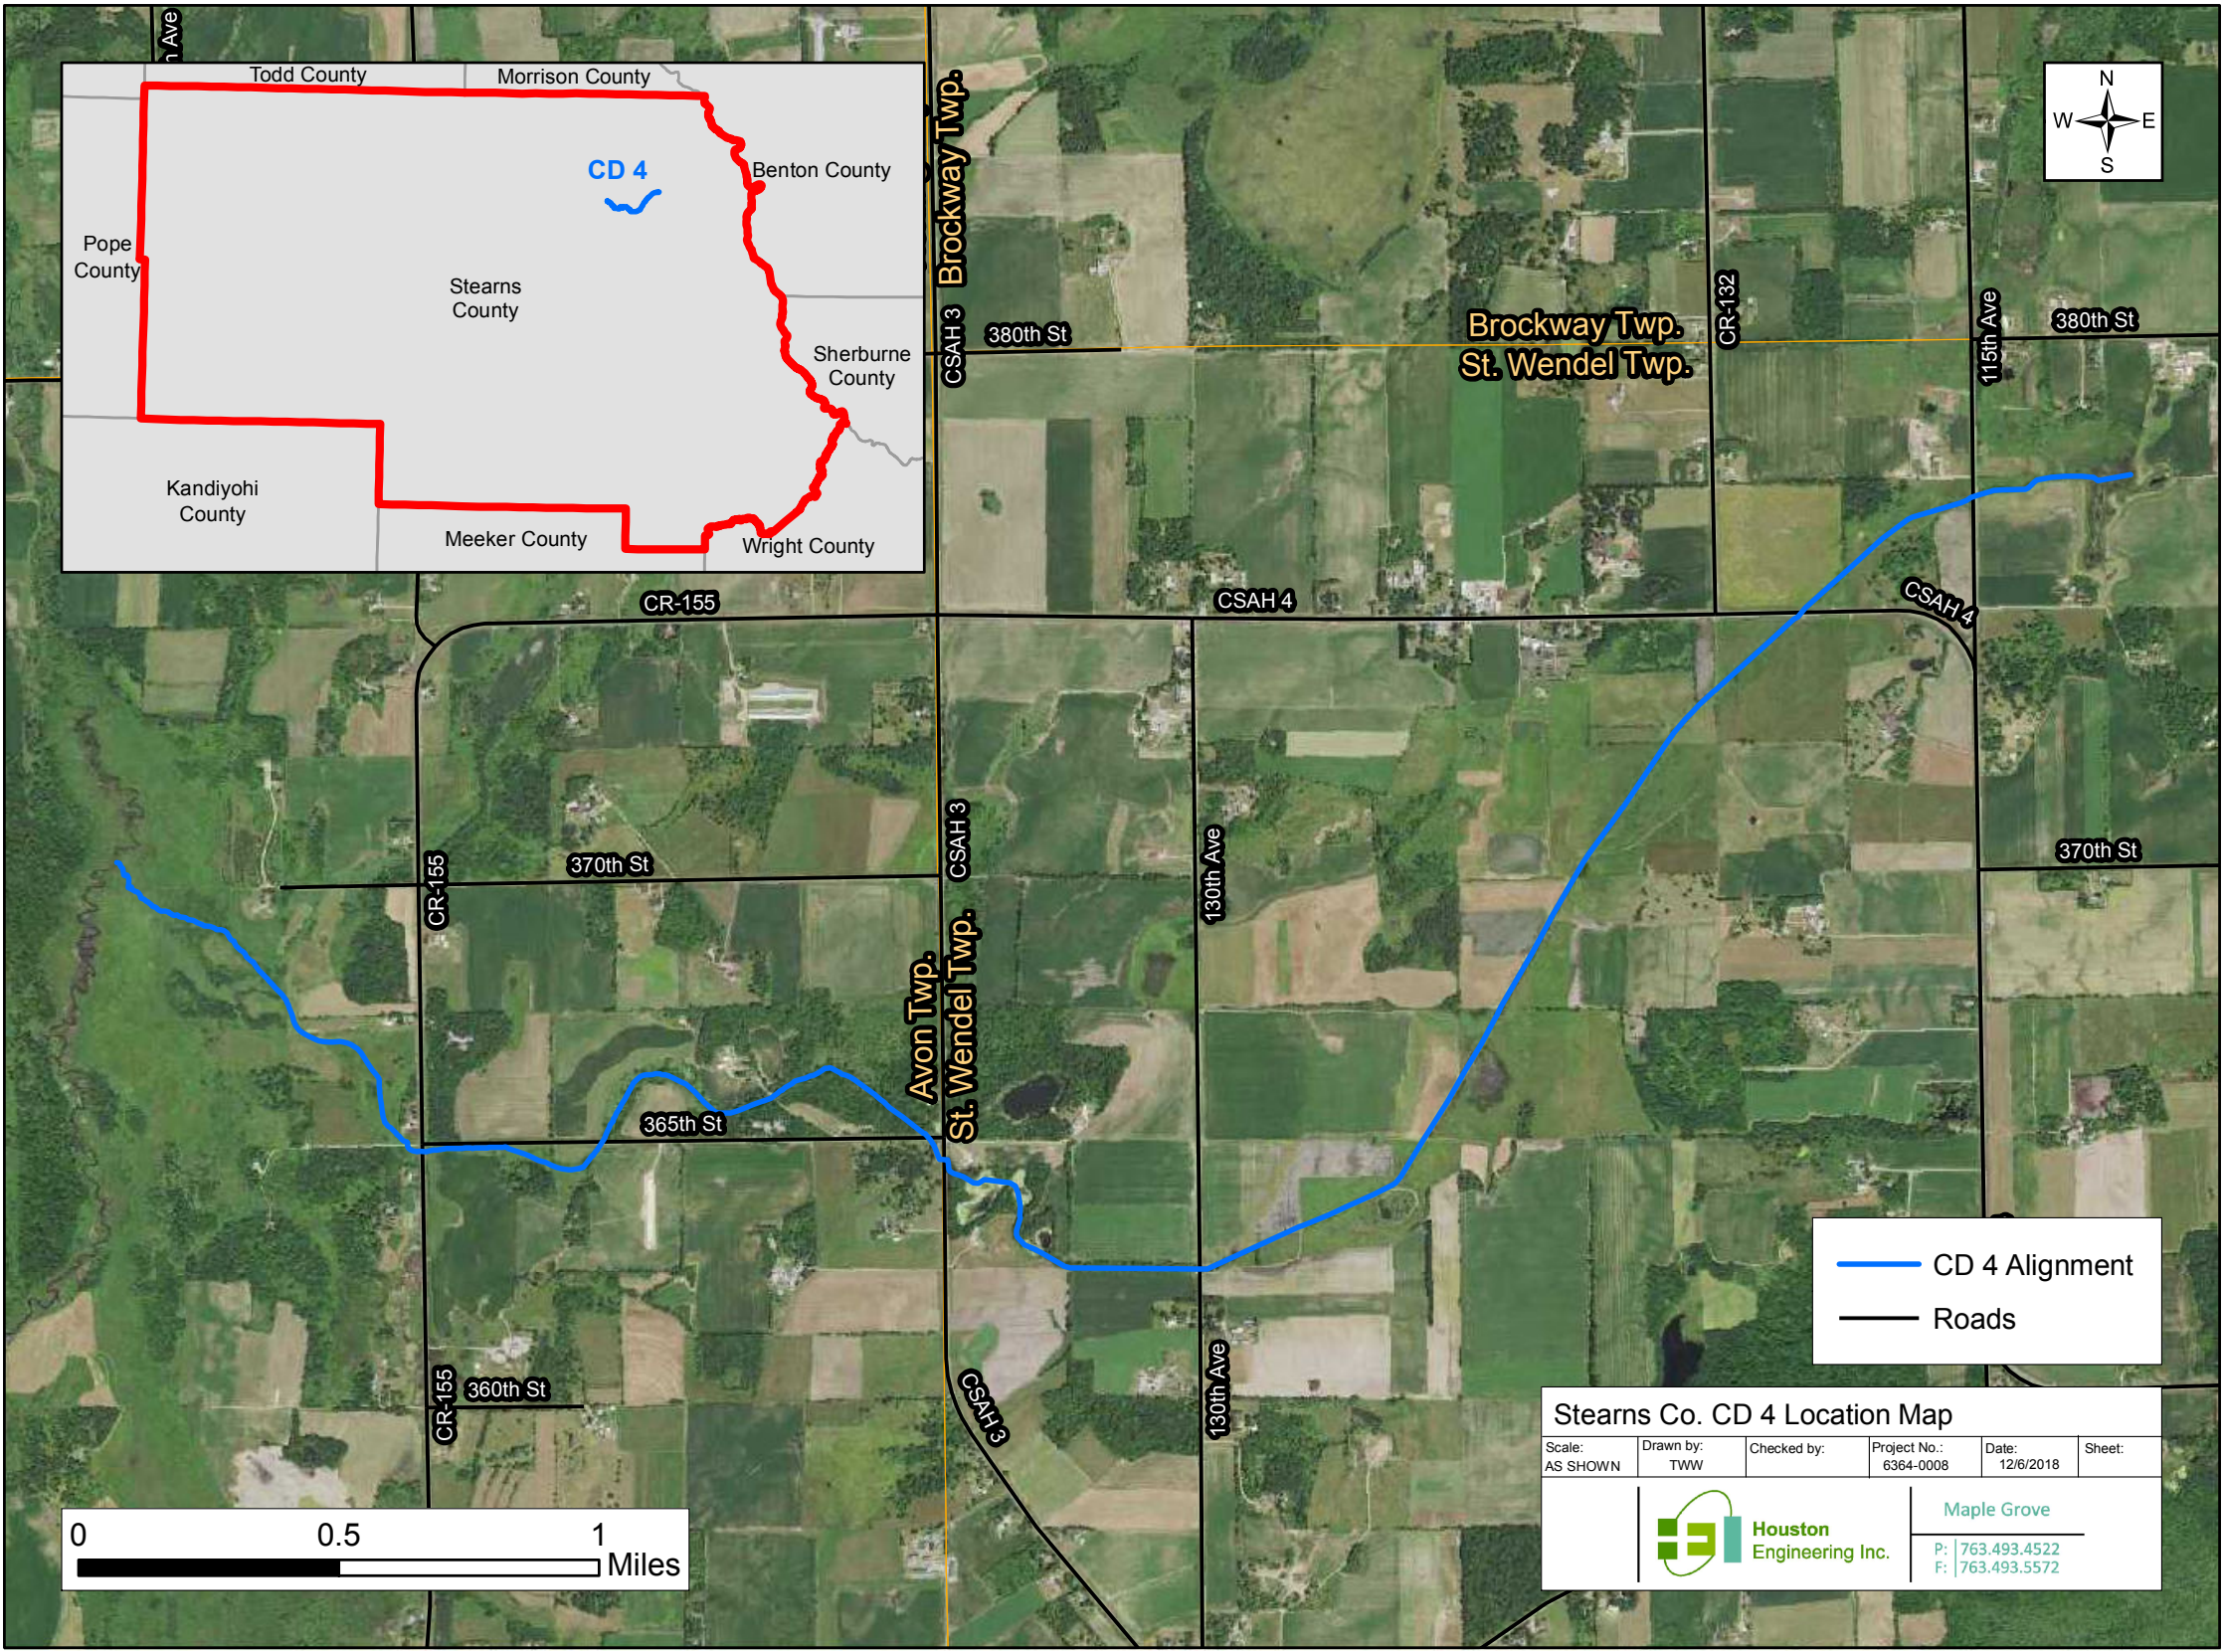
- CD 4 Alignment
- Roads

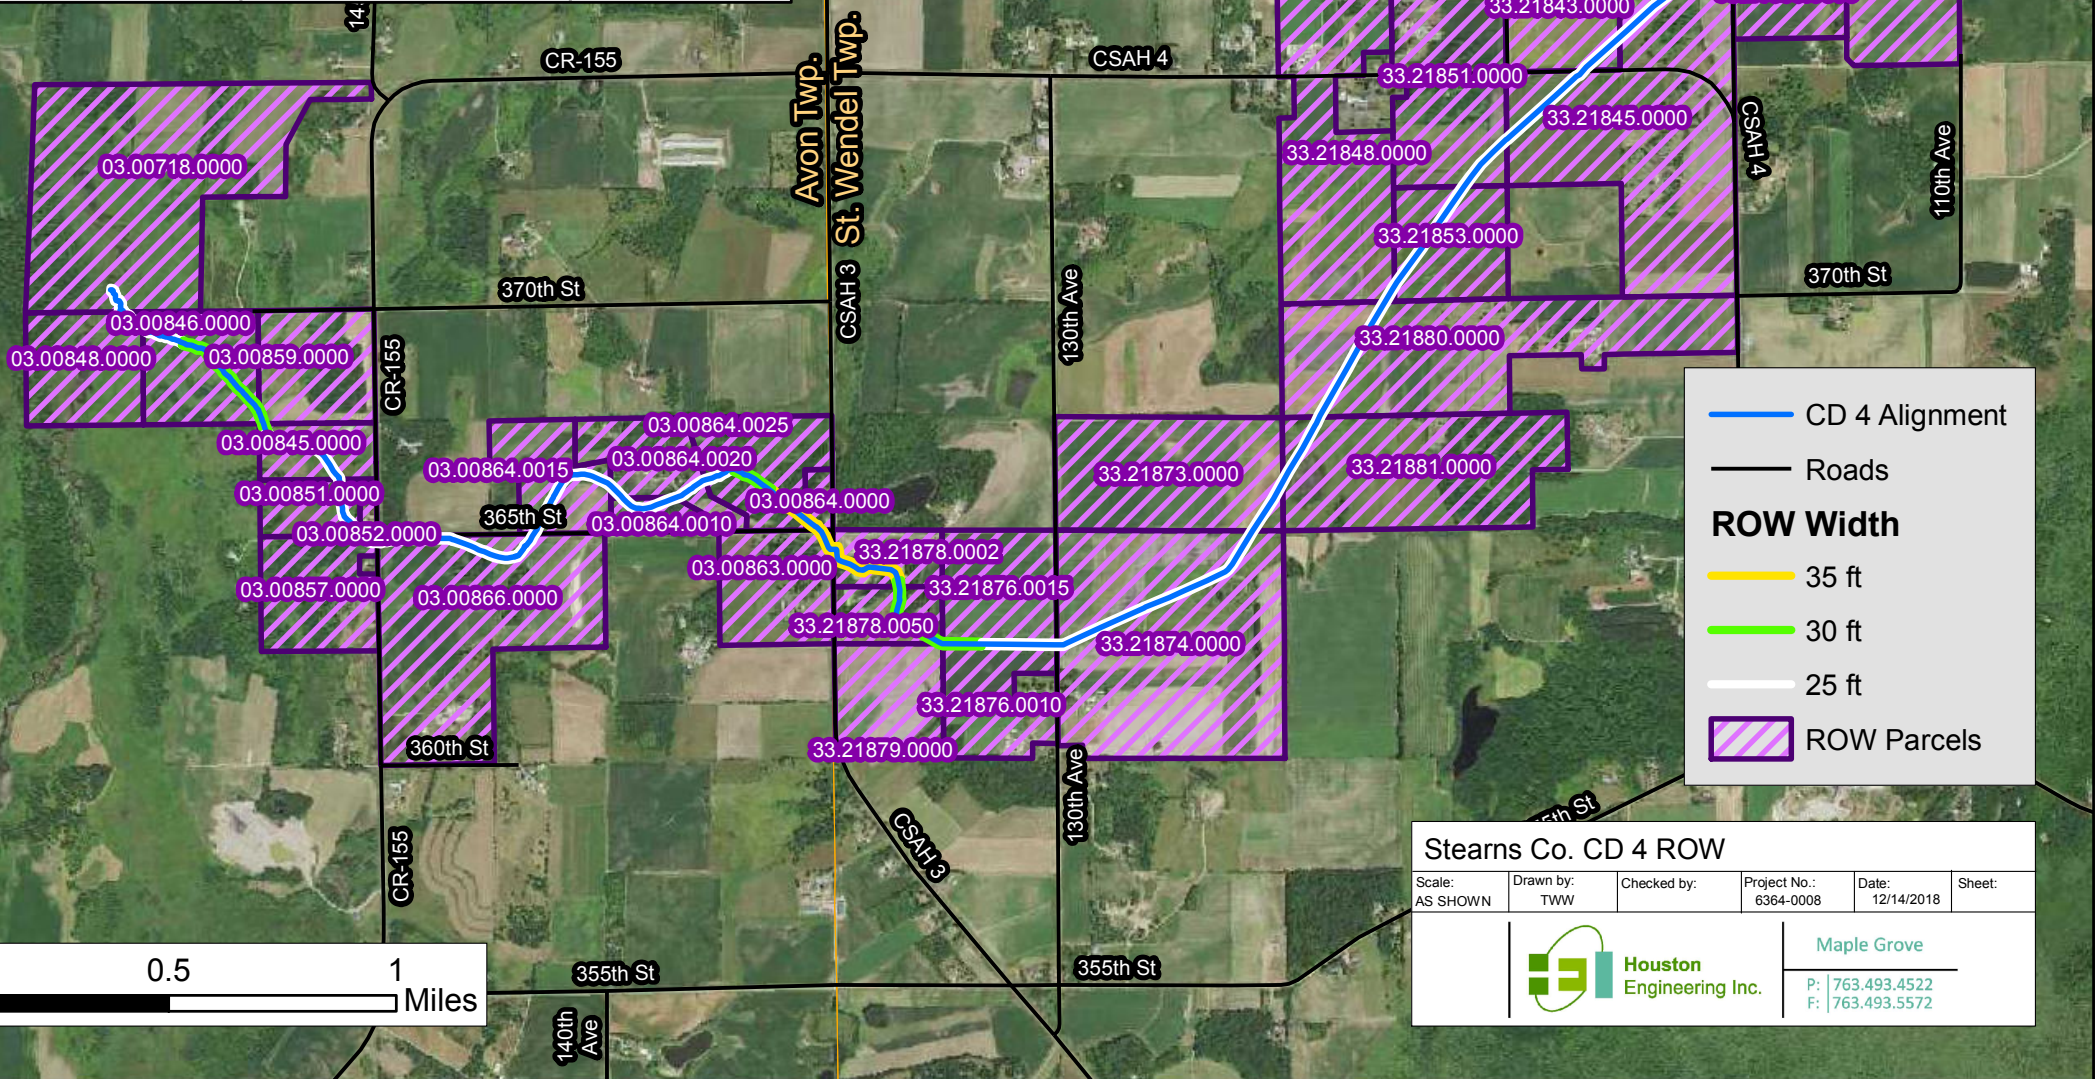
— CD 4 Alignment
— Roads
ROW Width
— 35 ft
— 30 ft
— 25 ft
 ROW Parcels

Proceedings for the original establishment of the drainage system awarded damages for the areas physically occupied by the drainage system along with an easement for the area required for construction activities such as land clearing and spoil disposal. This combination of areas constitutes the right-of-way for the drainage system and is often described as the area reasonably necessary for the drainage authority to perform its repair, maintenance, inspection obligations, along with an area of reasonable set-back to protect the drainage system. The right of way required was estimated by computing the approximate geometry of the spoil piles and the width needed for continued maintenance. The majority of the right of way is 25 feet from the top of bank of the ditch. However, there are a few locations where the ditch right of way extends to 30 feet from the top of bank, such as stations 5+00 to 20+00, 140+00 to 155+00, 175+00 to 180+00, and 250+00 to 265+00. In addition,
