**In the Matter of:
the Reestablishment of Stearns County
Ditch 28 Drainage System Records**

**FINDINGS AND ORDER
REESTABLISHING DRAINAGE
SYSTEM RECORDS**

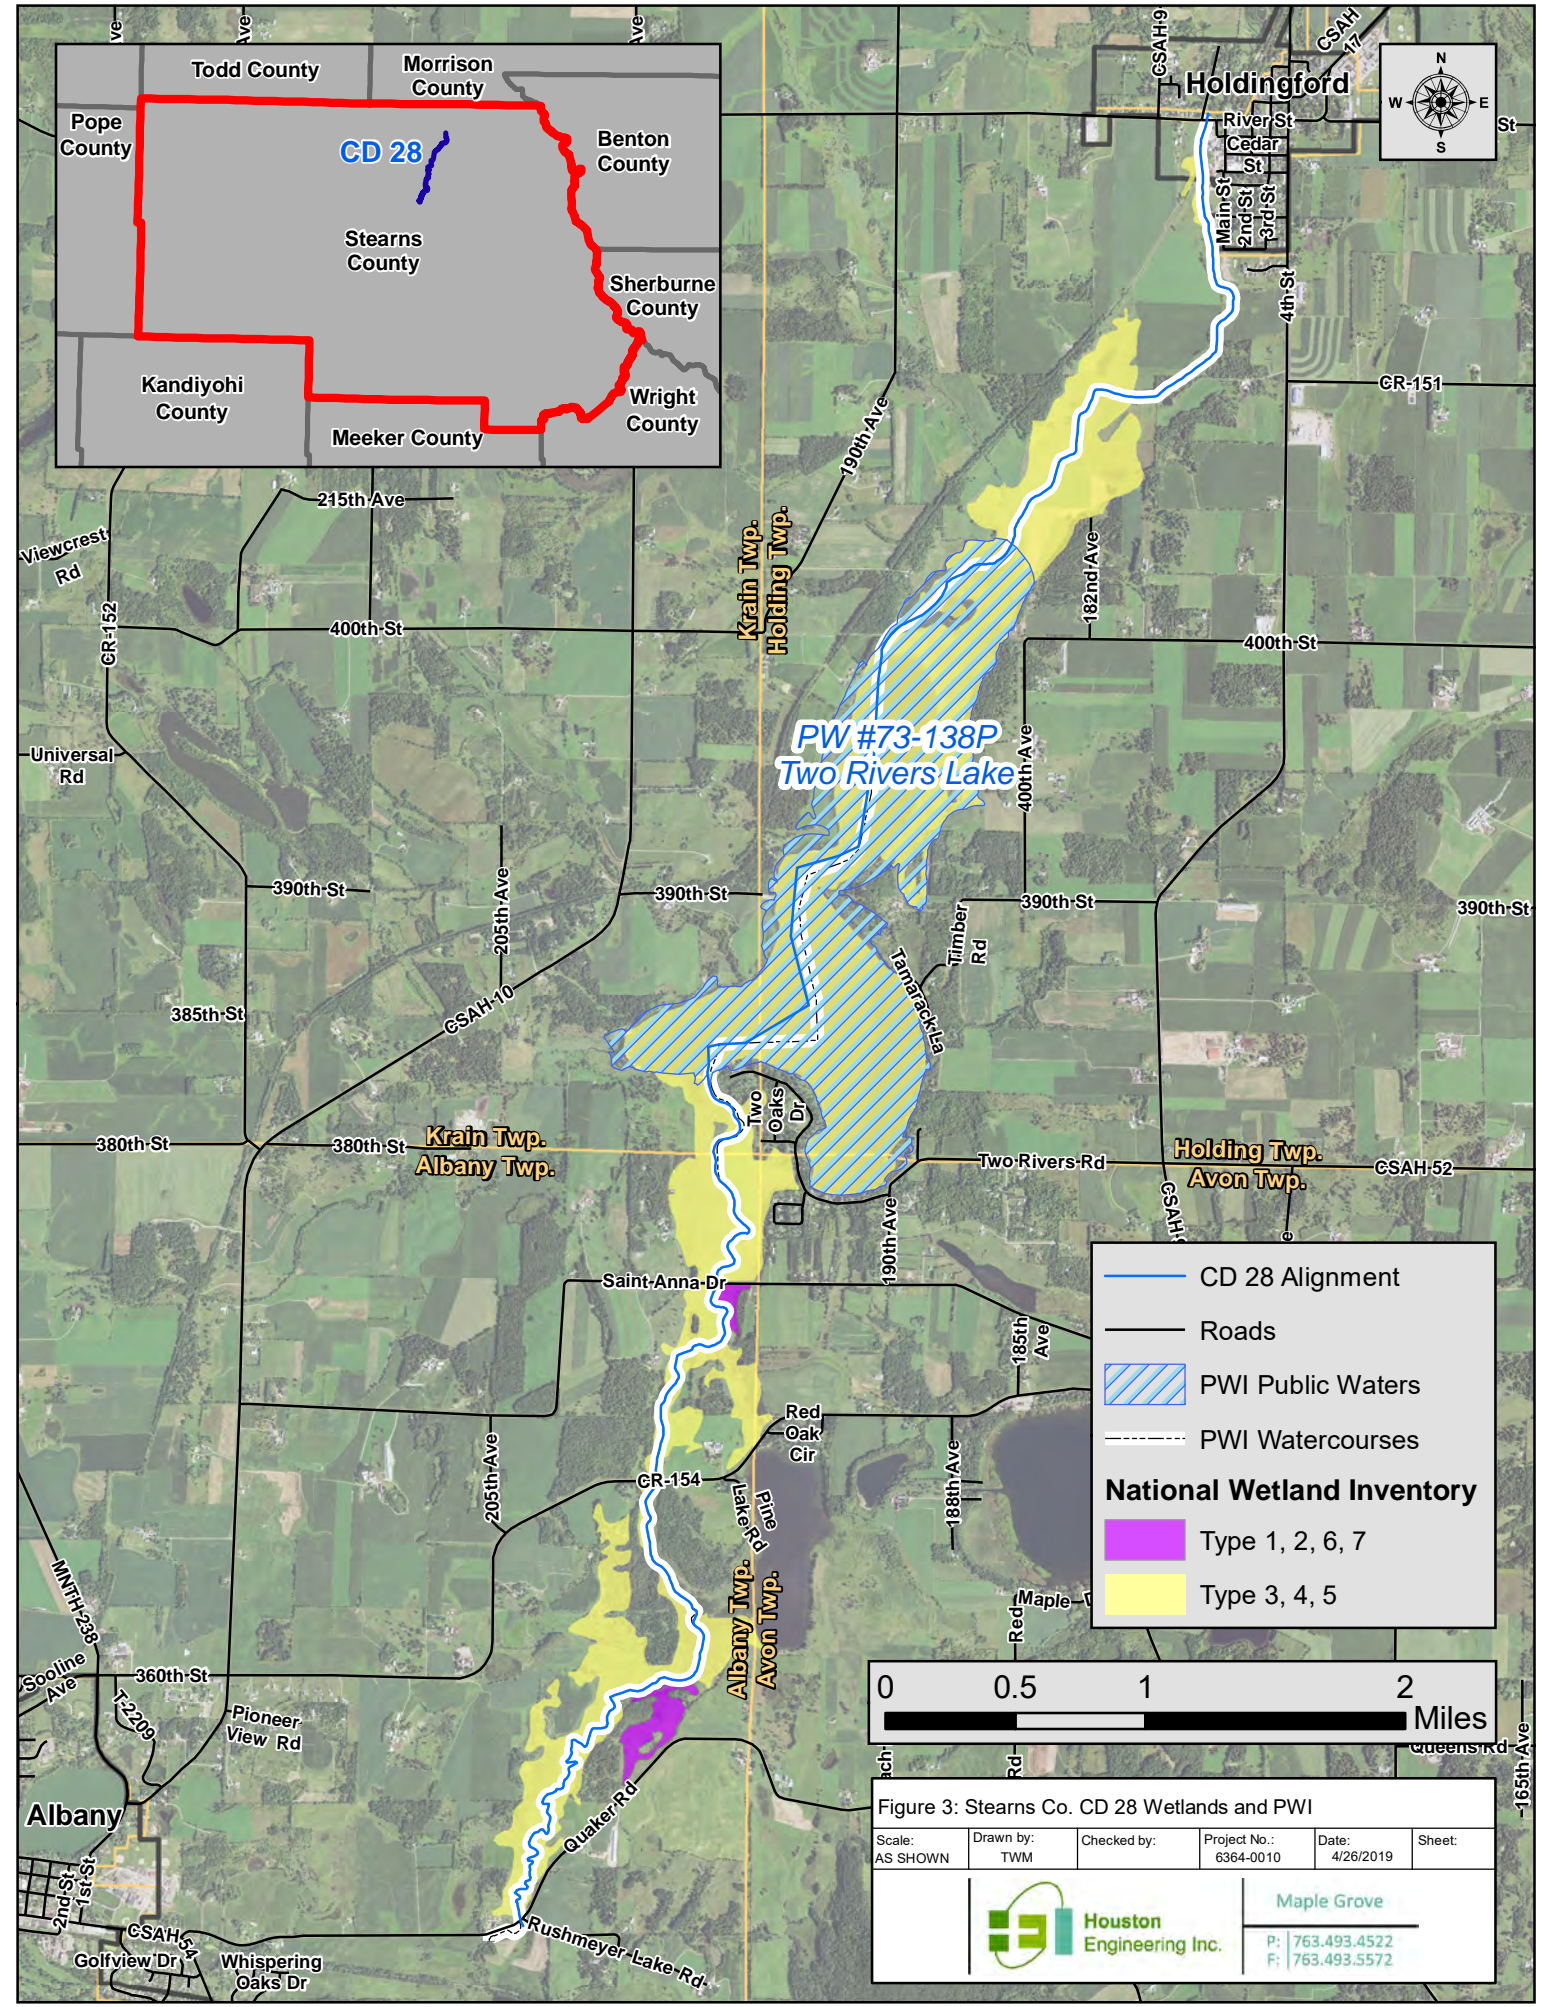
— CD 28 Alignment
 — Roads
 PWI Public Waters
 - - - PWI Watercourses
National Wetland Inventory
 Type 1, 2, 6, 7
 Type 3, 4, 5

As seen in **Figure 3**, the CD 28 public drainage system flows through one MnDNR listed Public Water Basin (Two River Lake, #73-138W). Additionally, the entirety of the CD 28 drainage system is also listed as Public Ditch / Altered Natural Watercourse (South Two River, # M-084) within the Public Waters Inventory. The MnDNR regulates many activities within listed Public Waters. Drainage system repair activities within Public Waters (below the OHW elevation of the PW) require notification to the MnDNR.

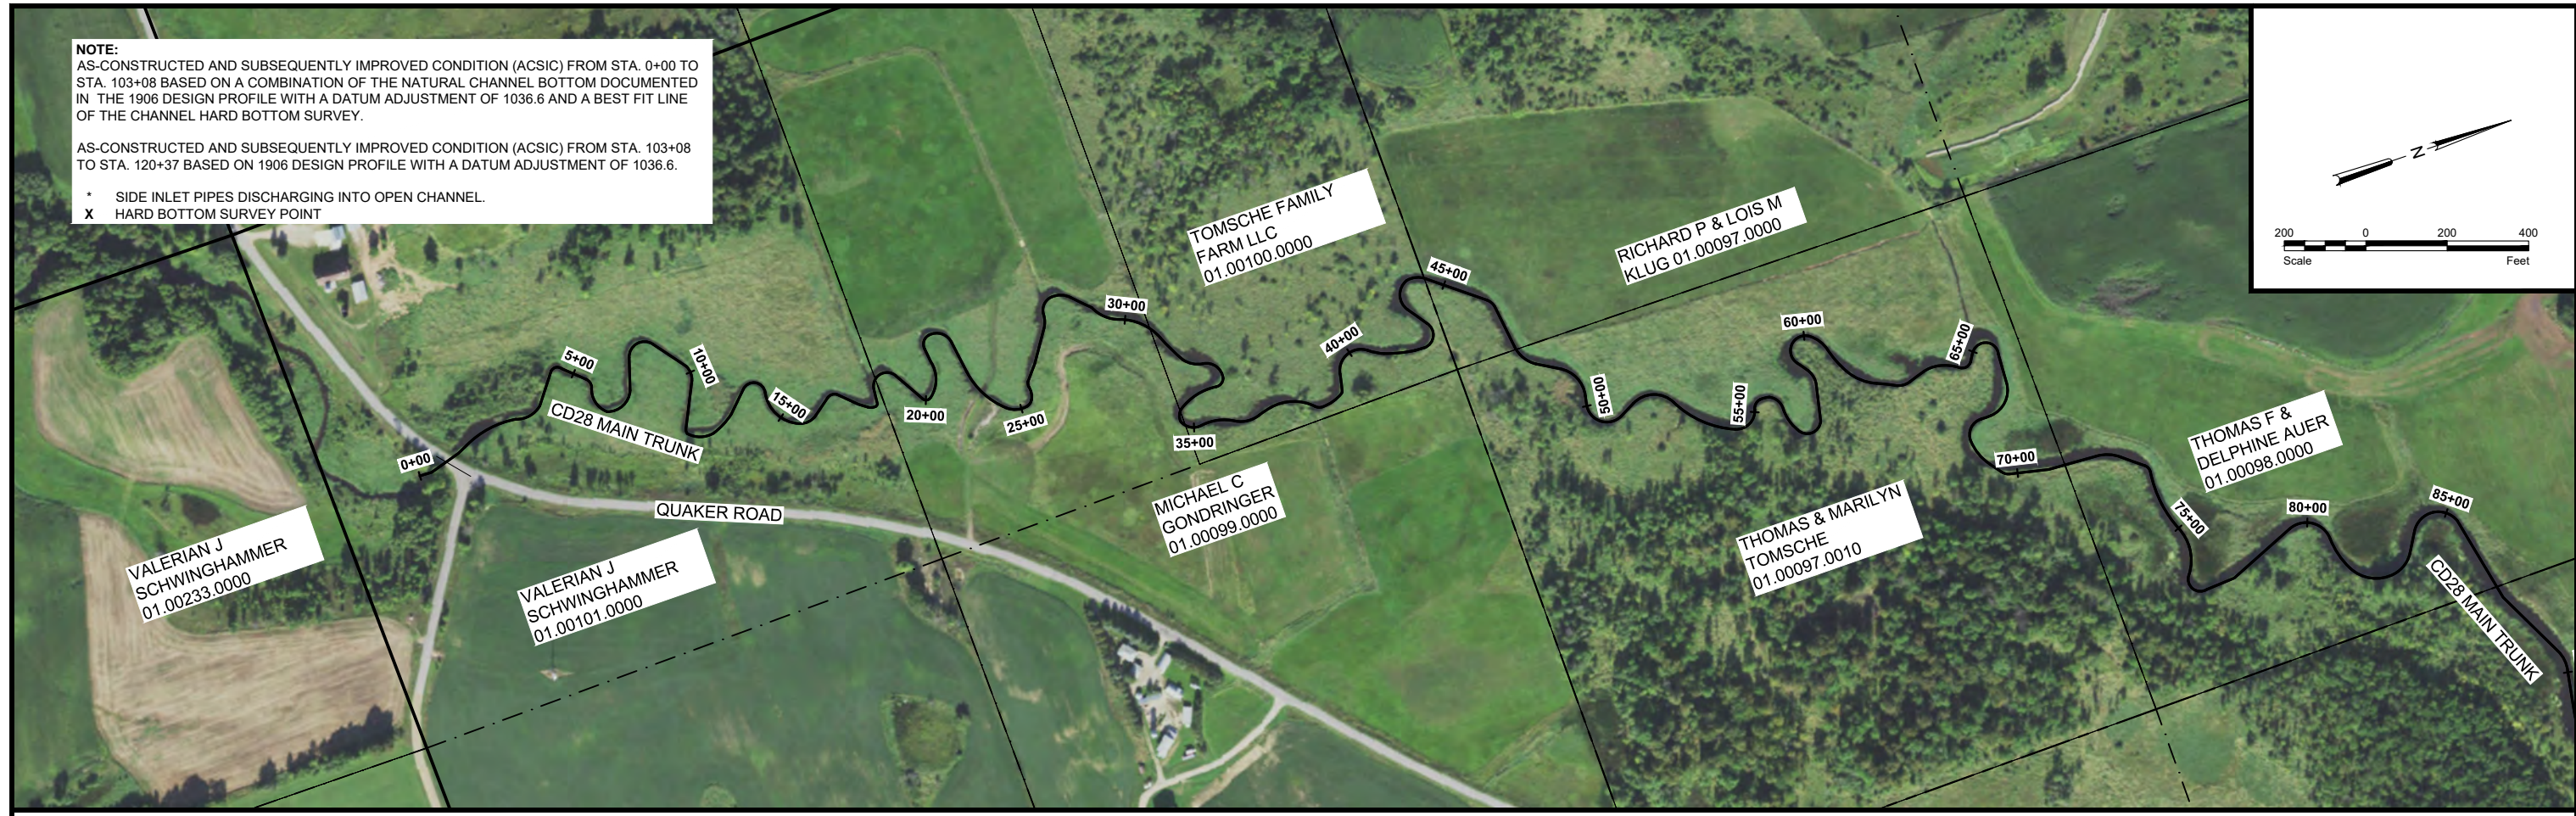
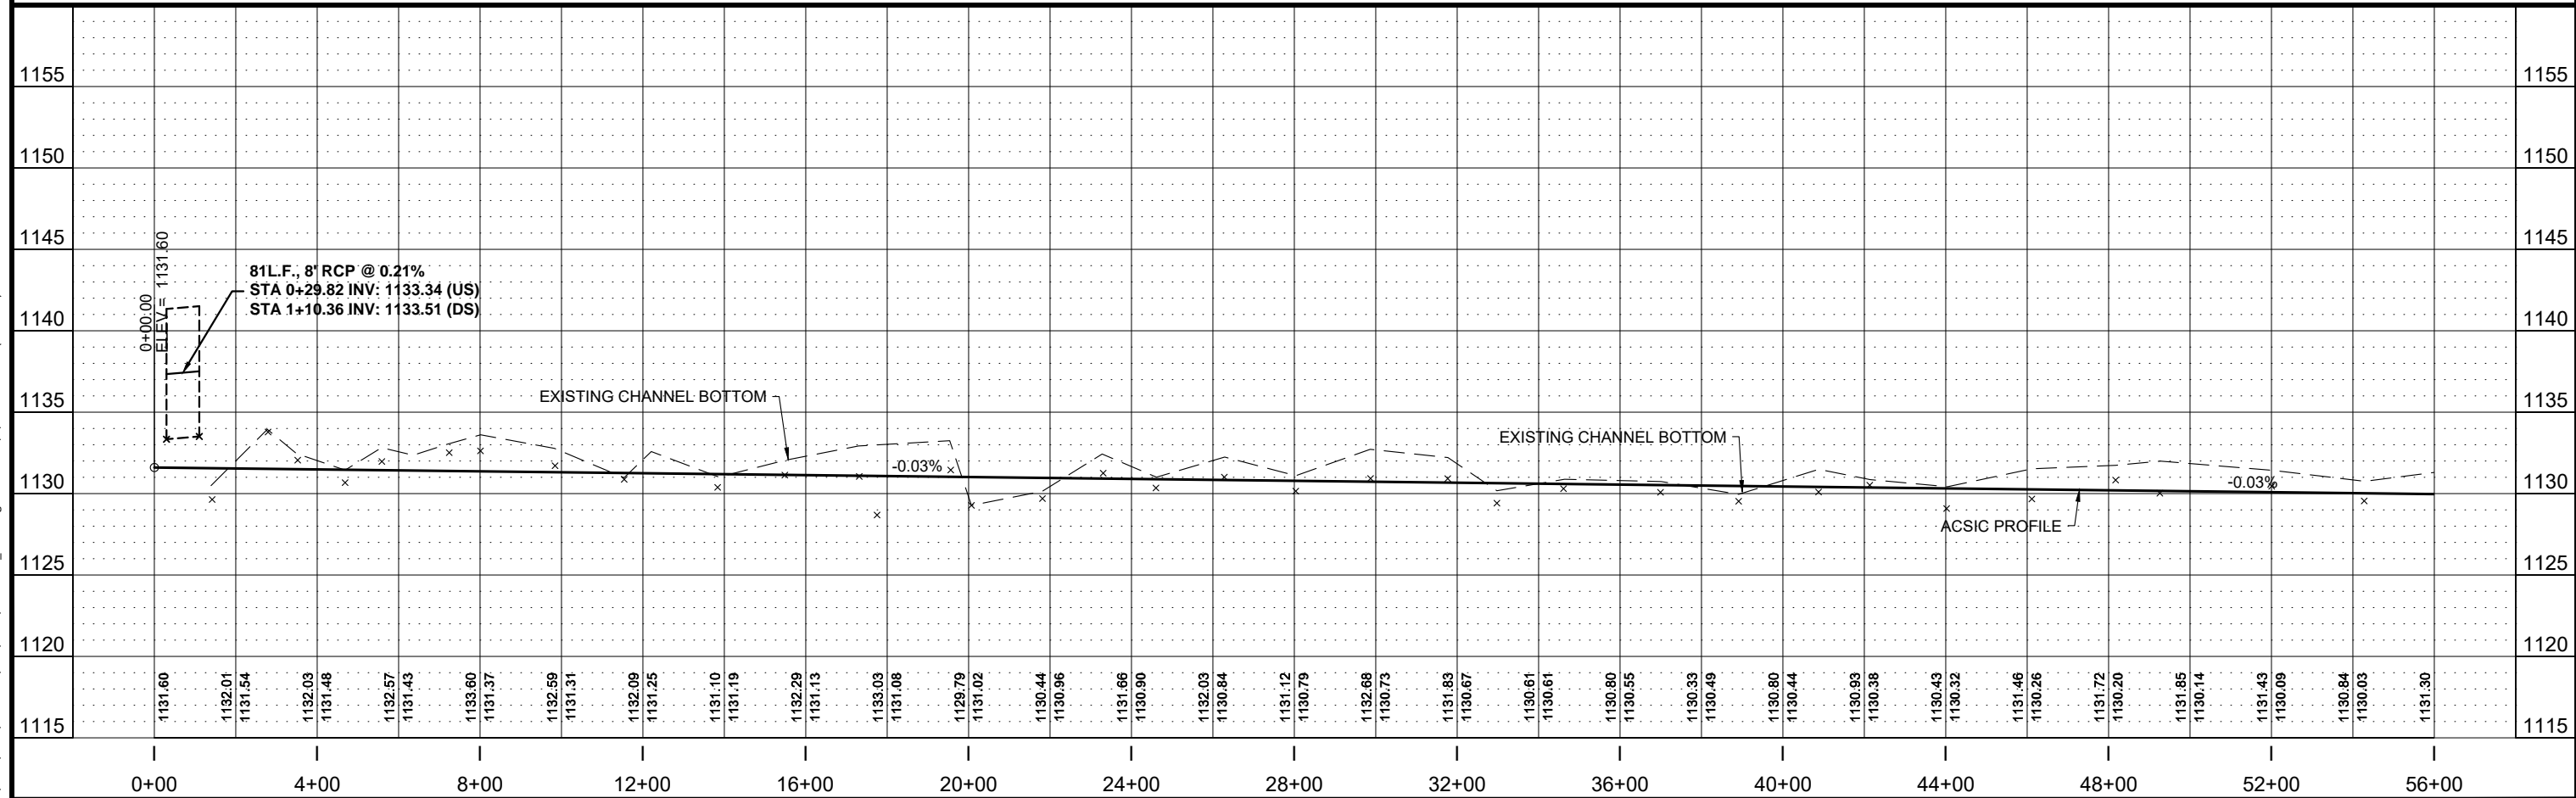
NOTE:
 AS-CONSTRUCTED AND SUBSEQUENTLY IMPROVED CONDITION (ACSIC) FROM STA. 0+00 TO STA. 103+08 BASED ON A COMBINATION OF THE NATURAL CHANNEL BOTTOM DOCUMENTED IN THE 1906 DESIGN PROFILE WITH A DATUM ADJUSTMENT OF 1036.6 AND A BEST FIT LINE OF THE CHANNEL HARD BOTTOM SURVEY.

AS-CONSTRUCTED AND SUBSEQUENTLY IMPROVED CONDITION (ACSIC) FROM STA. 103+08 TO STA. 120+37 BASED ON 1906 DESIGN PROFILE WITH A DATUM ADJUSTMENT OF 1036.6.

* SIDE INLET PIPES DISCHARGING INTO OPEN CHANNEL.
 X HARD BOTTOM SURVEY POINT

This portion of the memorandum describes the current condition of the public drainage system as observed “on-the-ground” (i.e., existing) as determined by a review of the available records, field survey, aerial imagery, and other available historical evidence. CD 28 consists entirely of an open channel ditch with several culvert crossings. The stationing used to describe the alignment proceeds from upstream to downstream. **Appendix A** shows the existing and ACSIC grades and alignment.

Two excavated portions of CD 28 that had a good statistical fit (STA 103+08 – 120+37 and downstream of Two Rivers Lake), when analyzed separately, both result in a vertical datum adjustment of 1036.6. The furthest upstream portion of CD 28 that was excavated (STA 84+46 - 89+99), did not have an acceptable fit of the 1906 design profile to the observed hard bottom shots. Similarly, the ACSIC grade directly upstream of Two Rivers Lake (Sta. 238+78 – 264+00) did not have an acceptable fit to 1906 design profile.

There is an inconsistency in the 1906 profile near historic STA 110+00 that results in a poor fit of the profile from current STA 120+37 to 264+00. In this reach the ACSIC was determined by drawing a “best fit” line to match the hard-bottom survey. When this was compared to the historic 1906 profile, it was found that the best fit line reflected the general rising and falling characteristics of the original profile. See **Appendix A** for the ACSIC profile, as compared to existing open channel bottom survey elevations.

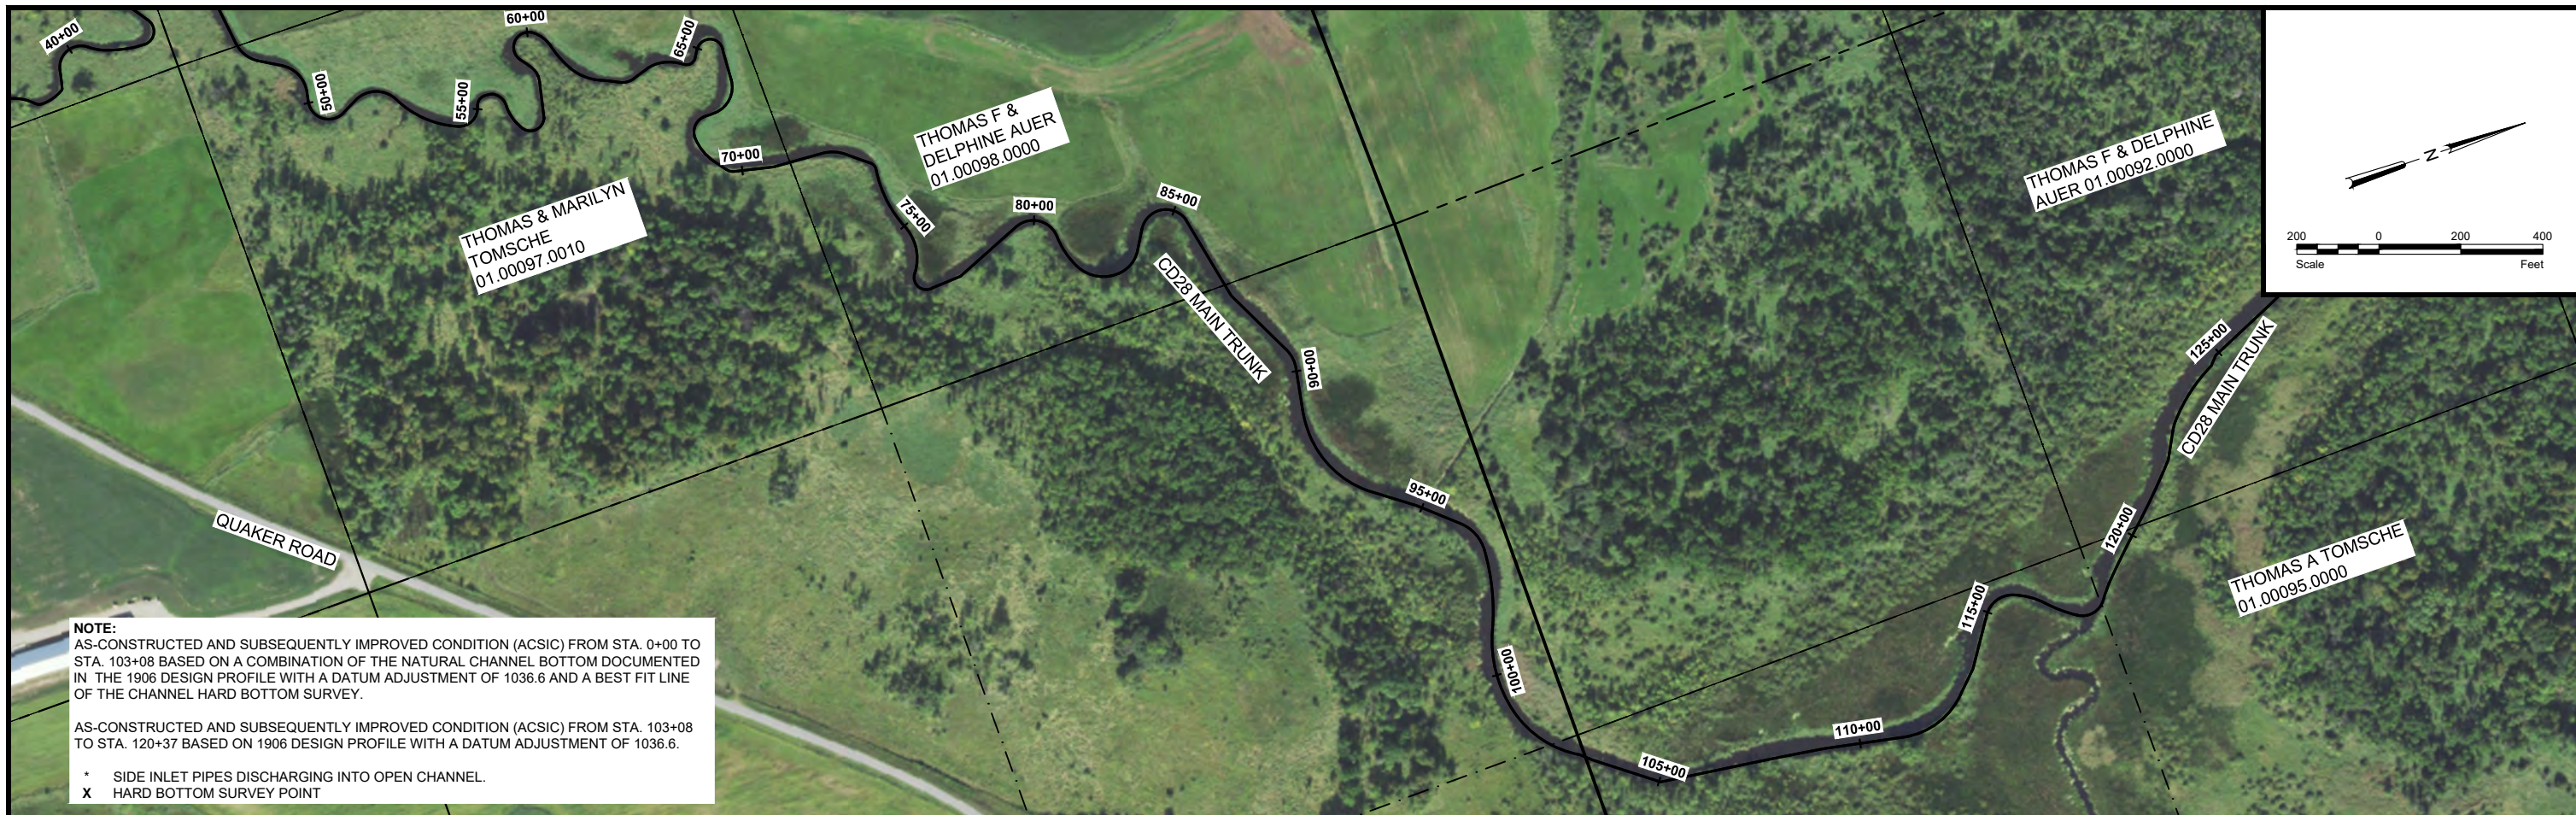
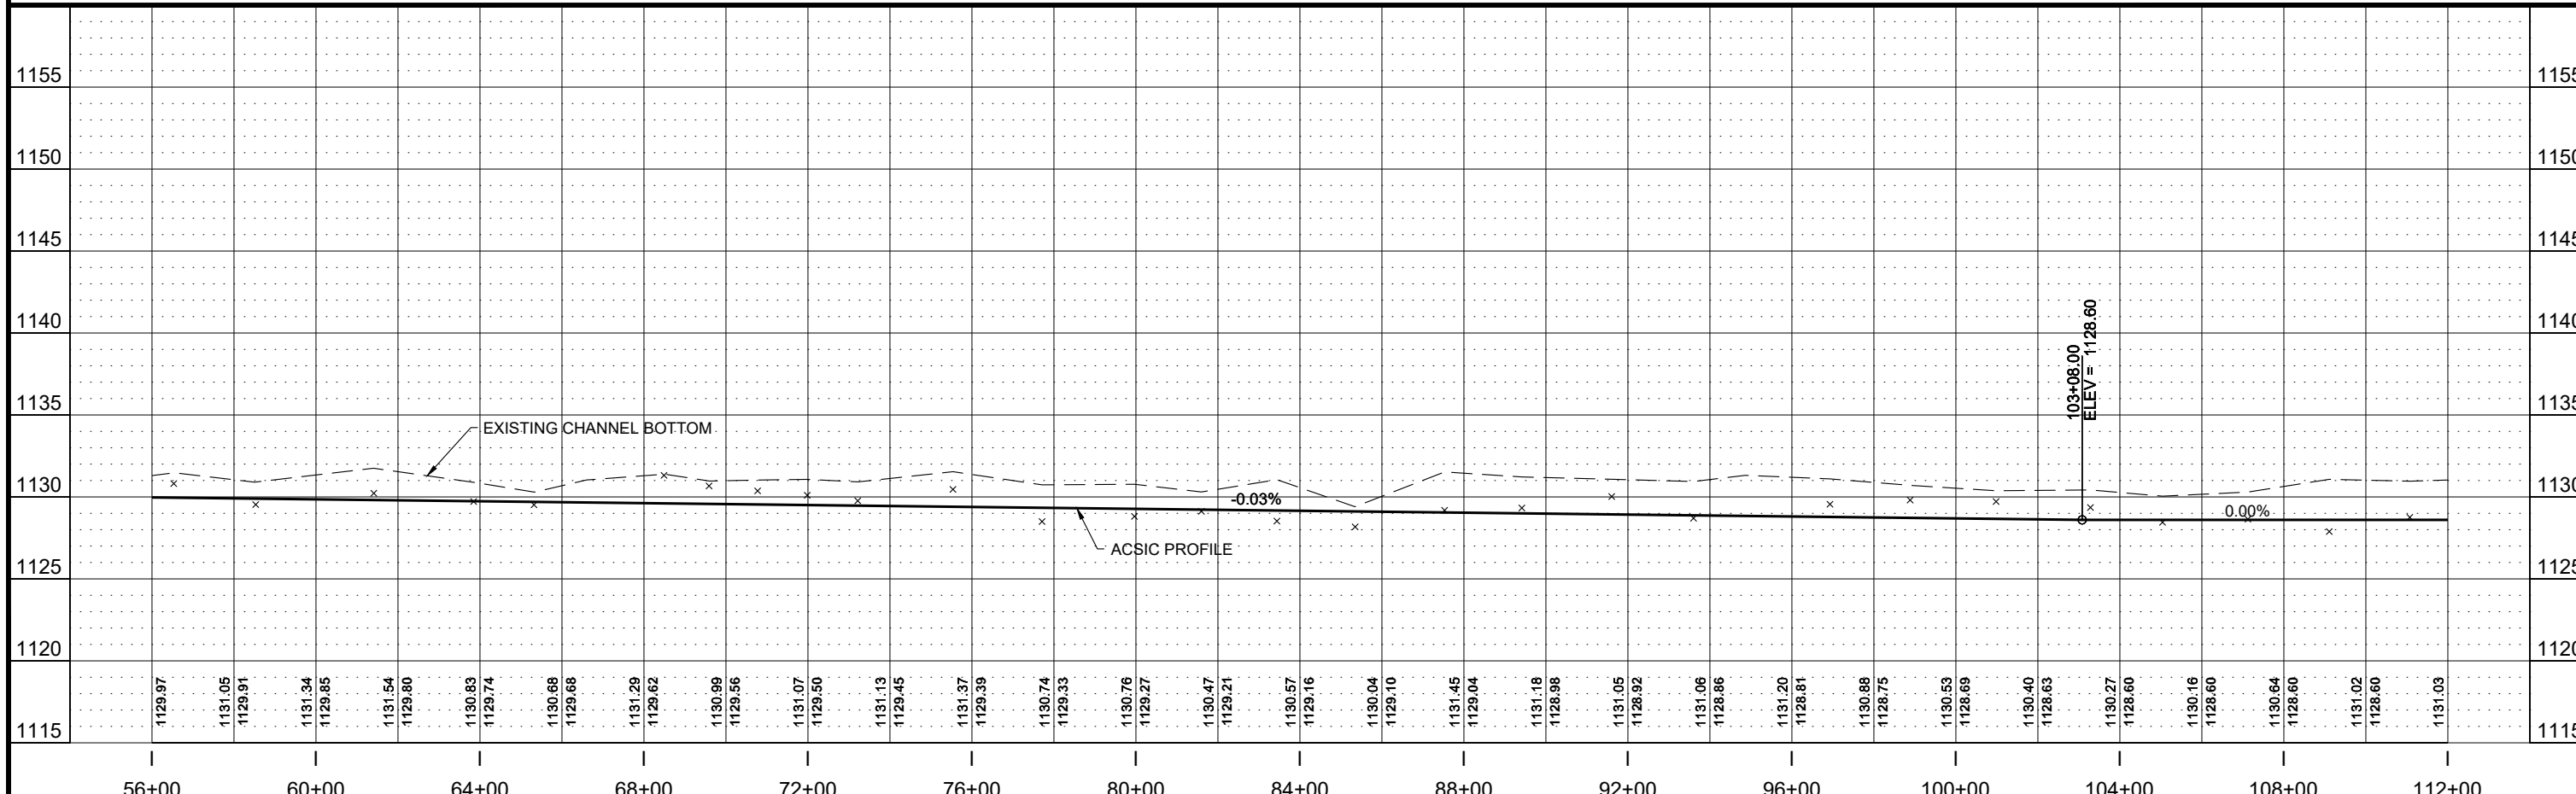
NOTE:
 AS-CONSTRUCTED AND SUBSEQUENTLY IMPROVED CONDITION (ACSIC) FROM STA. 0+00 TO STA. 103+08 BASED ON A COMBINATION OF THE NATURAL CHANNEL BOTTOM DOCUMENTED IN THE 1906 DESIGN PROFILE WITH A DATUM ADJUSTMENT OF 1036.6 AND A BEST FIT LINE OF THE CHANNEL HARD BOTTOM SURVEY.

AS-CONSTRUCTED AND SUBSEQUENTLY IMPROVED CONDITION (ACSIC) FROM STA. 103+08 TO STA. 120+37 BASED ON 1906 DESIGN PROFILE WITH A DATUM ADJUSTMENT OF 1036.6.

* SIDE INLET PIPES DISCHARGING INTO OPEN CHANNEL.
 X HARD BOTTOM SURVEY POINT

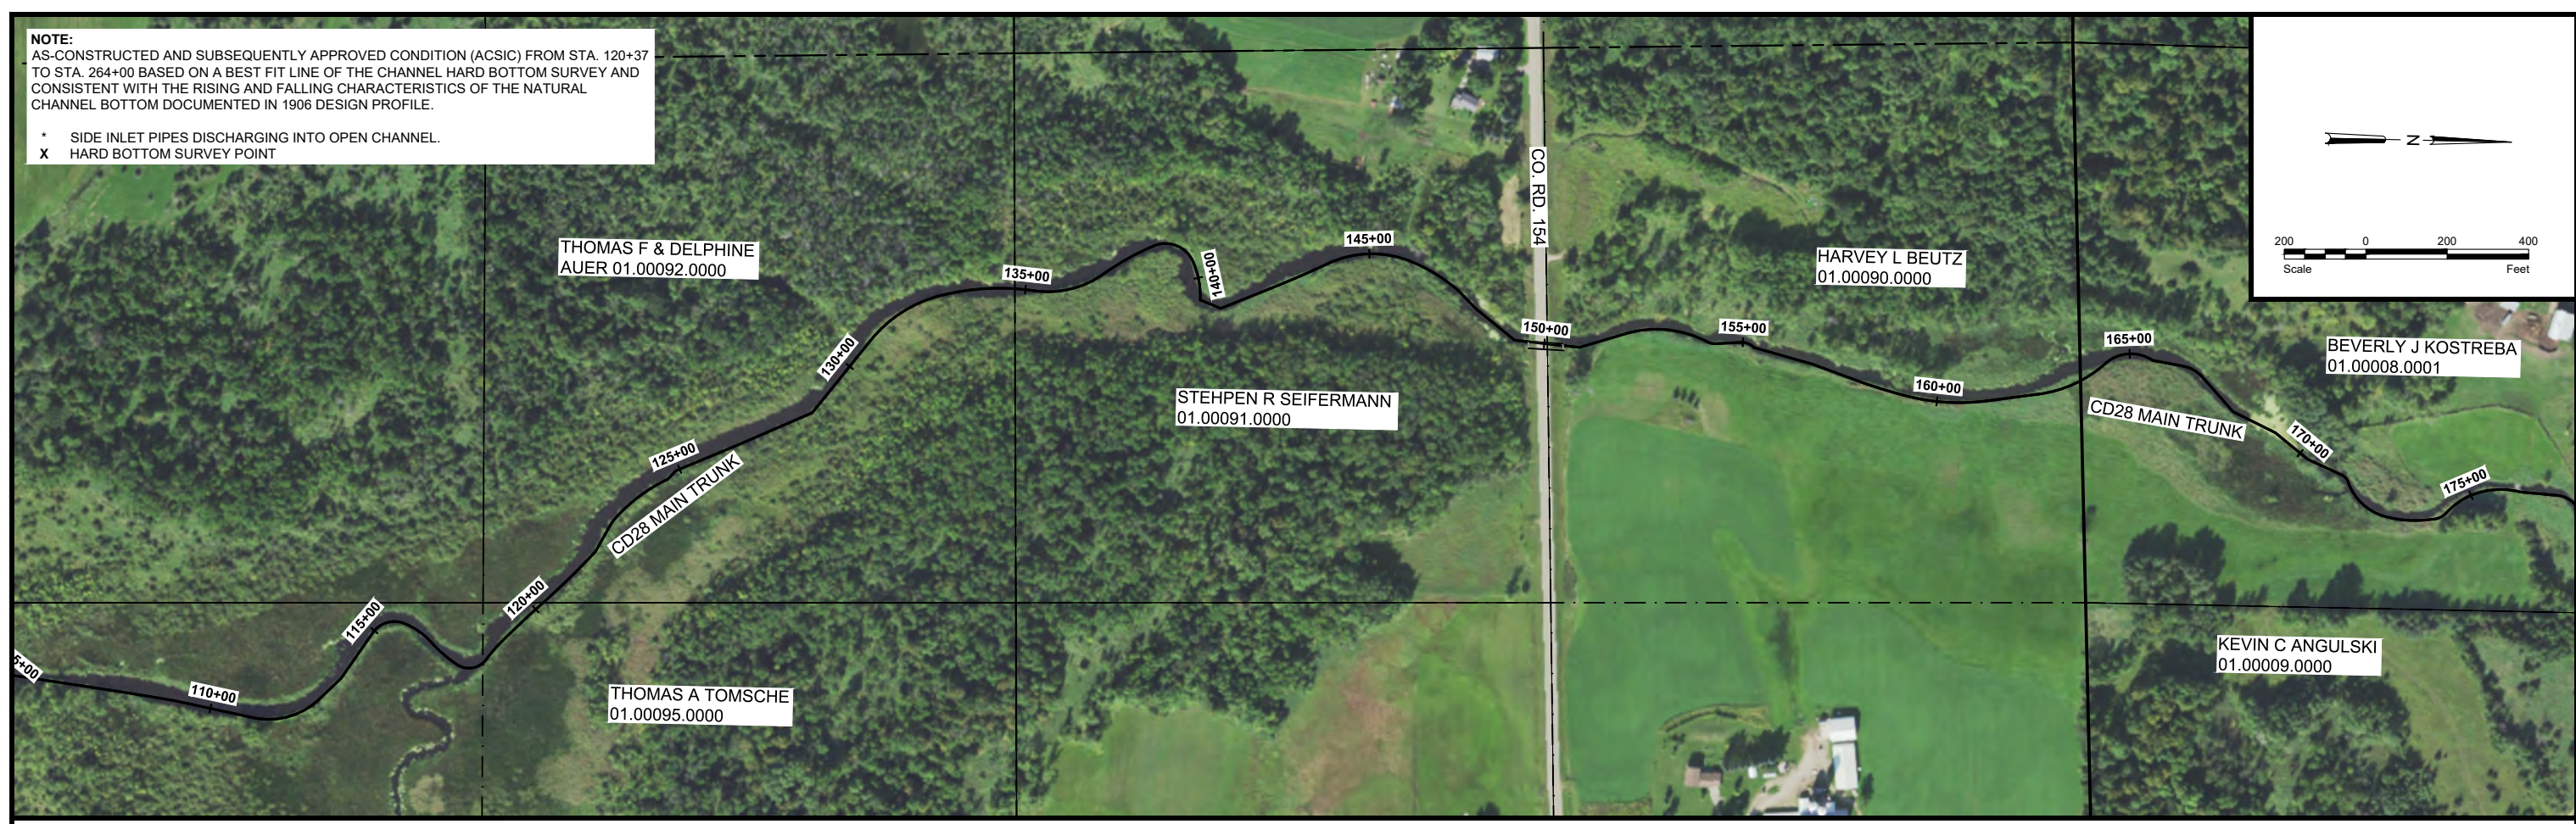
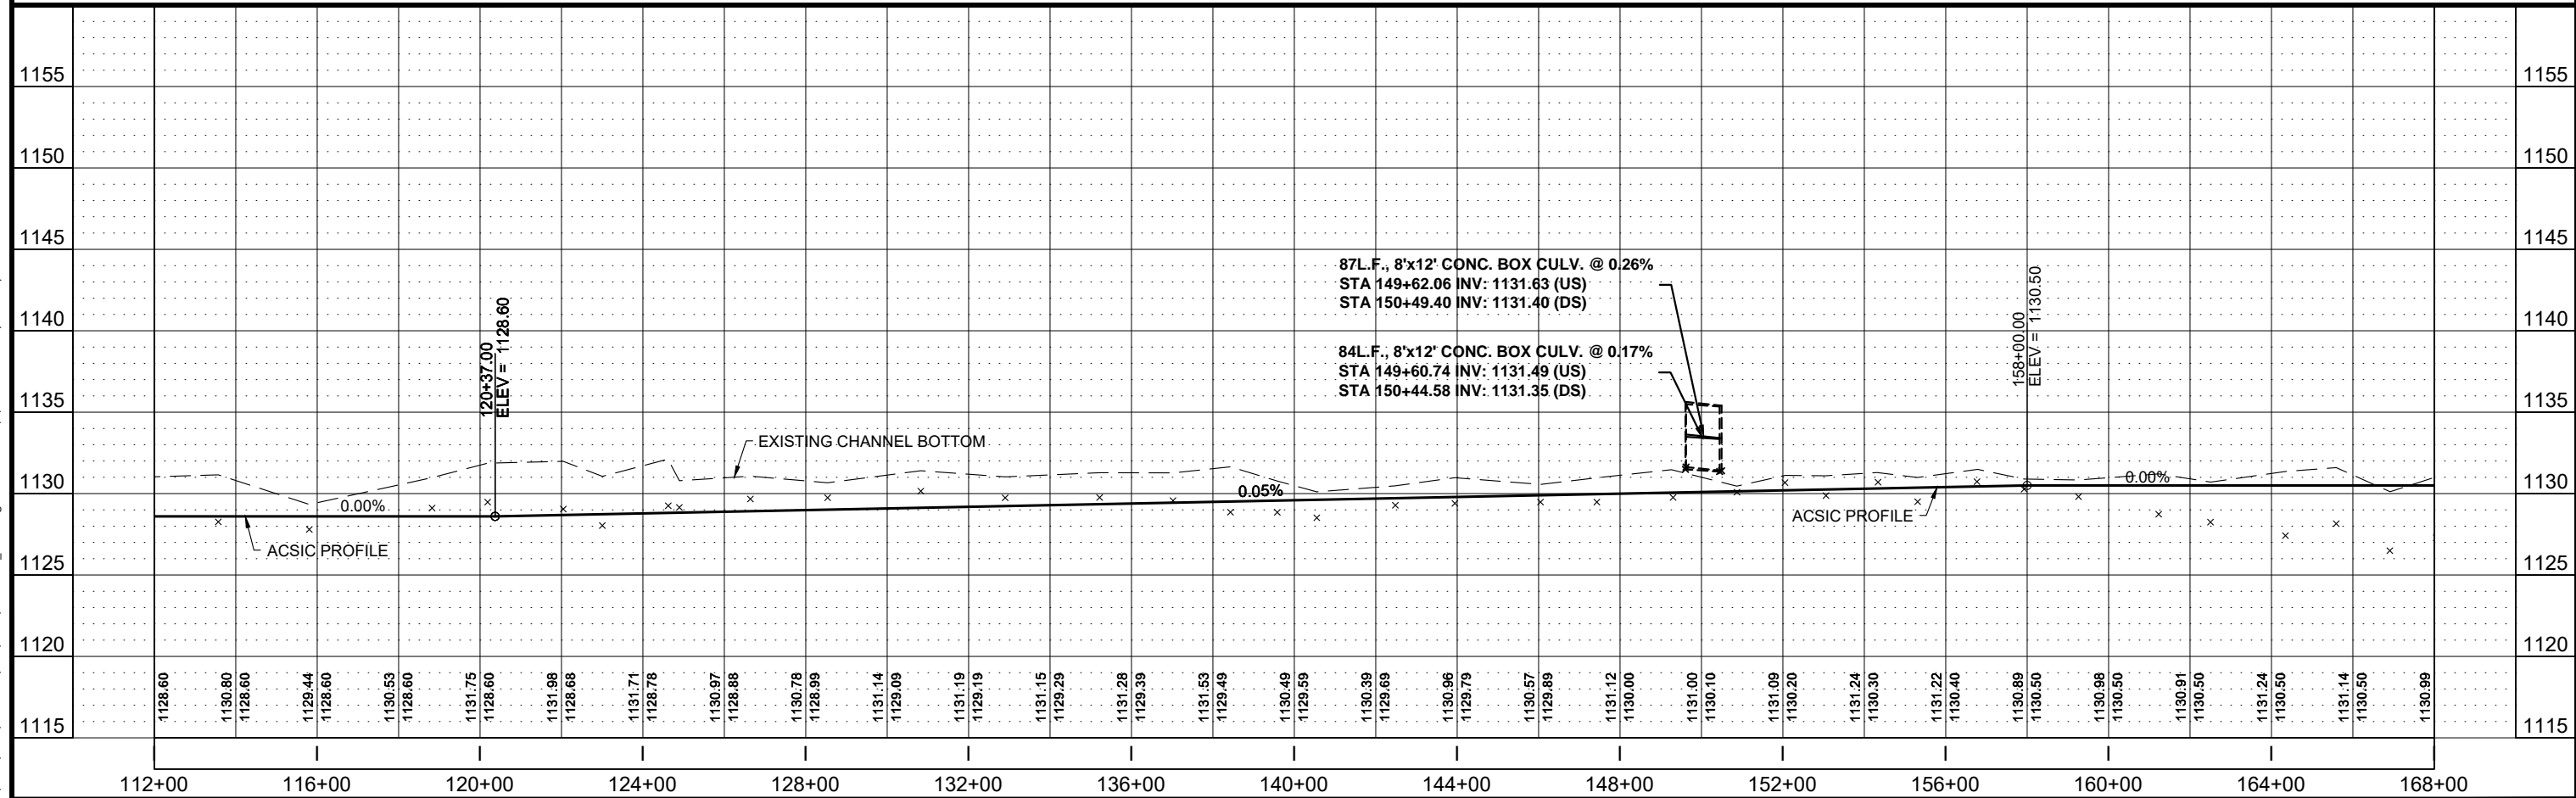
No.		Revision		Date	By	<p>PRELIMINARY Not for Construction</p>	Maple Grove	Drawn by TAM	Date 5-09-2019	REESTABLISHMENT OF STEARNS COUNTY DITCH 28 STEARNS COUNTY HOLDINGFORD, MN	STEARNS COUNTY DITCH 28 STA. 112+00 - 168+00 PROJECT NO. 6364-010	SHEET 3 of 8
P:		F:					Checked by GM	Scale AS SHOWN

NOTE:
 AS-CONSTRUCTED AND SUBSEQUENTLY APPROVED CONDITION (ACSIC) FROM STA. 120+37 TO STA. 264+00 BASED ON A BEST FIT LINE OF THE CHANNEL HARD BOTTOM SURVEY AND CONSISTENT WITH THE RISING AND FALLING CHARACTERISTICS OF THE NATURAL CHANNEL BOTTOM DOCUMENTED IN 1906 DESIGN PROFILE.

* SIDE INLET PIPES DISCHARGING INTO OPEN CHANNEL.
 X HARD BOTTOM SURVEY POINT

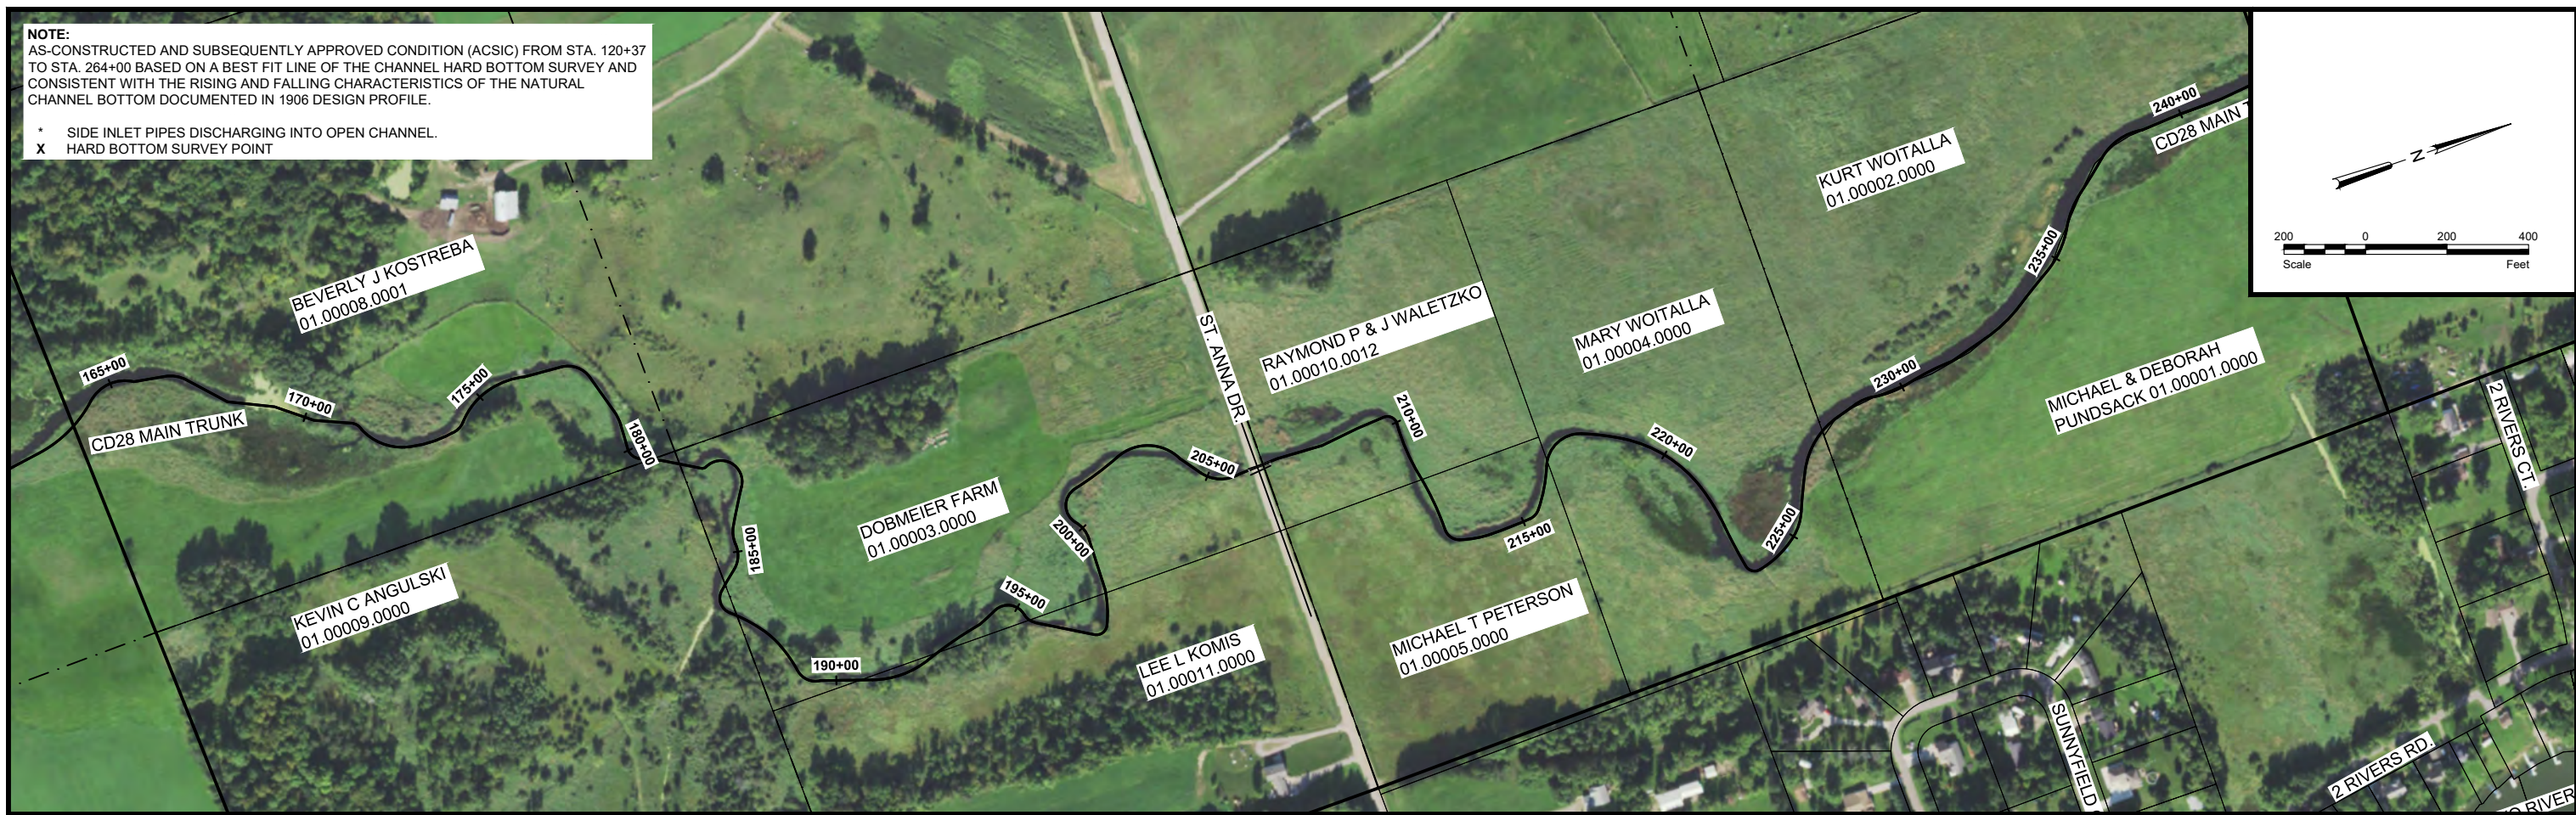
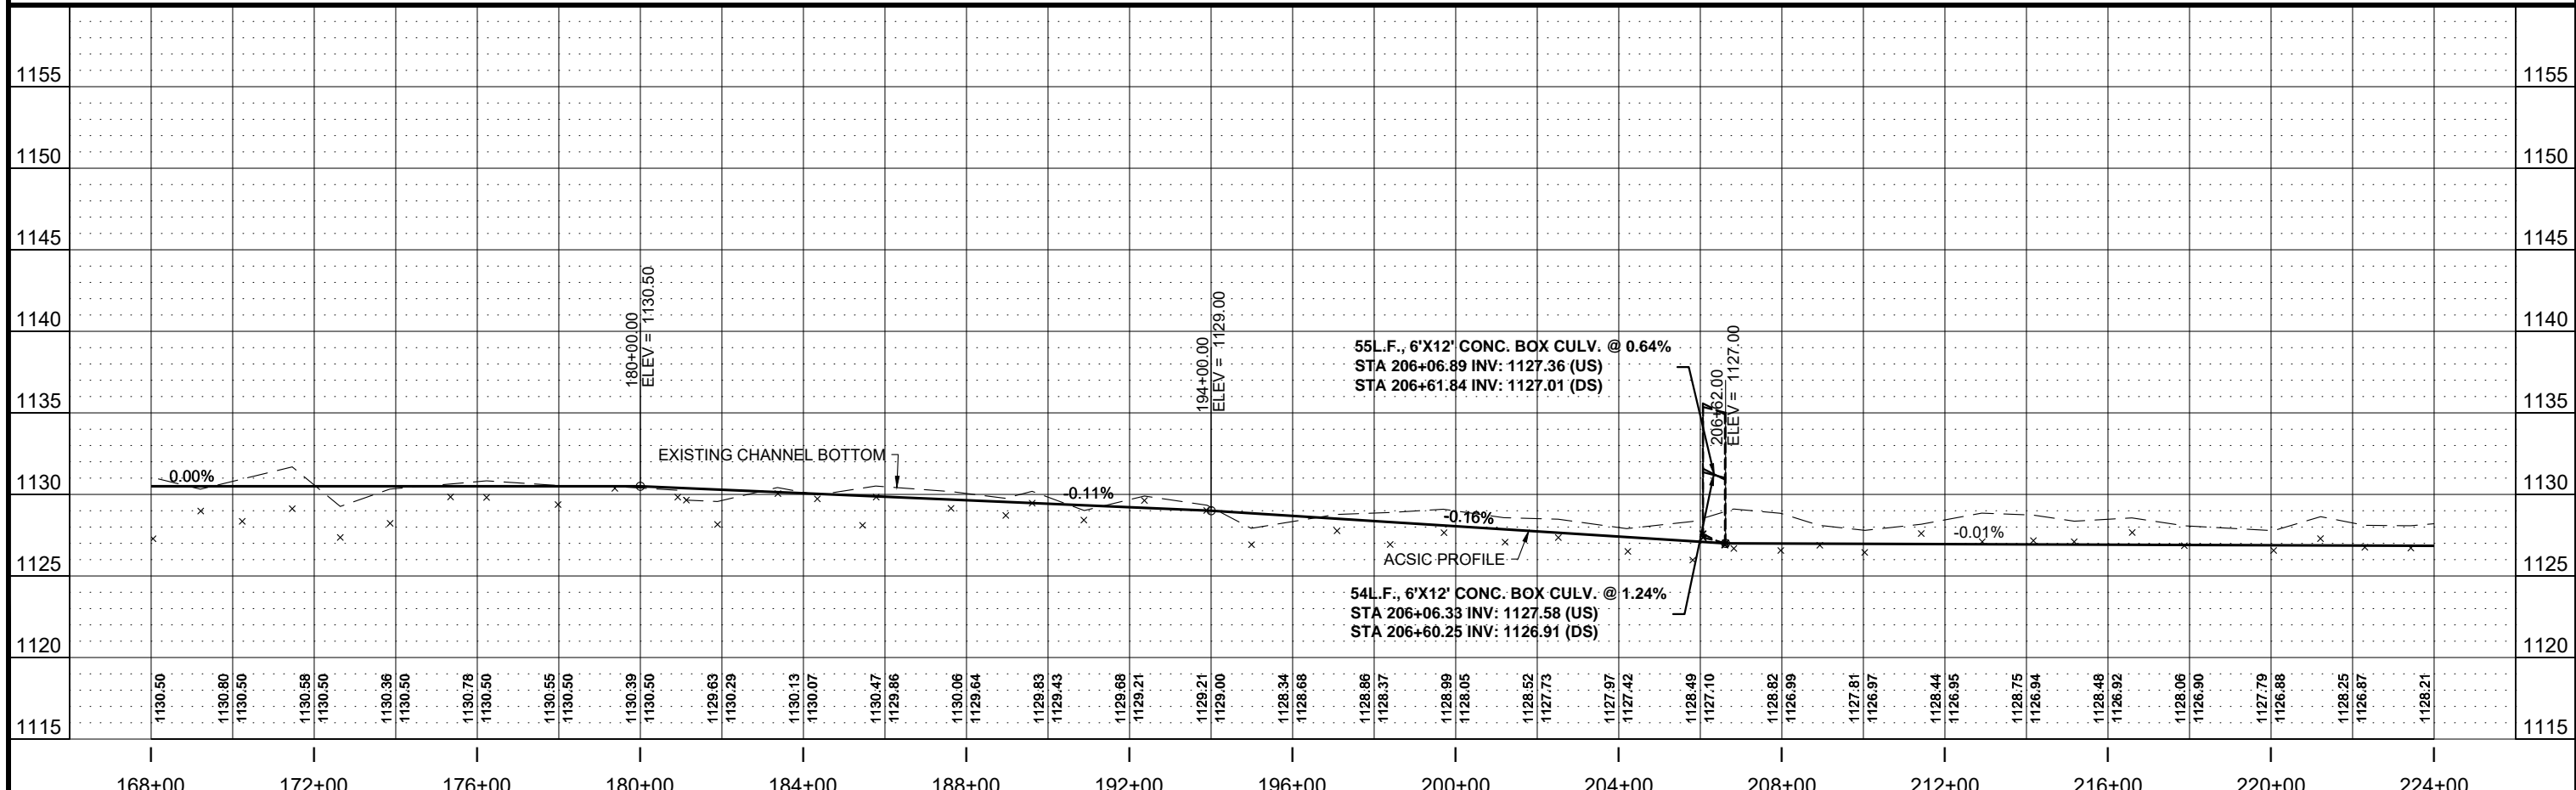
NOTE:
 AS-CONSTRUCTED AND SUBSEQUENTLY APPROVED CONDITION (AC SIC) FROM STA. 120+37 TO STA. 264+00 BASED ON A BEST FIT LINE OF THE CHANNEL HARD BOTTOM SURVEY AND CONSISTENT WITH THE RISING AND FALLING CHARACTERISTICS OF THE NATURAL CHANNEL BOTTOM DOCUMENTED IN 1906 DESIGN PROFILE.

* SIDE INLET PIPES DISCHARGING INTO OPEN CHANNEL.
 X HARD BOTTOM SURVEY POINT
