**In the Matter of:
the Reestablishment of Stearns County
Ditch 28 Drainage System Records**

**FINDINGS AND ORDER
REESTABLISHING DRAINAGE
SYSTEM RECORDS**

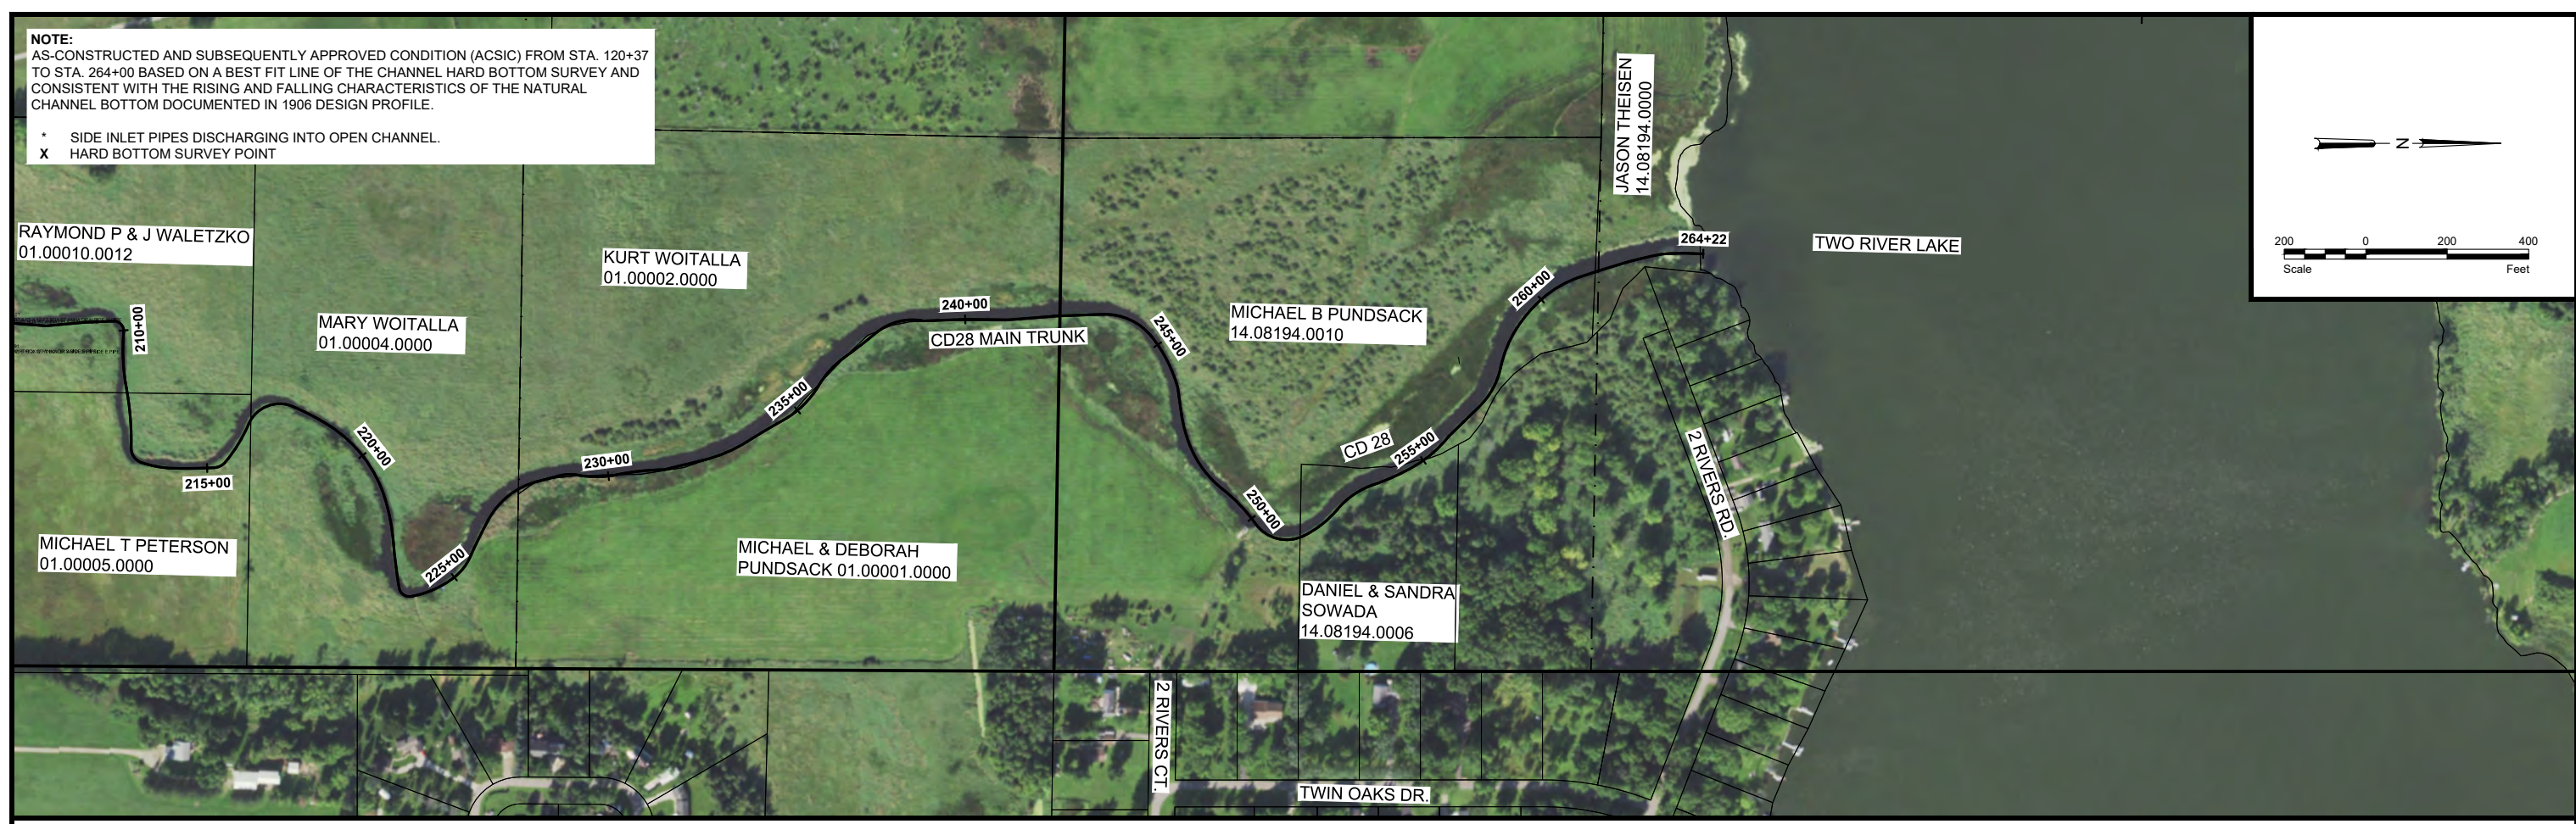
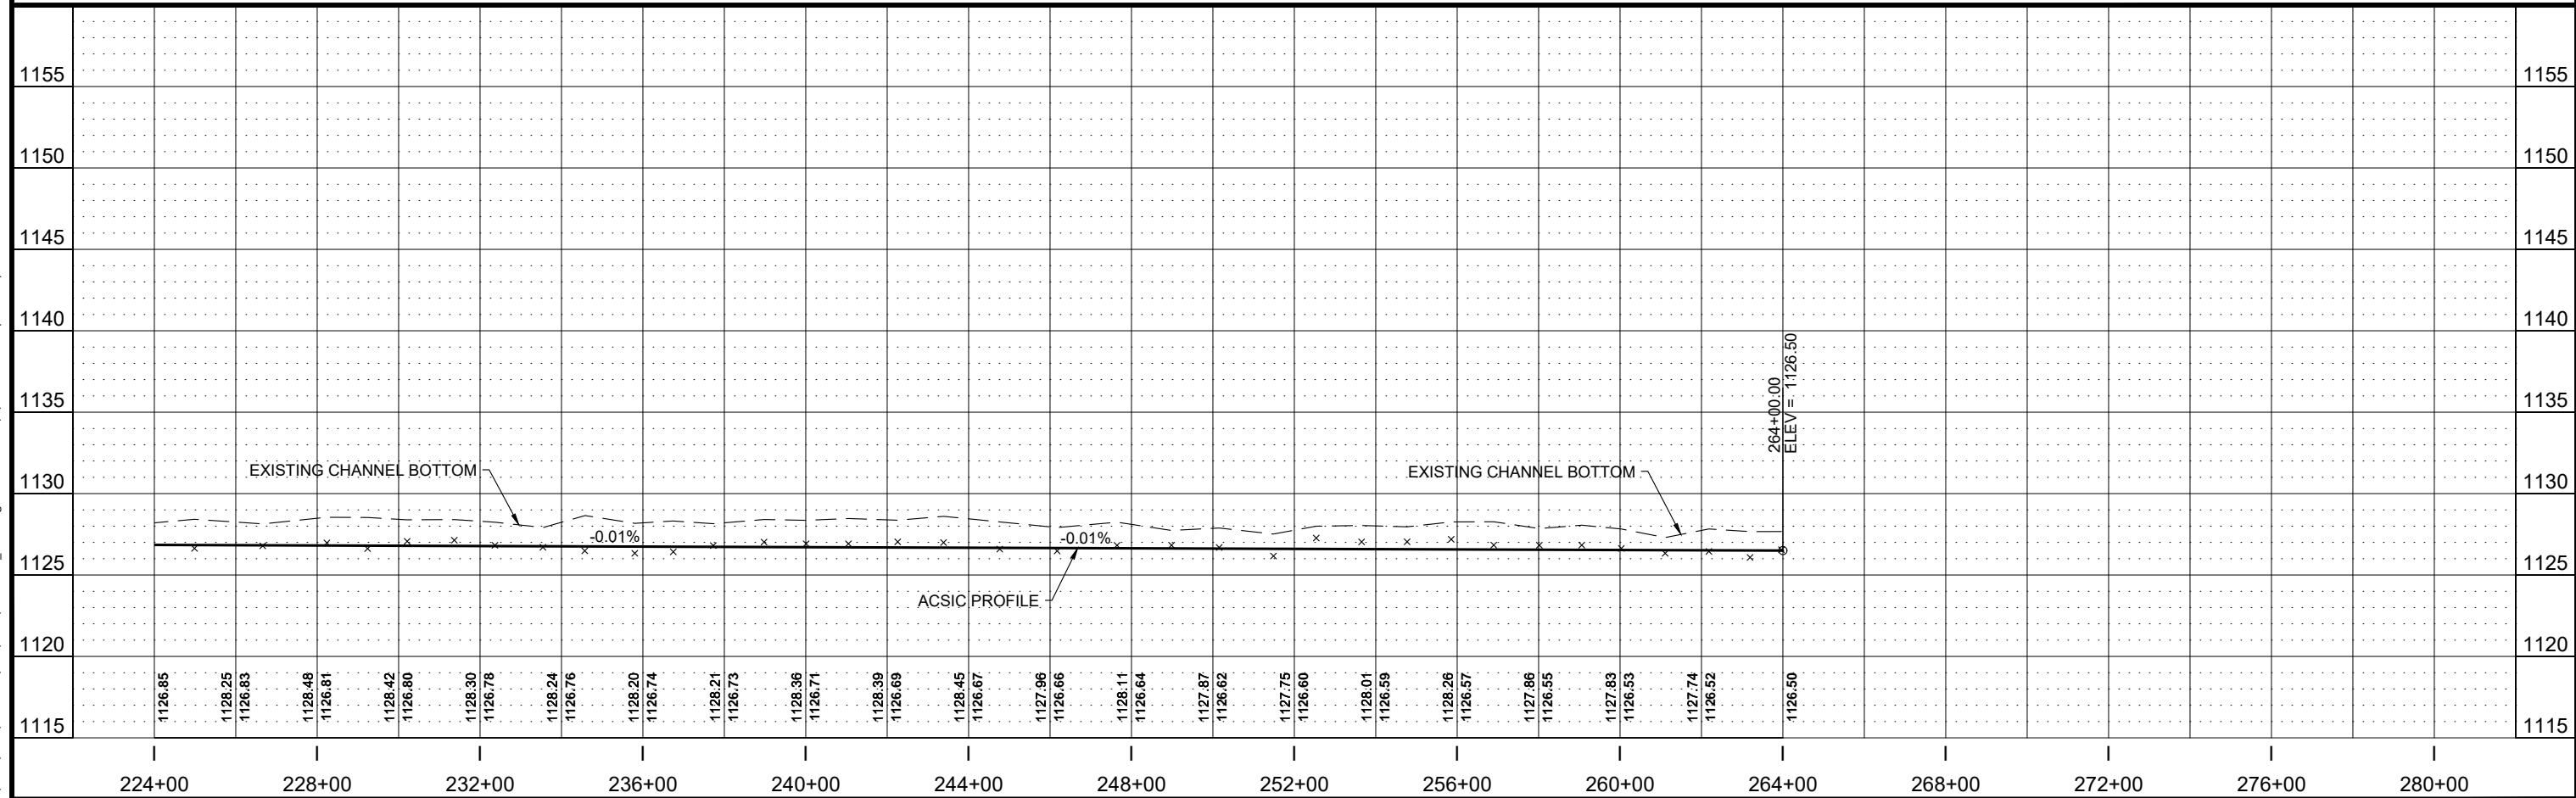
No.		Revision		Date	By	<p>PRELIMINARY Not for Construction</p>	Maple Grove	Drawn by TAM	Date 5-09-2019	REESTABLISHMENT OF STEARNS COUNTY DITCH 28 STEARNS COUNTY HOLDINGFORD, MN	STEARNS COUNTY DITCH 28 STA. 224+00 - 264+00 PROJECT NO. 6364-010	SHEET 5 of 8
P:		F:						Checked by GM	Scale AS SHOWN

NOTE:
 AS-CONSTRUCTED AND SUBSEQUENTLY APPROVED CONDITION (ACSIC) FROM STA. 120+37 TO STA. 264+00 BASED ON A BEST FIT LINE OF THE CHANNEL HARD BOTTOM SURVEY AND CONSISTENT WITH THE RISING AND FALLING CHARACTERISTICS OF THE NATURAL CHANNEL BOTTOM DOCUMENTED IN 1906 DESIGN PROFILE.

* SIDE INLET PIPES DISCHARGING INTO OPEN CHANNEL.
 X HARD BOTTOM SURVEY POINT

Two excavated portions of CD 28 that had a good statistical fit (STA 103+08 – 120+37 and downstream of Two Rivers Lake), when analyzed separately, both result in a vertical datum adjustment of 1036.6. The furthest upstream portion of CD 28 that was excavated (STA 84+46 - 89+99), did not have an acceptable fit of the 1906 design profile to the observed hard bottom shots. Similarly, the ACSIC grade directly upstream of Two Rivers Lake (Sta. 238+78 – 264+00) did not have an acceptable fit to 1906 design profile.

There is an inconsistency in the 1906 profile near historic STA 110+00 that results in a poor fit of the profile from current STA 120+37 to 264+00. In this reach the ACSIC was determined by drawing a “best fit” line to match the hard-bottom survey. When this was compared to the historic 1906 profile, it was found that the best fit line reflected the general rising and falling characteristics of the original profile. See **Appendix A** for the ACSIC profile, as compared to existing open channel bottom survey elevations.

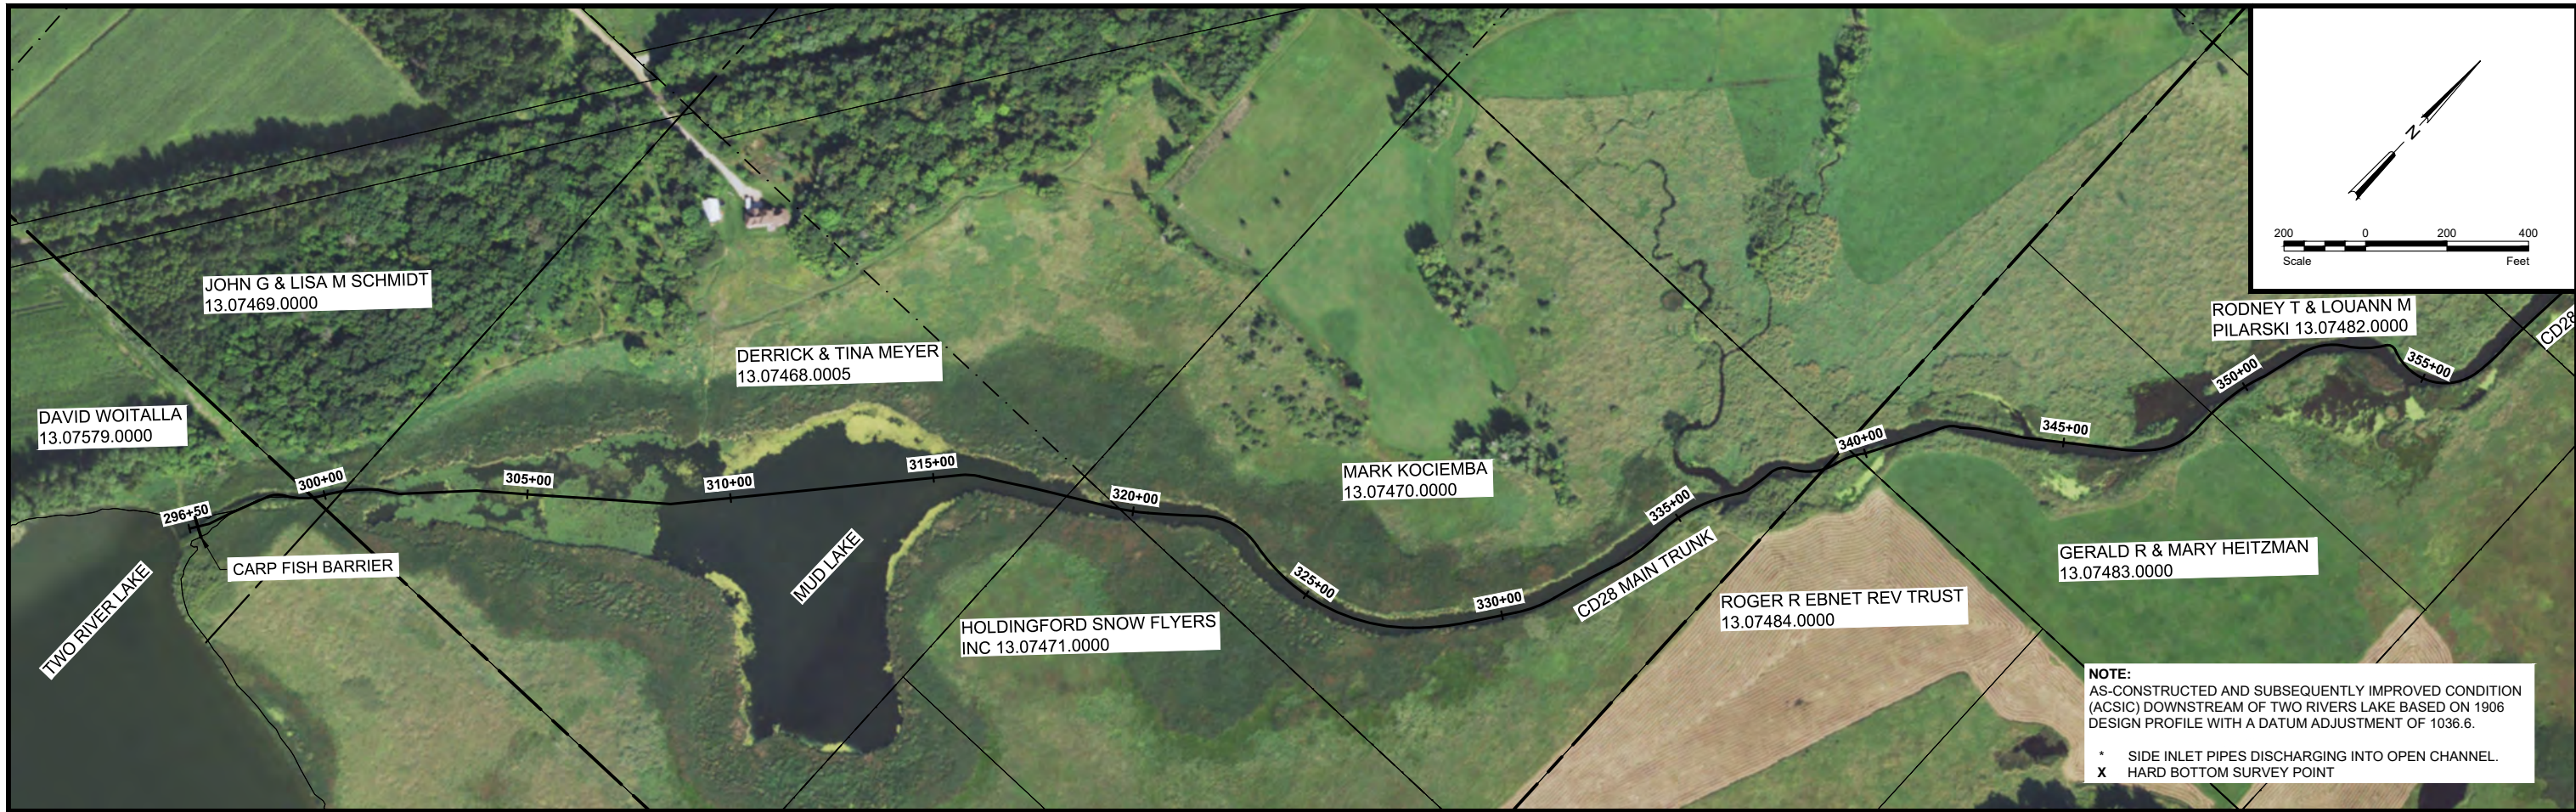
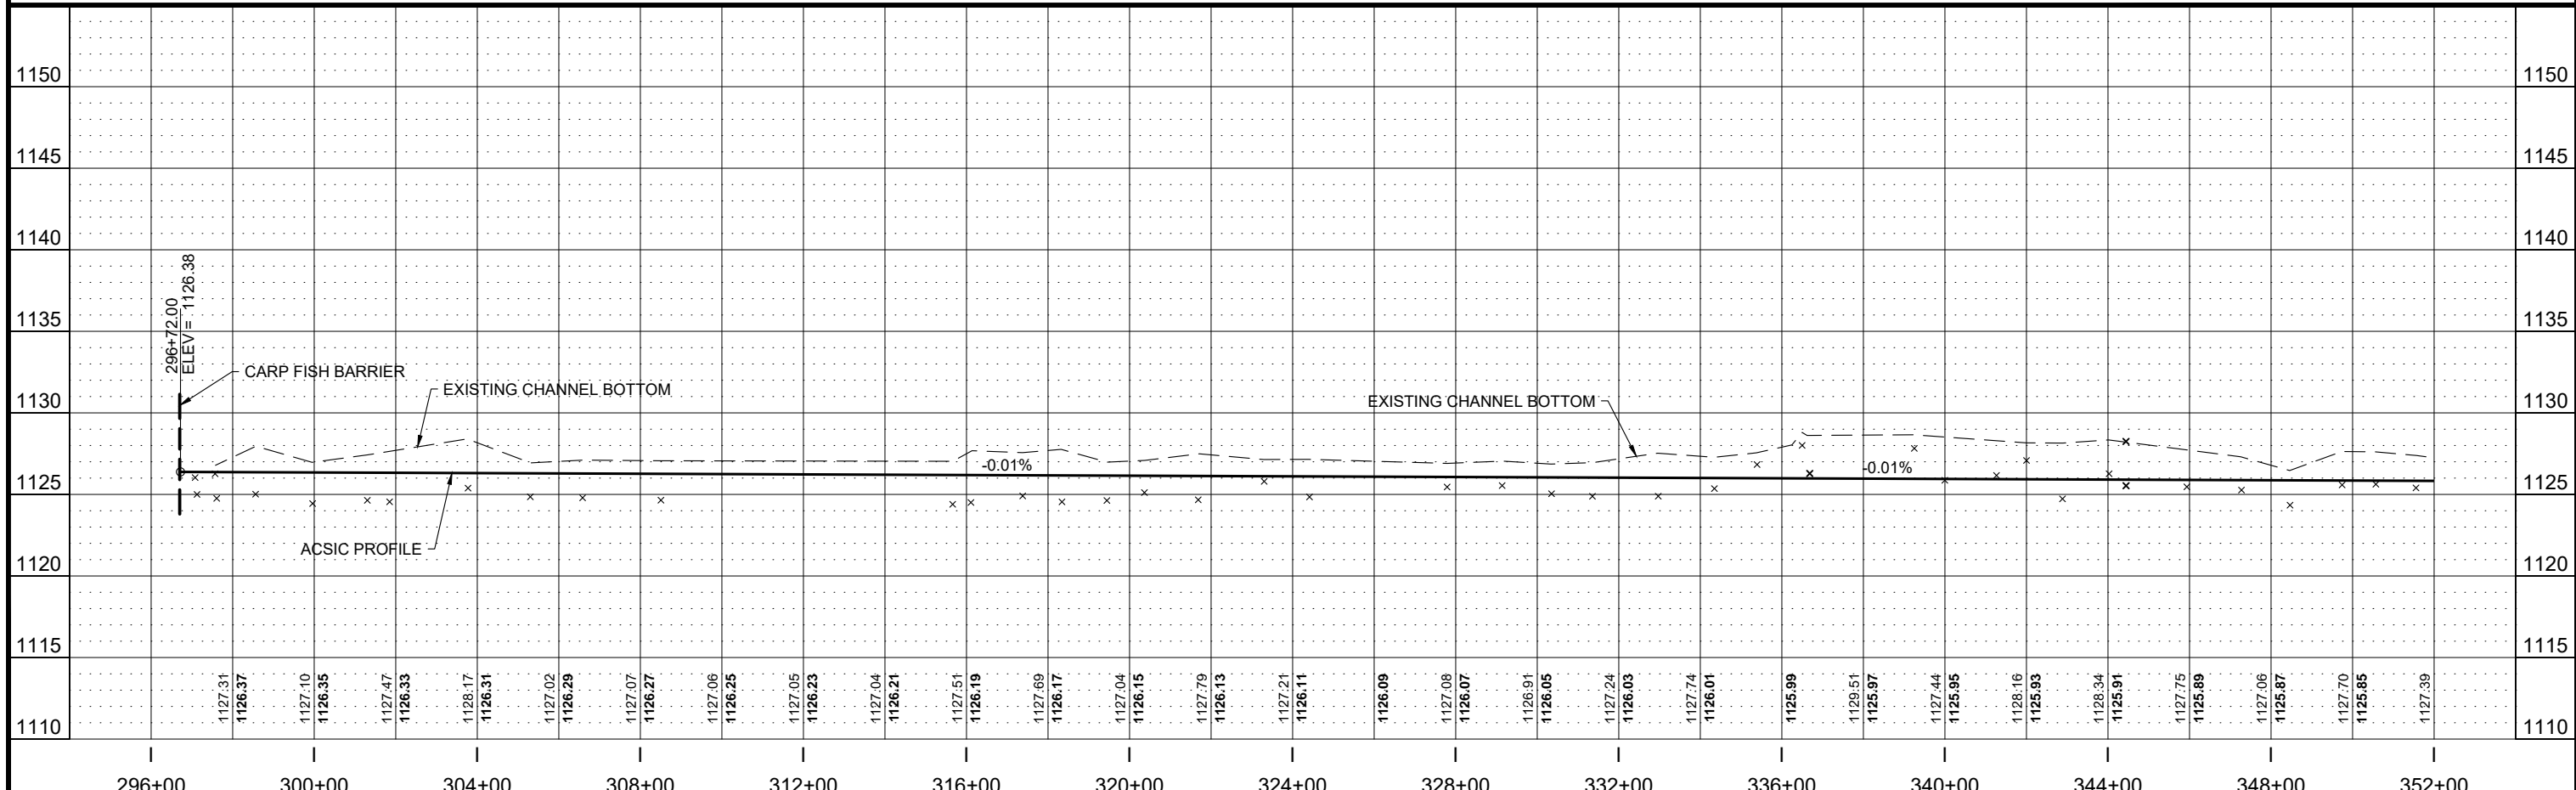
NOTE:
 AS-CONSTRUCTED AND SUBSEQUENTLY IMPROVED CONDITION (ACSIC) DOWNSTREAM OF TWO RIVERS LAKE BASED ON 1906 DESIGN PROFILE WITH A DATUM ADJUSTMENT OF 1036.6.
 * SIDE INLET PIPES DISCHARGING INTO OPEN CHANNEL.
 X HARD BOTTOM SURVEY POINT

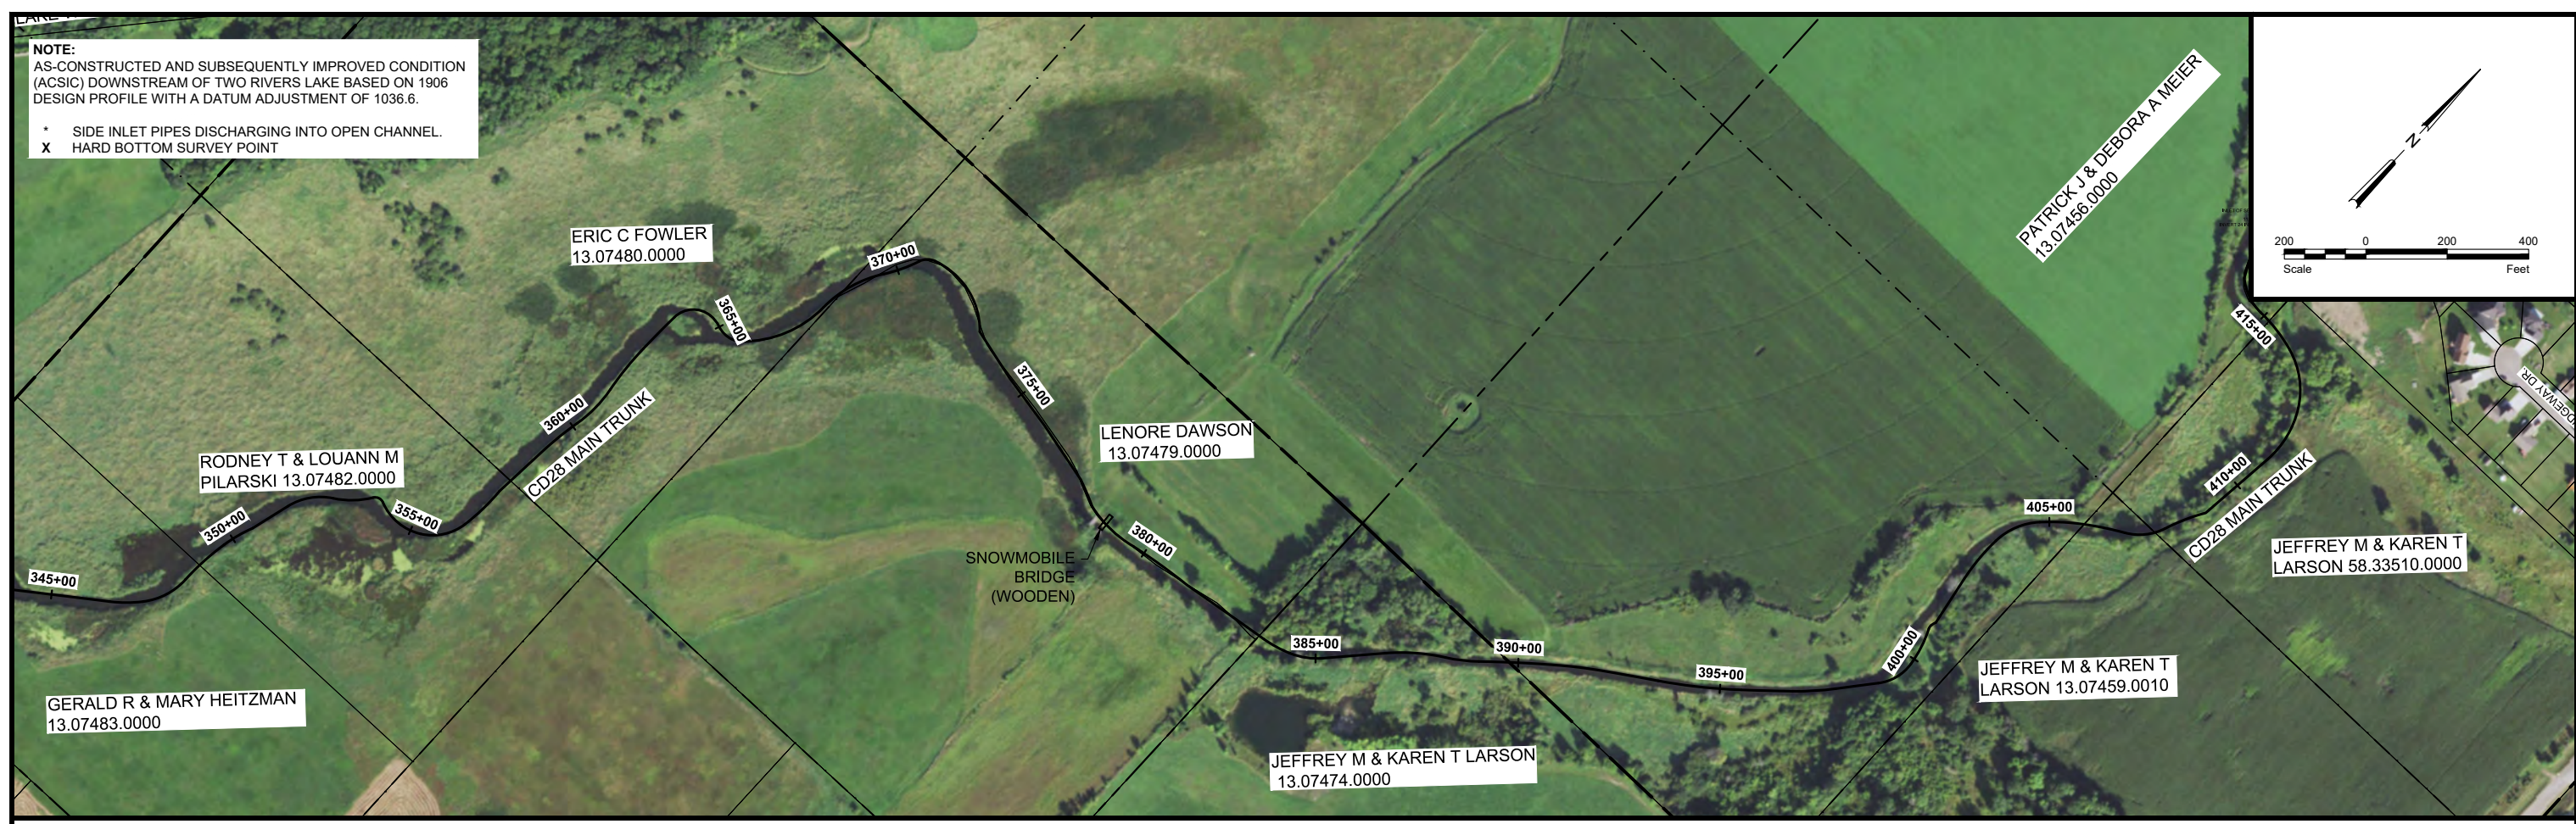
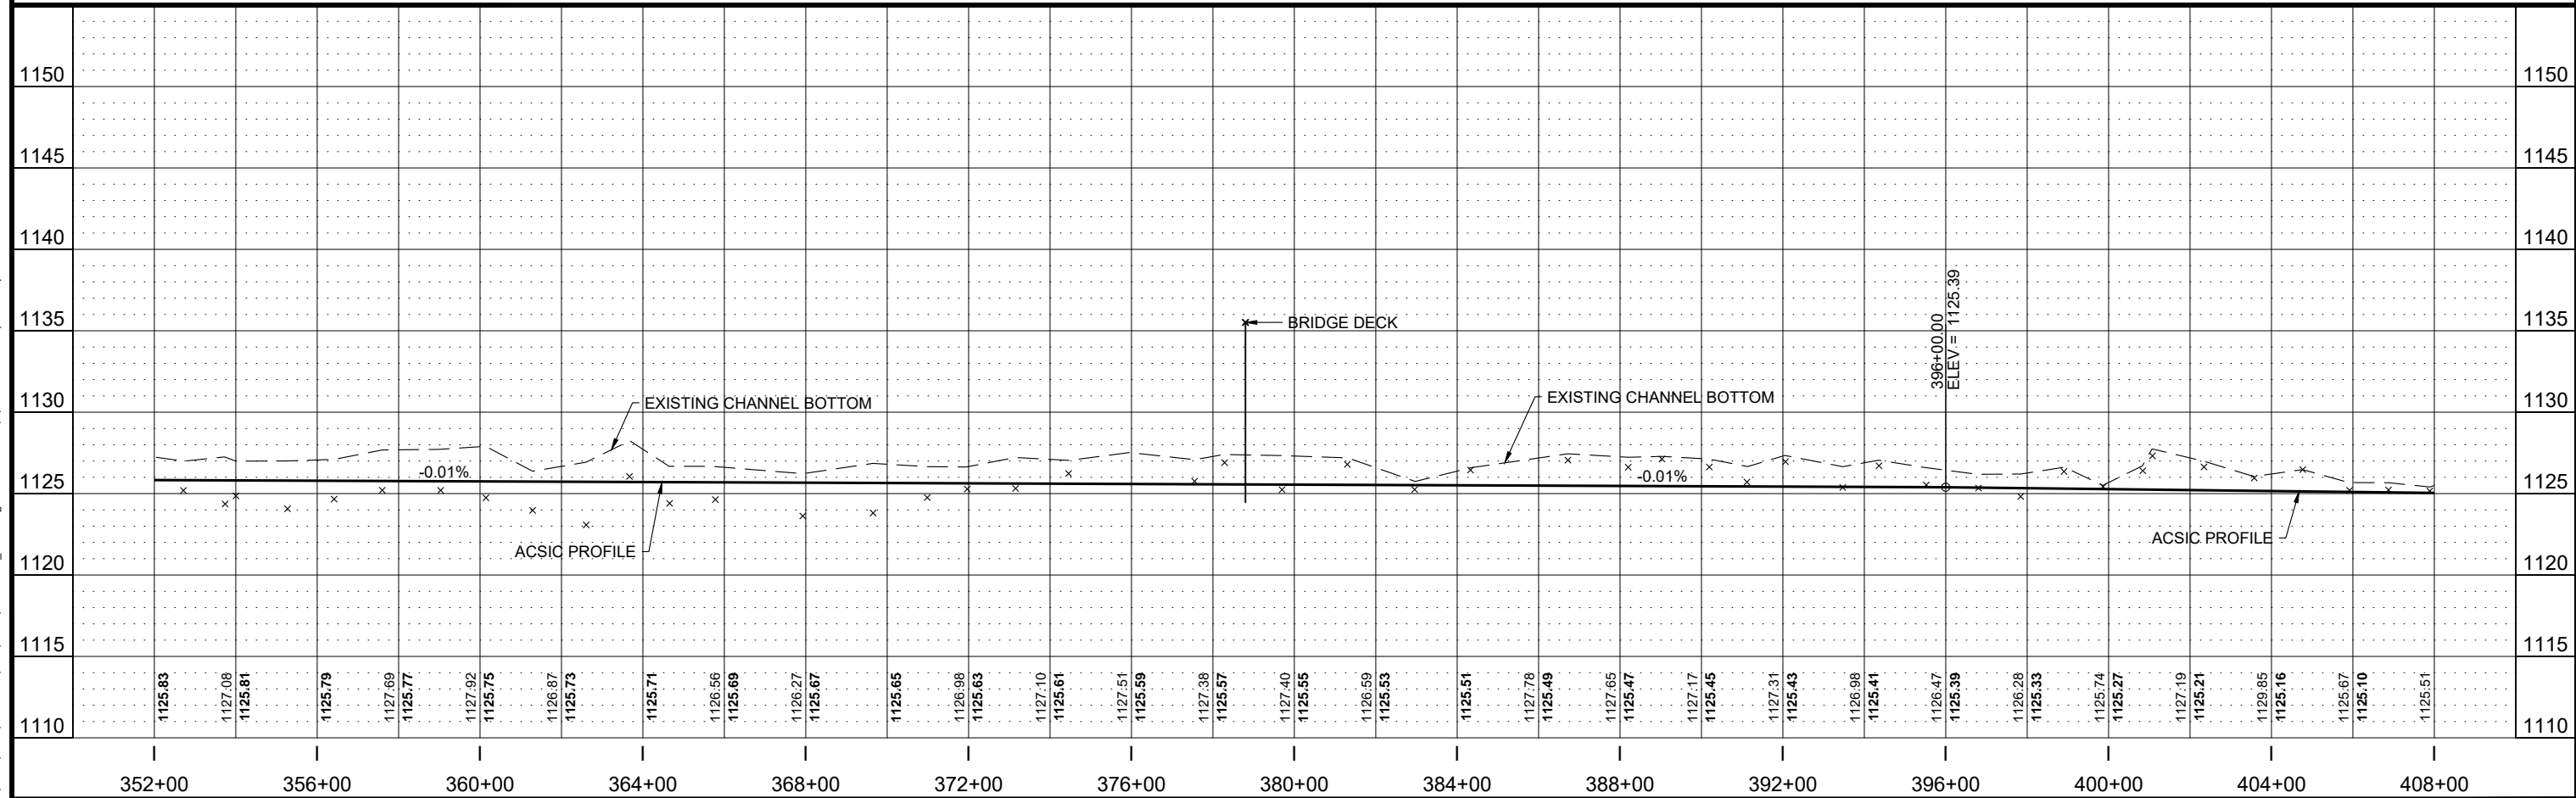
NOTE:
 AS-CONSTRUCTED AND SUBSEQUENTLY IMPROVED CONDITION (ACSIC) DOWNSTREAM OF TWO RIVERS LAKE BASED ON 1906 DESIGN PROFILE WITH A DATUM ADJUSTMENT OF 1036.6.

* SIDE INLET PIPES DISCHARGING INTO OPEN CHANNEL.
 X HARD BOTTOM SURVEY POINT

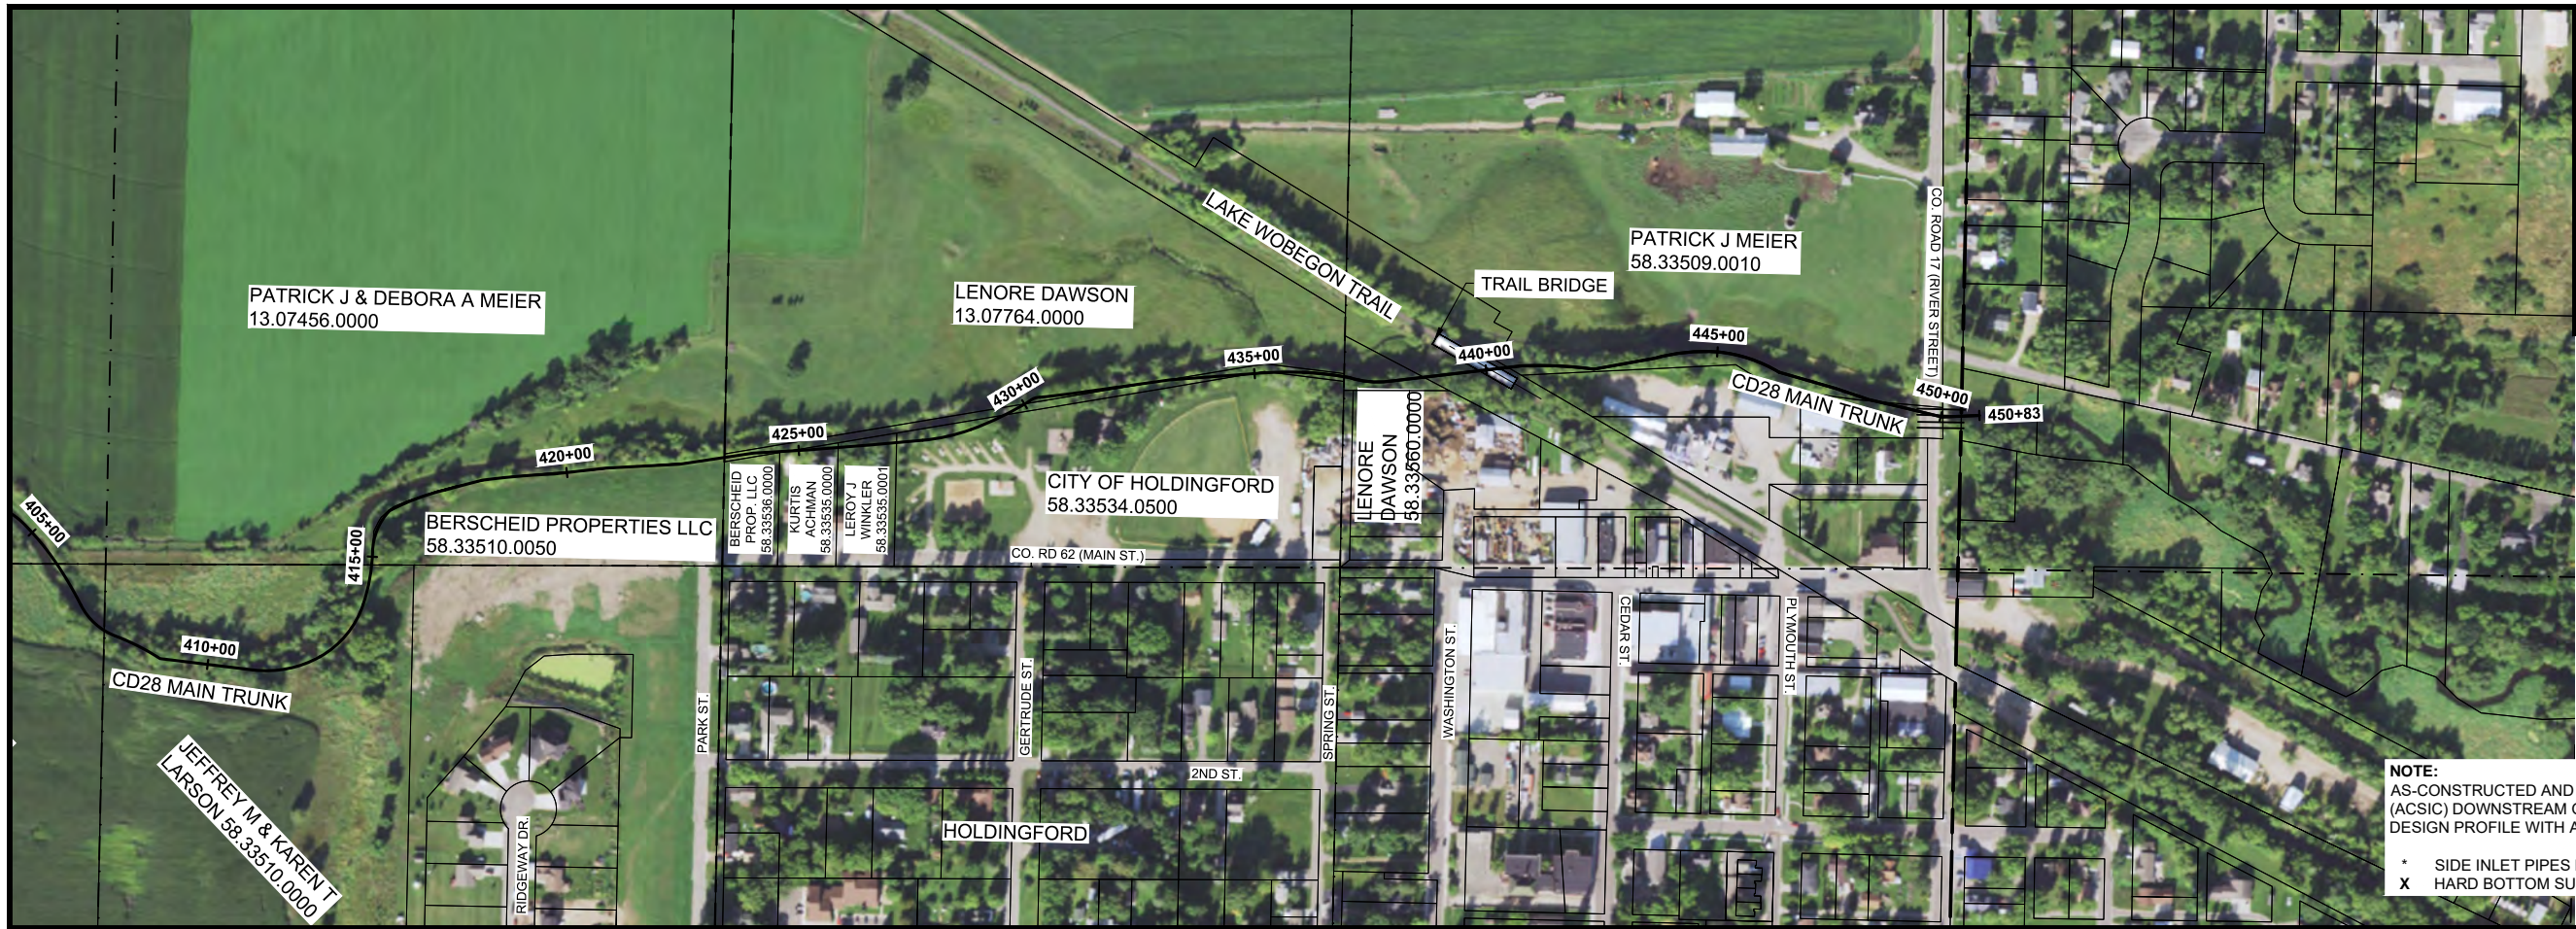
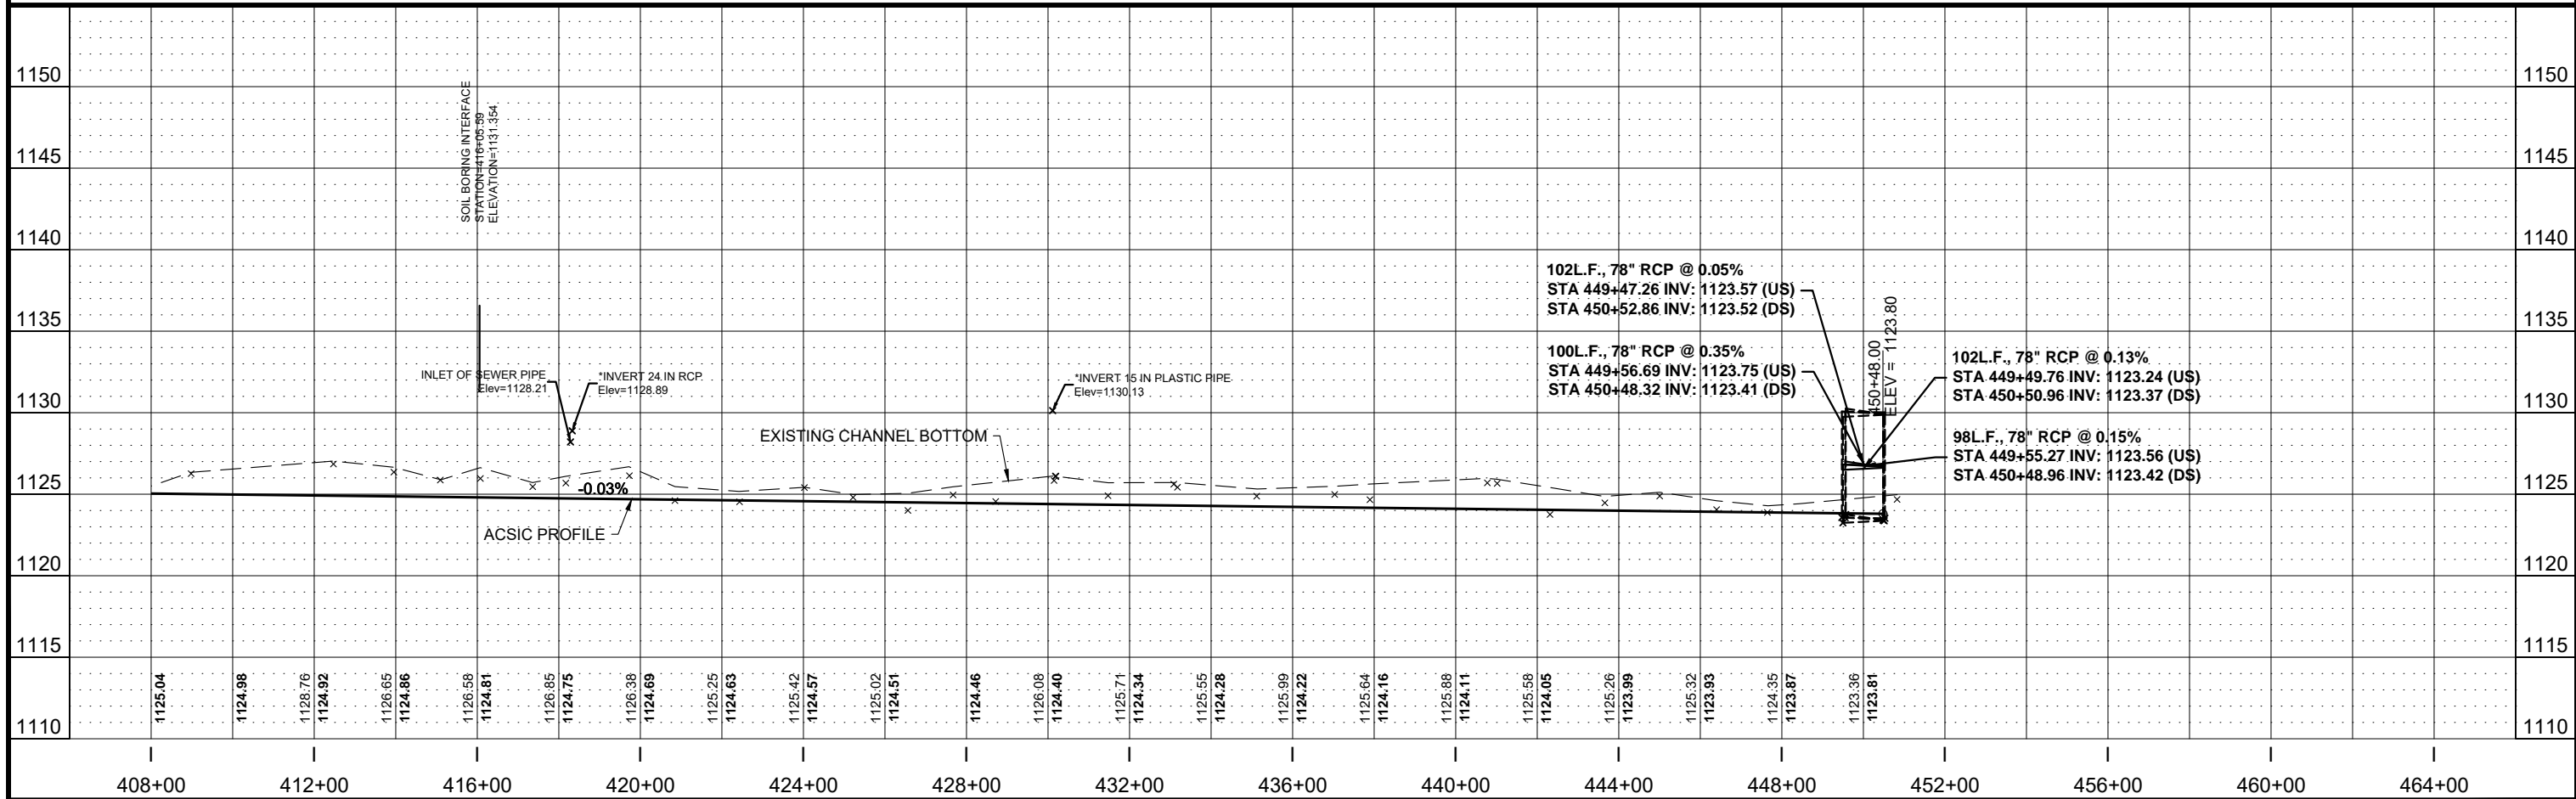
NOTE:
 AS-CONSTRUCTED AND SUBSEQUENTLY IMPROVED CONDITION (ACSIC) DOWNSTREAM OF TWO RIVERS LAKE BASED ON 1906 DESIGN PROFILE WITH A DATUM ADJUSTMENT OF 1036.6.
 * SIDE INLET PIPES DISCHARGING INTO OPEN CHANNEL.
 X HARD BOTTOM SURVEY POINT
